## **Yellow Creek Watershed Technical Memorandum**

Prepared for  
**Summit County Engineer's Office**  
**September 2019**

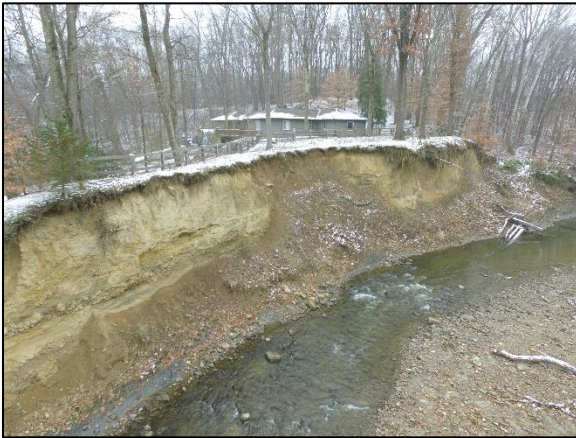
Figure 4: Geotechnical mass wasting (bank failure) along Lower Yellow Creek.

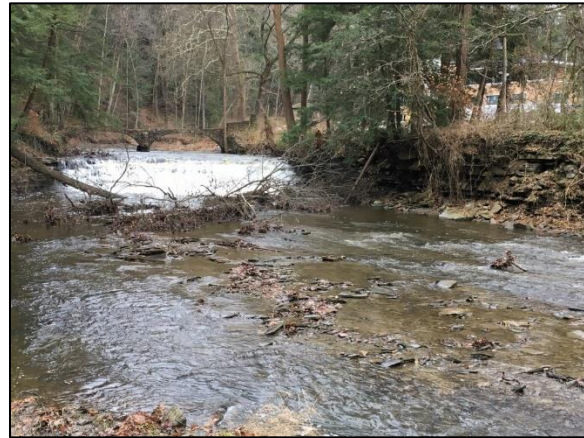
Figure 5: Knickpoint on Yellow Creek corresponding to elevations ~810-816

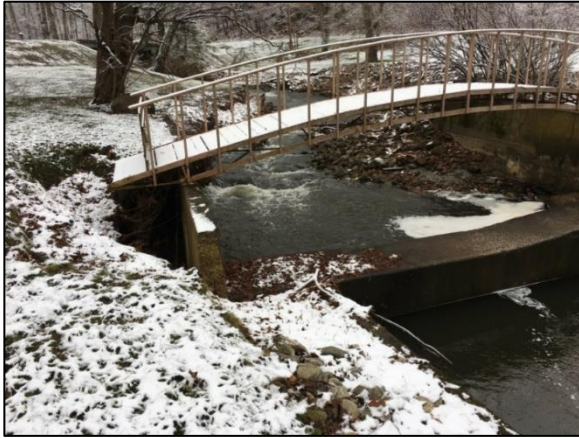
*Figure 8: Private bridge with tall, unstable banks and flanking behind bridge abutments*

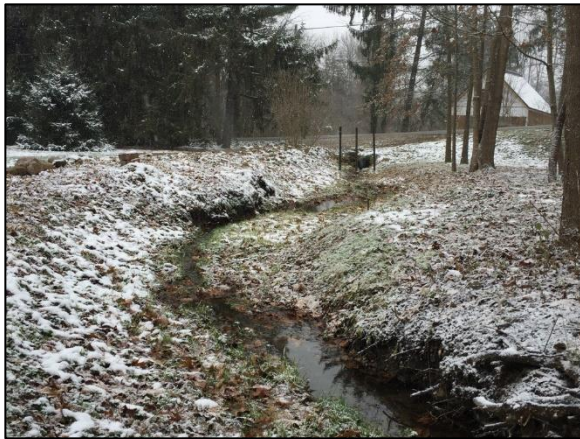
**1395 Partridge Culvert Study and Upsizing (Bath Township)**

*Figure 14: Culvert across Partridge Lane with landscaping rocks and driveway on left*

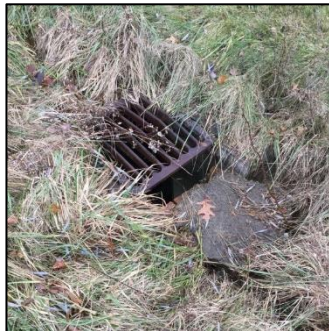
### Lakeview Dr Catch Basin Maintenance (Bath Township)

*Figure 16: Erosion and concrete failure at inlet*

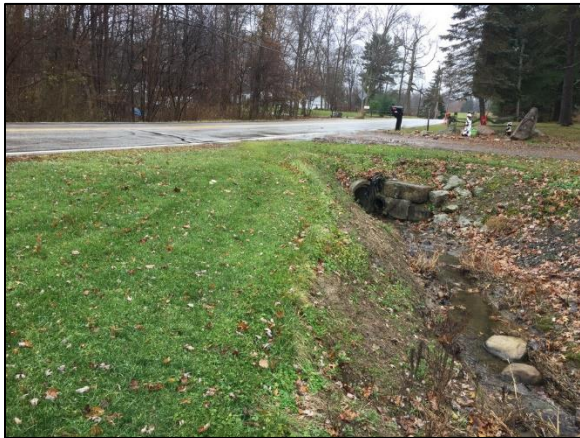
**Revere Rd 3 Culvert Study & Upsizing (SCE)**

*Figure 17: Culvert under Revere Road reported to have overtopped during past rain events*

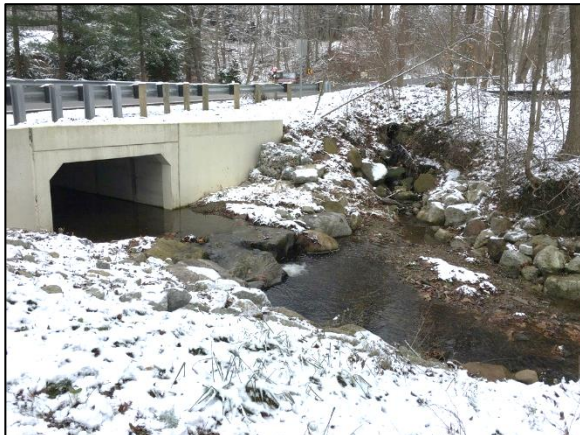
**Shaw Rd Outfall Repair (SCE)**

*Figure 18: Eroded stormwater outfall next to bridge*

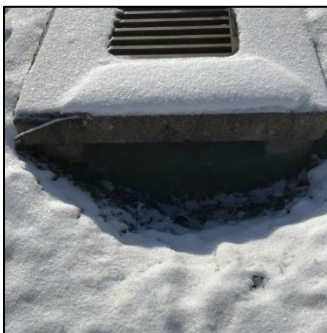
**Swan Lake Catch Basin Maintenance (Copley Township)**

*Figure 19: Erosion at inlet*

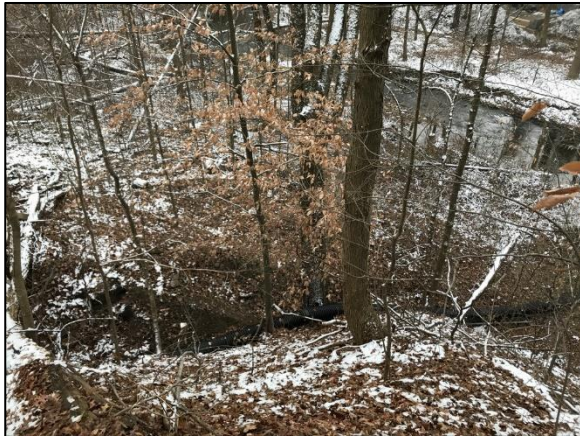
### Woodthrush Storm Sewer Repair and Channel Stabilization (Private)

*Figure 20: Black HDPE pipe lying in the ravine with Yellow Creek in the background*

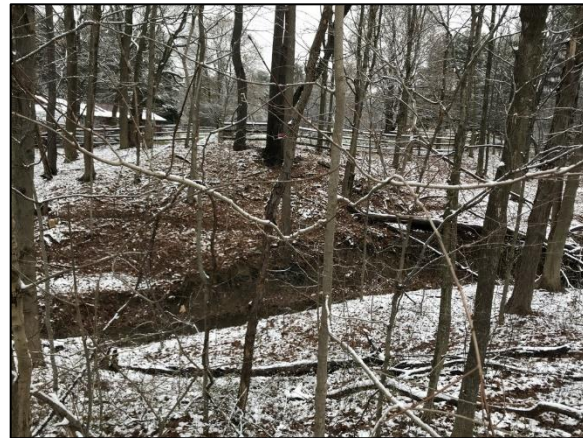
*Figure 29: Northern tributary near tennis courts exhibiting eroded banks*

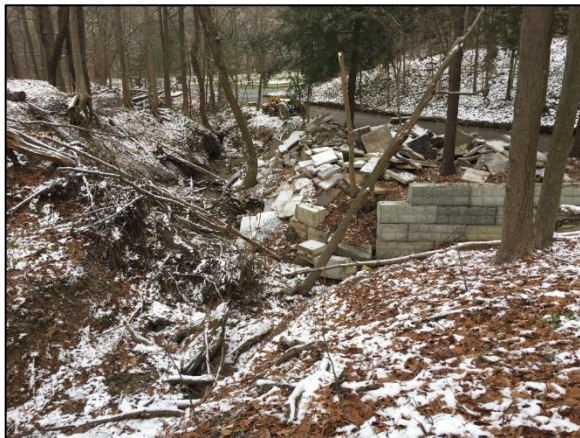
*Figure 30: Confluence of tributaries with mass wasting and compromised retaining walls*

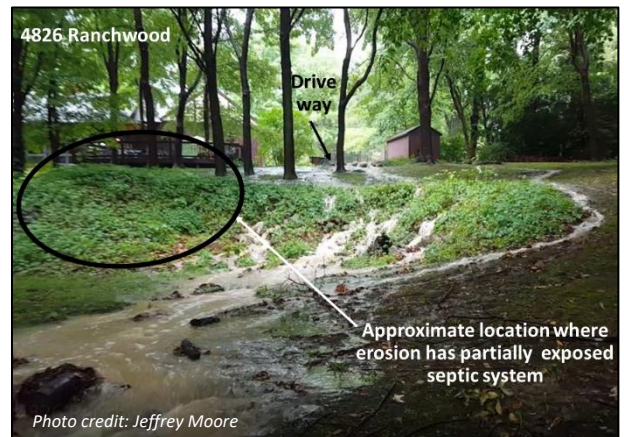
*Figure 34: Flooding looking from backyard with partially exposed septic location identified*

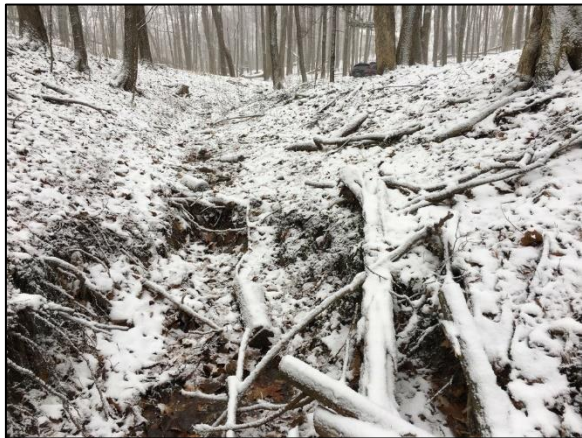
**Timberline Part C: Headcut Repair (SWMD/Private)**

*Figure 38: Headcut currently checked by tree root*

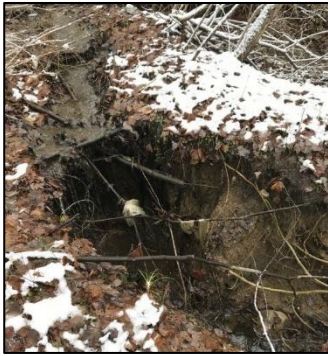
**Tributary Stabilization (SWMD/Private)**

*Figure 39: ~4-ft headcut in tributary*

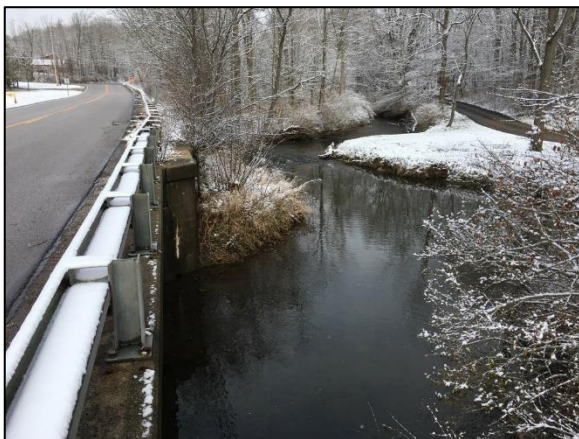
**Crystal Lake Stream Re-alignment (SCE/SWMD)**

*Figure 40: Yellow Creek along Crystal Lake Road, looking downstream at alignment and erosion*

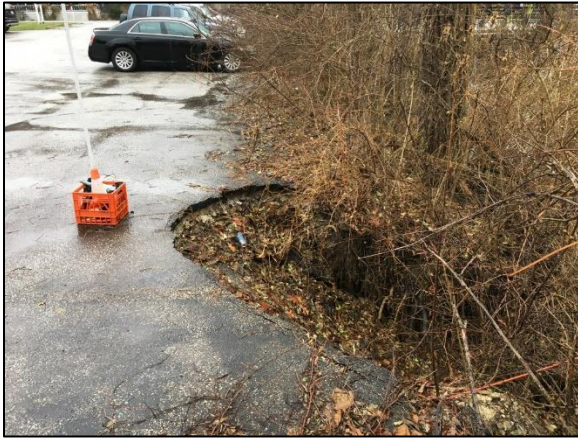
*Figure 41: Erosion in parking lot creating safety issue for users*

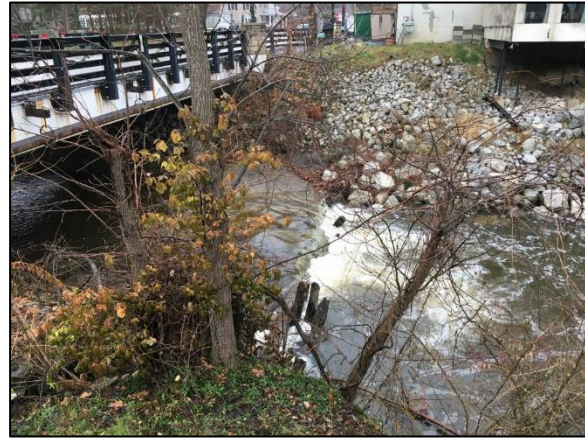
*Figure 42: Scour hole downstream of bridge and rock protection along Lanning's*

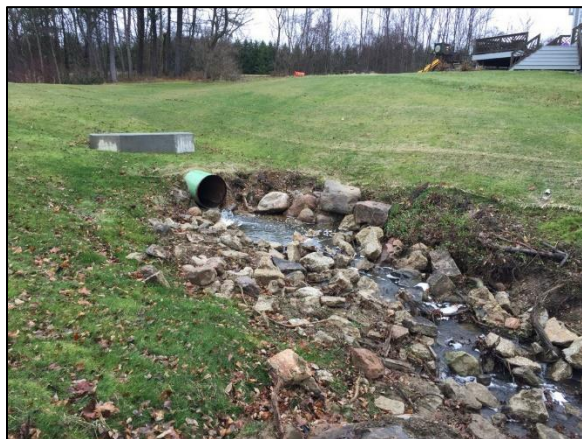
**Lakeview Dr Stream Stabilization (Assessed subdivision)**

*Figure 43: Bare bank areas downstream from the outfall indicate mobilized armoring*

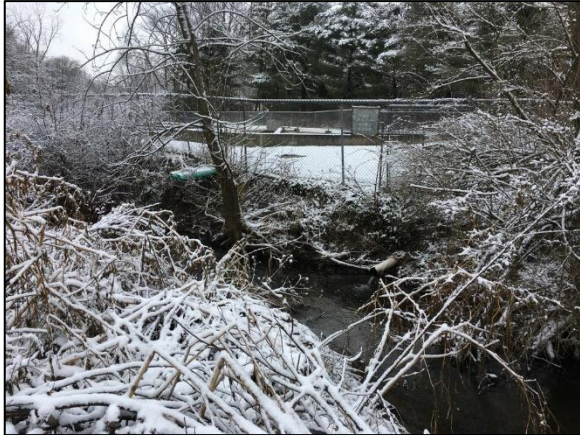
### Stabilization near WWTP (Private – Granger Lake Condos)

*Figure 46: Exposed pipes in bank show extents of bank erosion along WWTP fence*

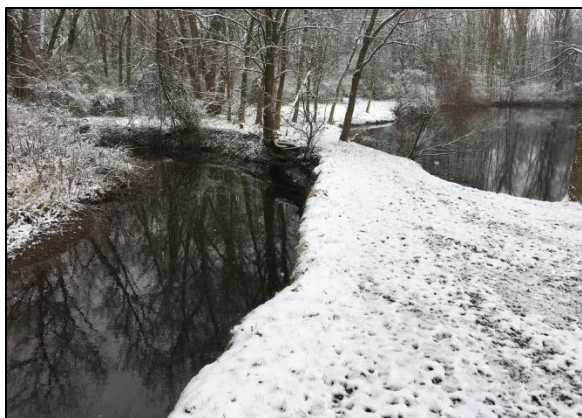
### Trellis Green Stream Stabilization (SWMD/assessed subdivision)

*Figure 47: Basin embankment with ~5-8 feet between pond and West Fork*

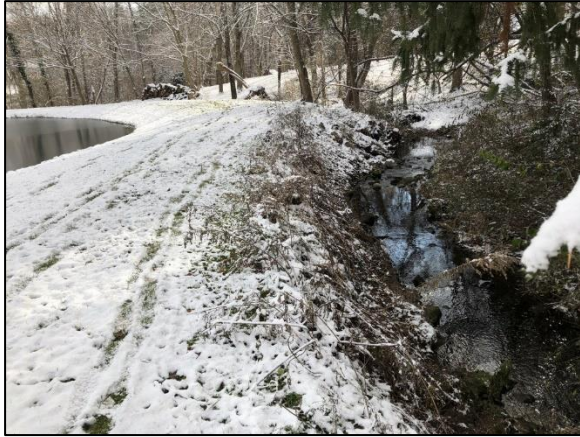
#### **West Creek Stabilization along Basin (Private)**

*Figure 48: Basin embankment with erosion on the bank of West Creek*

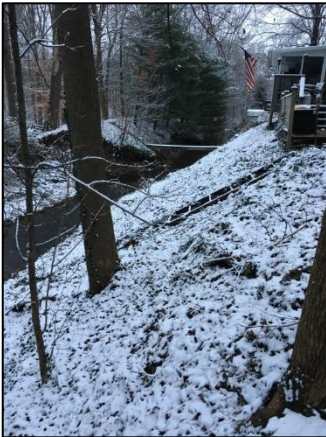
#### **Westmont Woods Subdivision Restoration (Private or Swan Lake Developer)**

*Figure 49: Steep slope and close proximity to structures*

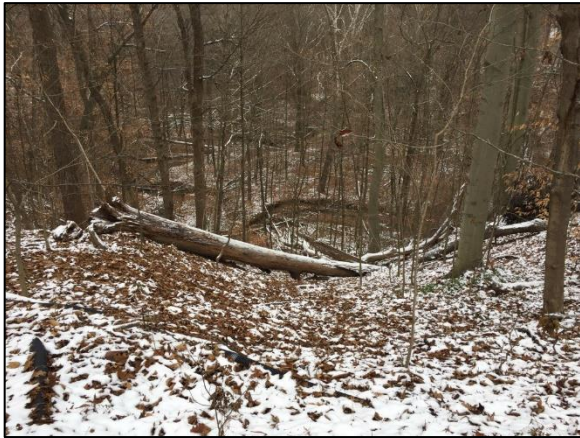
*Figure 52: Erosion and tree loss visible from the top of the valley*

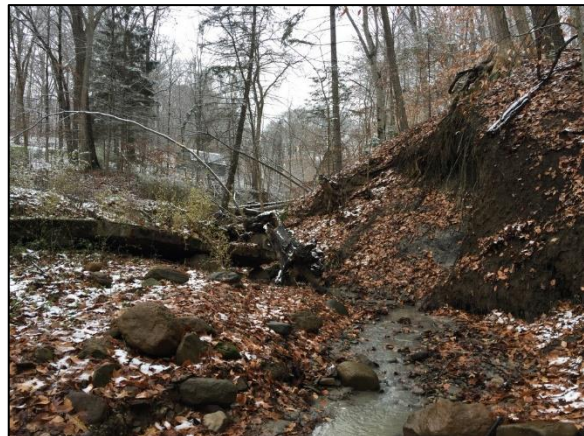
*Figure 54: Mass wasting along banks*

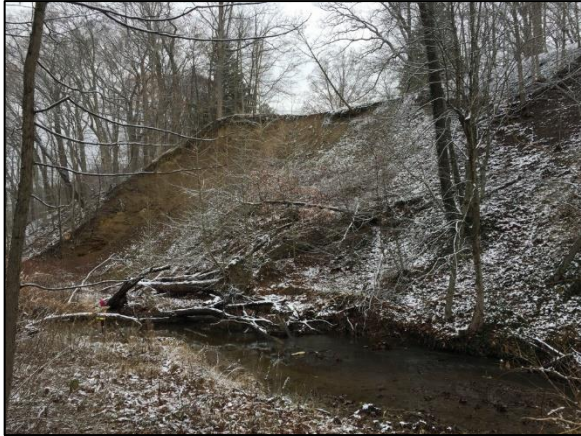
**North Fork Stream Re-alignment (SWMD/Private)**

*Figure 55: Mass wasting along ~70-ft-tall bank on North Fork*

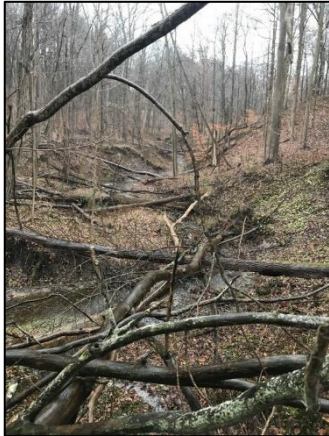
**Revere Run Select Stream Stabilization (SWMD/Private)**

*Figure 57: Mass wasting and tree loss on Revere Run*

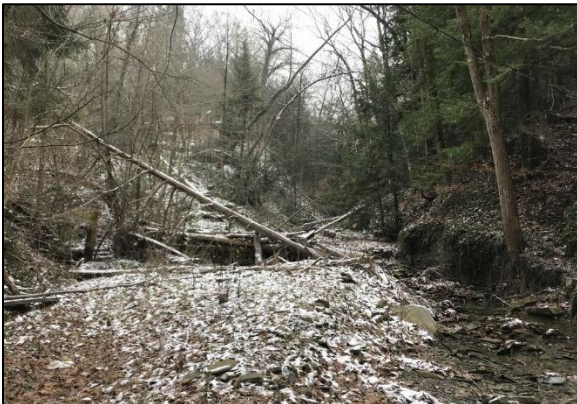
**Revere Rd to Yellow Creek Tributary Stabilization (SWMD/Private)*****Extrapolated***

*Figure 58: Bank erosion, damaged deck, and tree loss prevalent on this tributary*

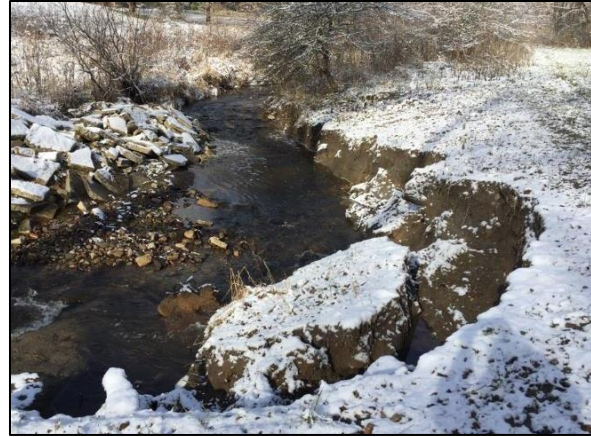
*Figure 61: ~6-foot slump in residential backyard lacking riparian vegetation.*

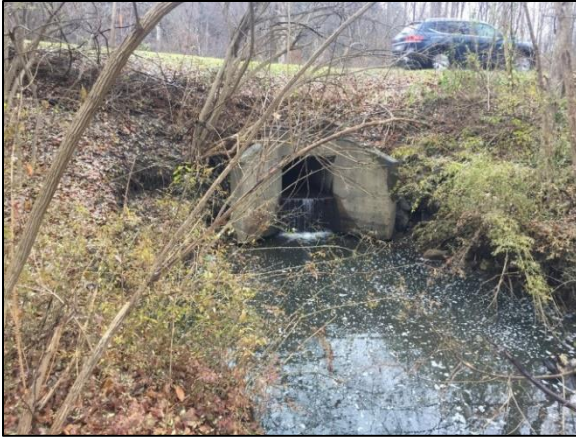
As stated in Section 4.0, there were numerous bridges and culverts that exhibited signs of instability (Figures 63 and 64). However, the project team is not qualified as structural engineers and only noted items that were visually apparent. If a bridge or culvert were to fail, it could cause harm to human life and property and create transportation complications during repair. Regular inspections of these assets will help responsible parties keep track of their condition and prioritize repairs as necessary. It would be helpful to create standard details, like wingwall protection with loose riprap or armored energy dissipation pools, for culvert repairs. Photos and a GIS database of all public and private bridges and culverts observed in December 2018 were provided to the Summit County Engineer's Office, to both the surface water and bridge groups.

*Figure 63: Culvert outfall with large scour pool that potentially risks exposing and/or undermining the culvert*

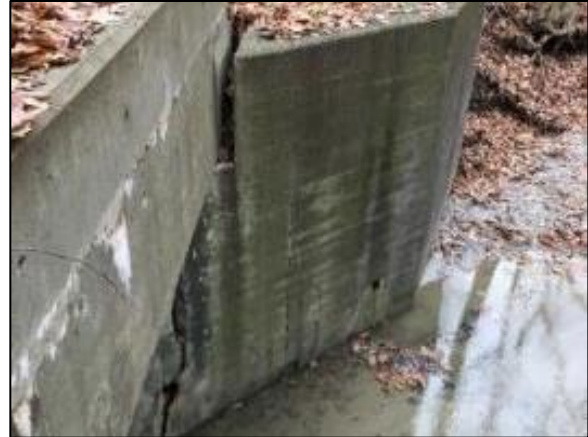
*Figure 64: Cracked bridge abutments*

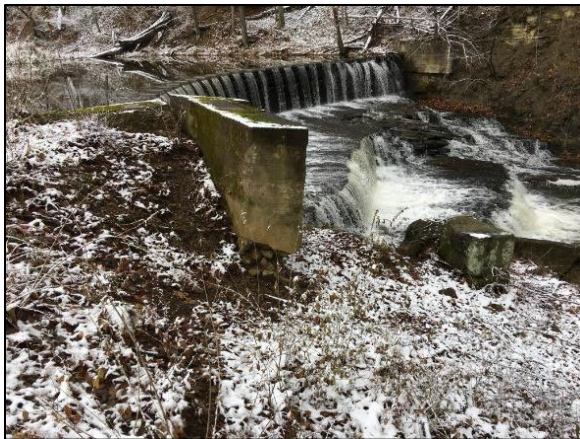
Several dams exhibited what appeared to be notable instability during the December 2018 visual assessment (Figures 65 and 66). Should one of these assets fail, it might result in damage to property and human life, as well as geomorphic damage to Yellow Creek. The majority of these dams are privately owned, but inspections and necessary maintenance on all dams are important. Performing regular inspections will ensure that these assets and their condition are recorded by responsible parties and repairs are prioritized. Coordination on dam inspections began by sharing data in December 2018 and contacting Ohio Department of Natural Resources (ODNR).

*Figure 65: Right abutment is leaning with a home under construction downstream.*

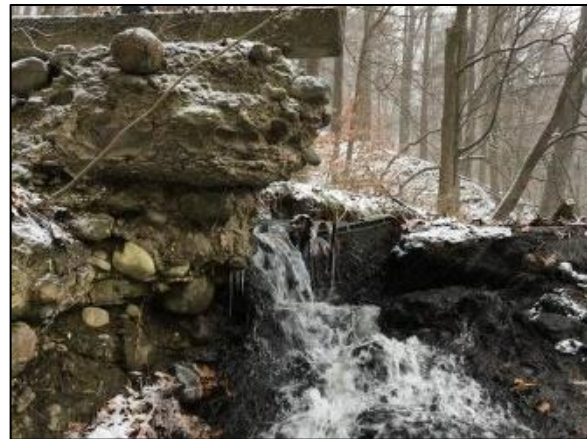
*Figure 66: Dam is patched with a piece of plywood & chain-link fence.*

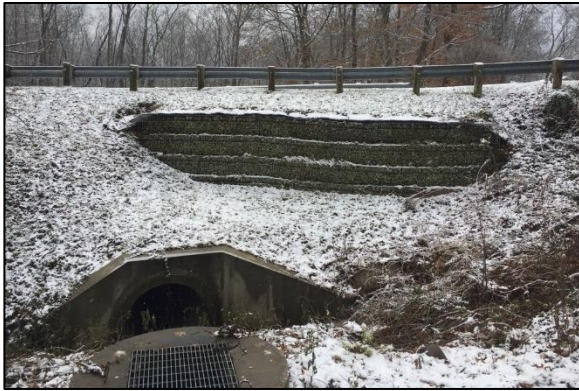
**Bonnebrook Dr Gabion Instability (Bath Township)**

*Figure 67: Slumping gabions along Bonnebrook Dr.*

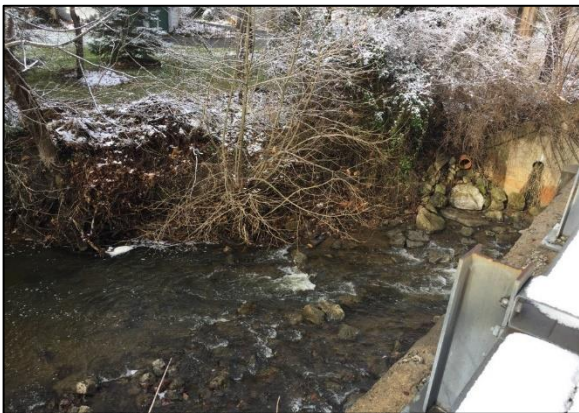
**Cleve-Mass Bridge at North Fork (SCE)**

*Figure 68: Bank erosion downstream of bridge*

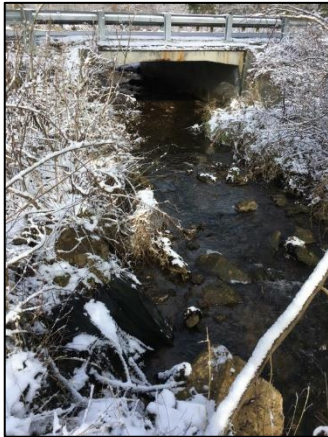
**Medina Line Rd Riprap Instability (SCE)**

*Figure 69: Exposed geotextile in the foreground*

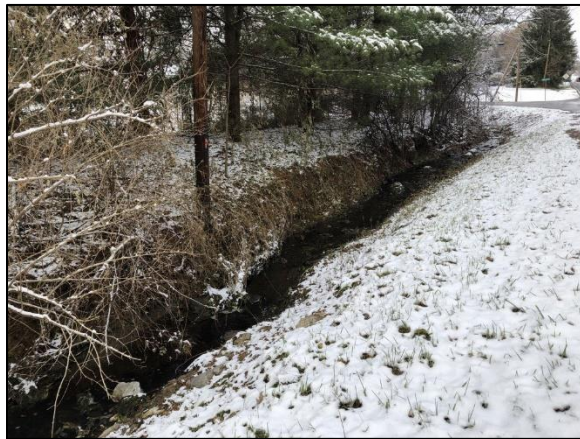
**N Hametown Channel Instability (Private)**

*Figure 70: Eroded channel with partially exposed power pole*

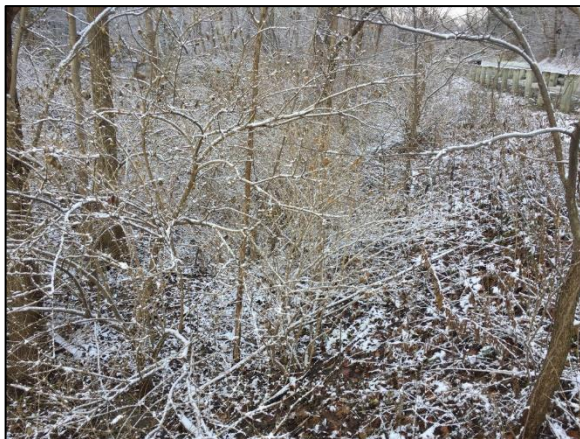
**North Fork Instability at Cleve-Mass (SCE)**

*Figure 71: Steep bank with N. Cleveland-Massillon Road on the right*

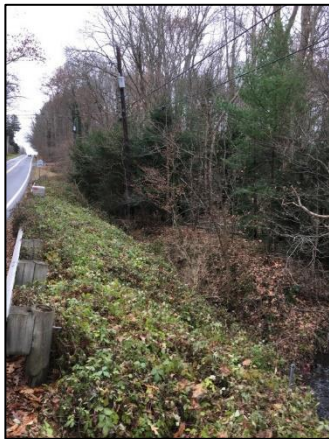
**Sourek Rd Swale Instability (SCE)**

*Figure 73: Leaning power pole*

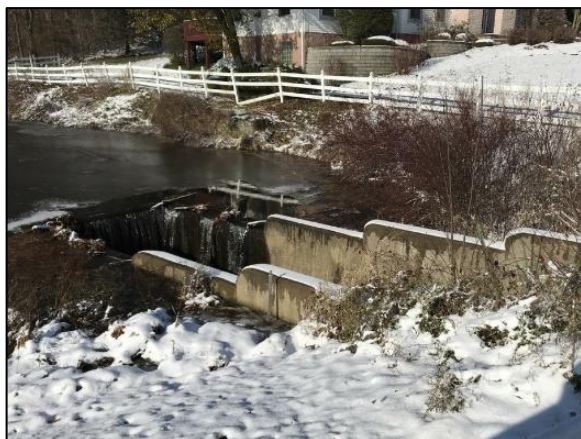
**Swan Lake Outlet Improvement (Developer)**

*Figure 74: Outlet structure without protective measures*

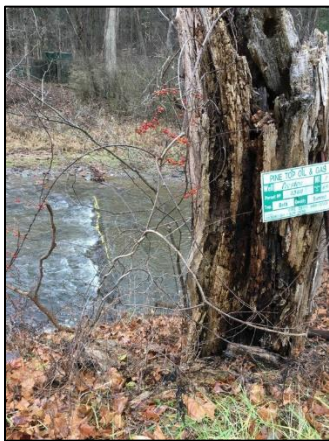
#### **Yellow Creek Exposed Gas Main (East Ohio Gas Company (EOG))**

The visual assessment identified an exposed gas main crossing Yellow Creek (see yellow spray paint in Figure 75). Per signage, it is assumed that the main is owned by Pine Top Oil & Gas. Being exposed, woody debris, rocks, or other items within the channel could potentially puncture the line, creating instream pollution. Protective measures should be taken to bury the gas main, which may include re-burying the line deeper below the stream bed and/or protecting the main with a grade control structure such as a Newberry riffle. This safety concern should be shared with the gas company.

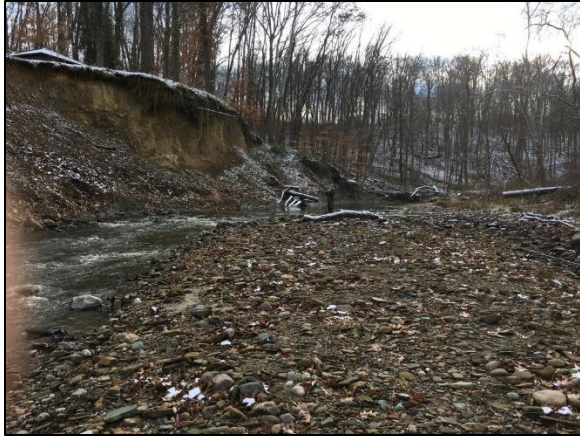
Figure 76: 2226 W. Bath Road with vertical, ~30-foot tall bank

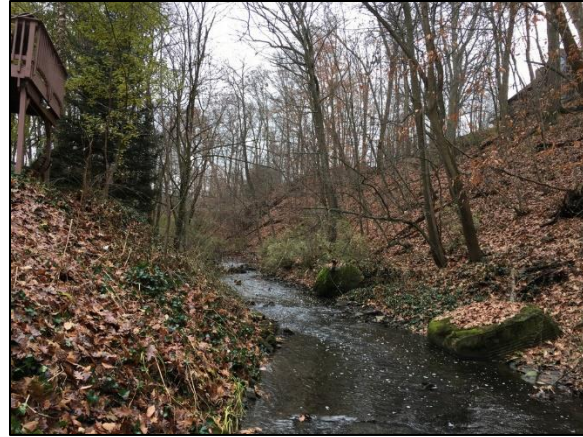
Figure 77: 2364 Berrywood Drive with encroaching deck and house on top of opposite bank

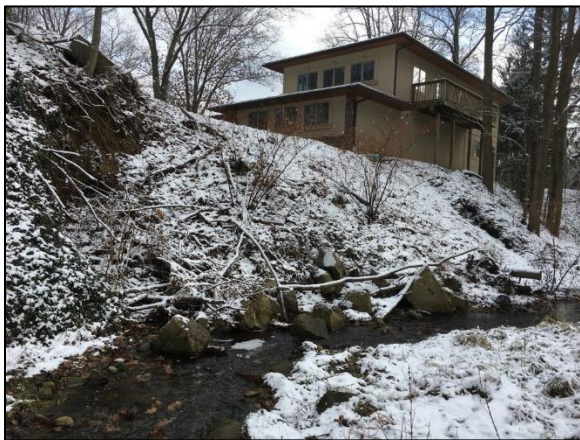
Figure 78: 4023 Shaw Road, where house may only be ~10 feet from the top of a potentially failing bank

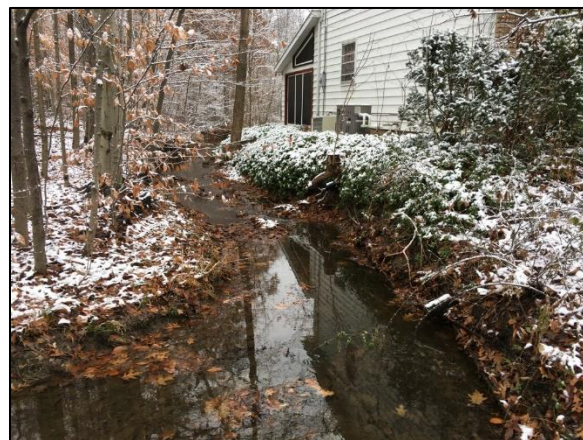
Figure 79: 4191 Janwood Drive with house ~10 to 12 feet from the top of bank
