# Weekly Construction Progress Report

Client:	Summit County Engineers
Project Name:	West Fork Bank Stabilization
Project Location:	Trellis Green Dr., Akron
Date:	WE 04-10-2020

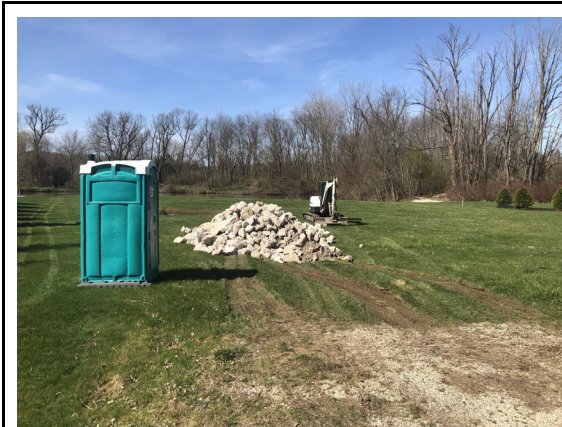
**Photograph 1 (April 6, 2020).** Stone, an excavator and sanitation facilities were brought to the site.

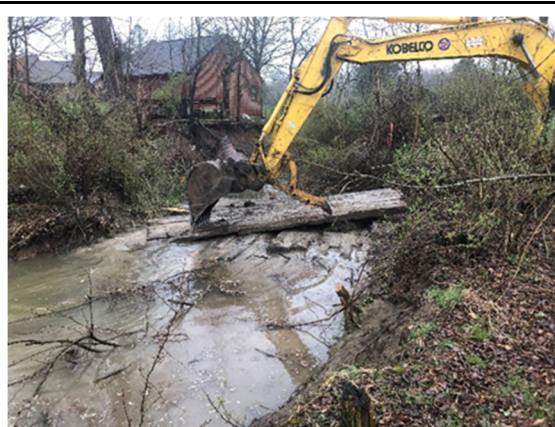
**Photograph 2 (April 7, 2020).** Timber mats were used to provide access into the stream.

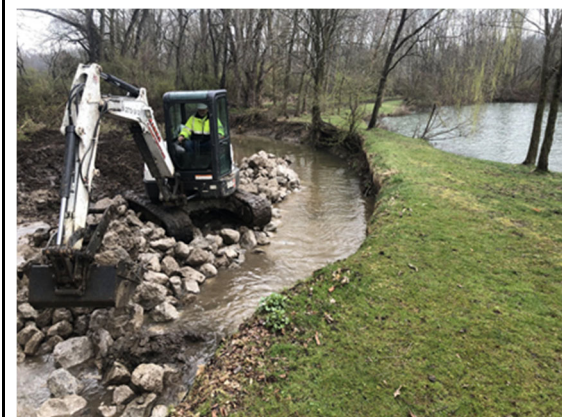
**Photograph 3 (April 8, 2020).** Toe protection was installed in the stream. The intervening area between the toe protection and the eroded bank was backfilled.

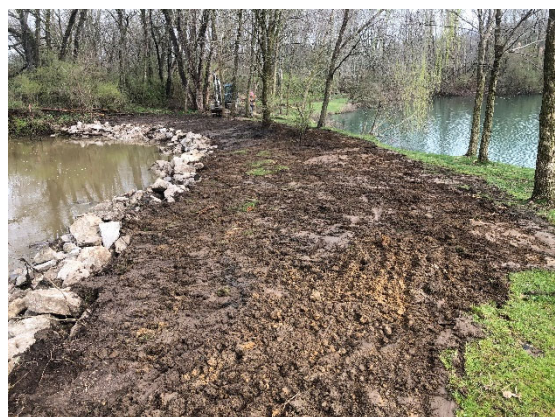
**Photograph 4 (April 9, 2020).** Onsite material was backfilled into the intervening space adjacent to the toe protection and the stream bank was regraded to a stable slope. The causeway between the stream and the pond has been extended 10 to 12 feet.

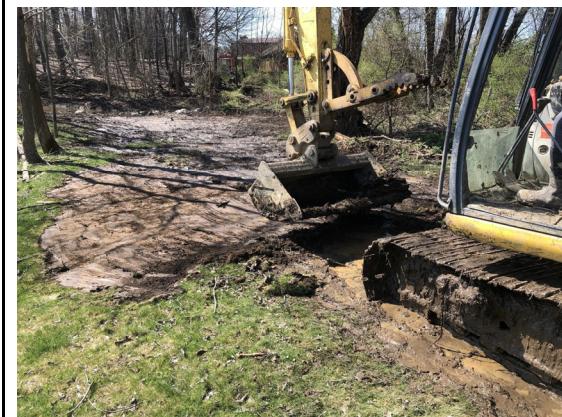
**Photograph 5 (April 8, 2020).** The access route was restored as the equipment was removed offsite.

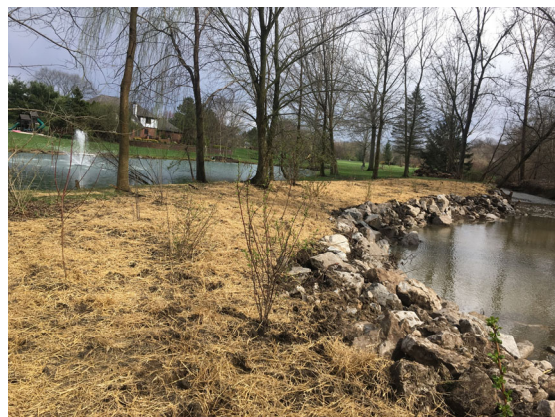
**Photograph 6 (April 9, 2020).** Shrubs, live stakes, seed, and straw were installed along the restoration area.
