# APPENDIX A

## Yellow Creek Watershed Maps

**HIGH INFILTRATION AREA PROTECTION**  
**BATH CENTER CEMETERY FOREST PRESERVATION**  
 BATH TOWNSHIP DRAINAGE BASIN IMPROVEMENT  
 SUMMIT COUNTY SURFACE WATER MANAGEMENT DISTRICT

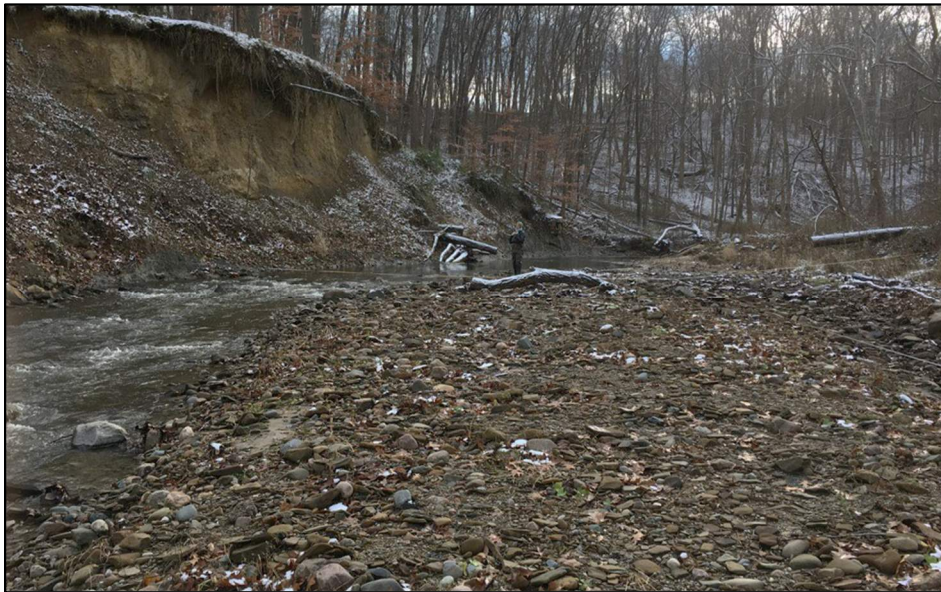
Notes: Slope is flatter (~1%), macroinvertebrates found on 90s (d60) but not 64s (d45). As such, d50 is appropriate as a representative bed material for Qc.

Figure C1: Looking upstream from cross section location.

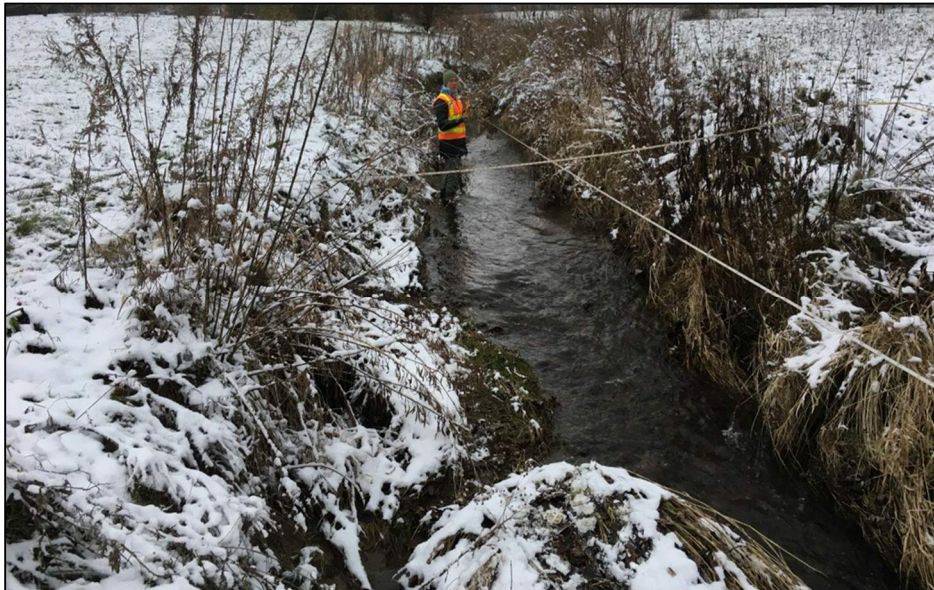
Notes: Slope is flatter (<1%). Mobile gravel bed (no macroinvertebrates observed) with nearby grade control to protect sewer crossing. Site may be overly fine due to the influence of grade control. As such, it may not be a representative site to inform the regional Qc estimate.

Figure C17: Looking upstream with tapes laid out for cross section and profile

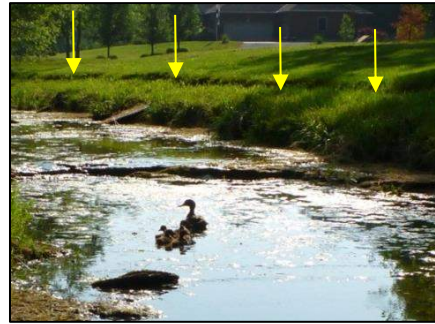
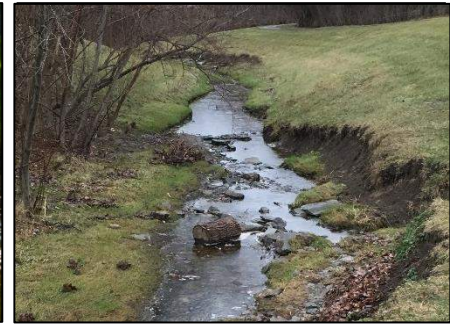
Stream erosion may start as a tension crack along the bank (left) that eventually leads to bank collapse and widening (right)
