2023 Routine Bridge Inspection Report

North Main Street High Level Bridge

SUM-M008-00908
SFN: 7730306

October 19, 2023

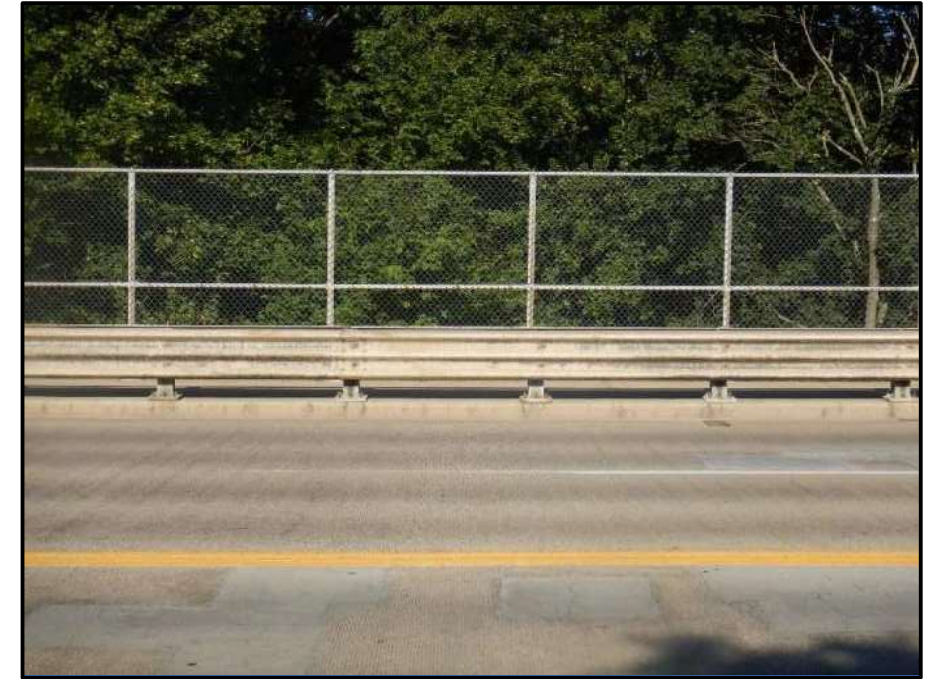
- The bridge railing exhibits light surface corrosion along the full length of both railings **(photo 3)**. No change from previous inspection.
- Very minor, isolated collision damage exists along the bridge railing and is heaviest on the east railing of span 2. No change from previous inspection.
- The east pedestrian fence posts exhibit heavy corrosion with multiple locations of 100% section loss **(photo 4)**. At some locations where heavy corrosion exists in the pedestrian fencing, steel plates were recently fastened to the horizontal pipes by county maintenance to stiffen the loose components. Most of the repairs were functioning at the time of inspection **(photo 5)**. Loose areas of the chain-link fence should be checked for during future inspections for safety.

Photo 3 – Looking west at the west sidewalk and railings. Note: typical minor corrosion throughout thrie-beam railing.

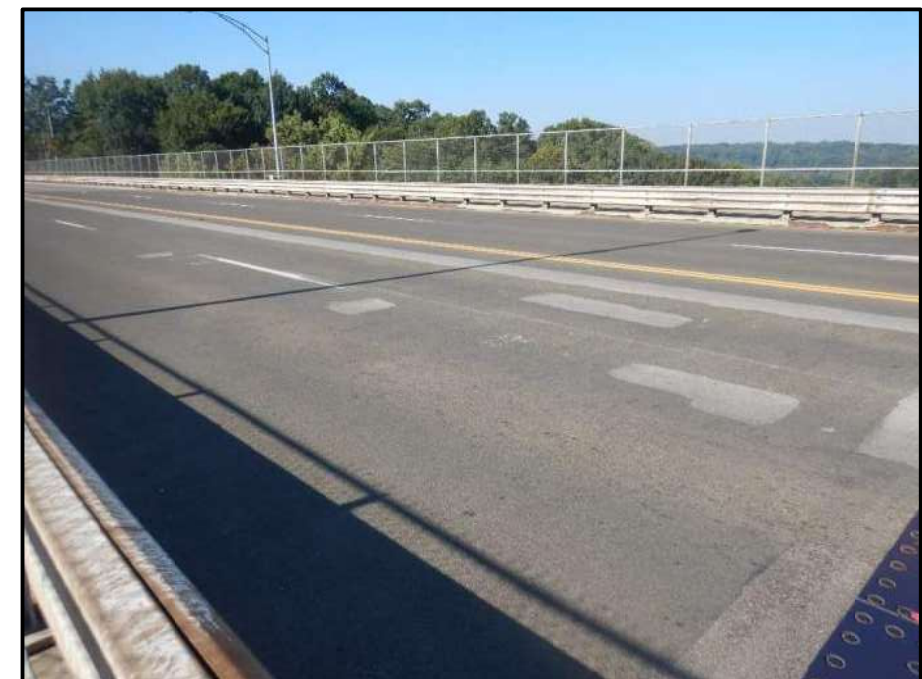
Photo 15 – Looking west at southbound lanes of bridge wearing surface near centerline, span 3. Note: 2 square-foot x 1-inch deep spall.

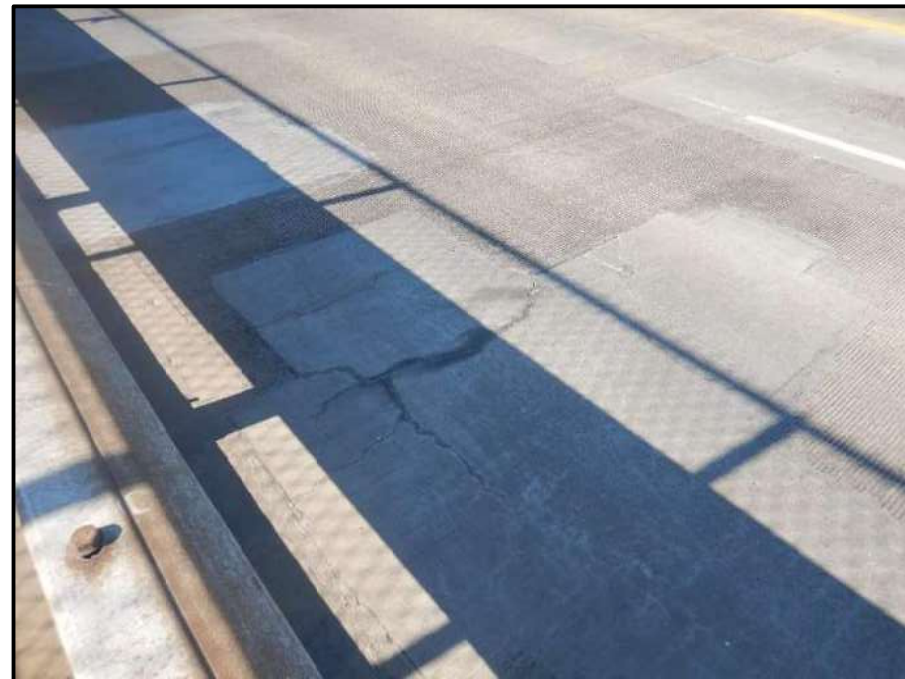
- Approximately 10% of the wearing surface (including patches) in spans 1 and 3 is delaminated. The highest density of delaminations, cracking, and cracked patches exists along the northbound lane of span 1 **(photos 17 and 18)**. Approximately 75% of the 2018 patches are cracked. Isolated locations of shallow spalls typically less than 1 square foot and up to 1 inch deep exist in the northbound lane.

Photo 17 – Looking west at northbound lanes of bridge wearing surface in span 1. Note: cracking in patches throughout.

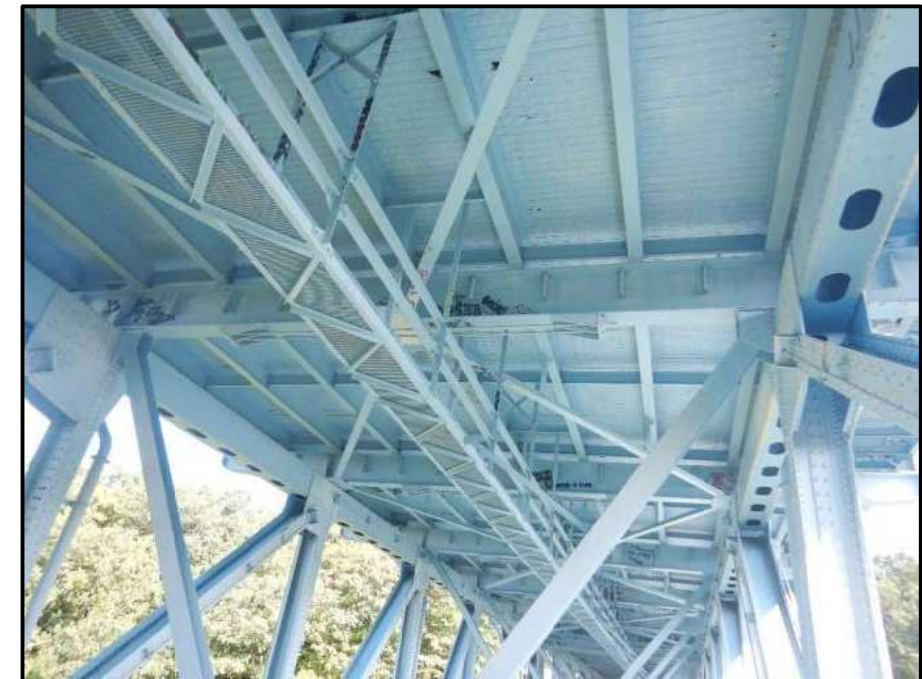
- The soffit exhibits isolated hairline longitudinal and transverse cracks, many with light efflorescence, in spans 1 and 3. The cracks are most prevalent in span 1, near midspan **(photo 19)**. No change from the previous inspection.
- Cracking with delaminations exist in isolated locations over the east truss. Due to the deficiencies in the top of the deck, this problem continues to appear more frequently each inspection.
- In span 2 (where grid deck exists), areas of corrosion exist along the longitudinal sidewalk joints due to leaking between the deck and joint. Isolated areas of surface corrosion also exist away from the sidewalk joint **(photo 20)**. No change from the previous inspection.

Photo 19 – Looking north at general underside of span 1. Note: cracking with light efflorescence in deck.

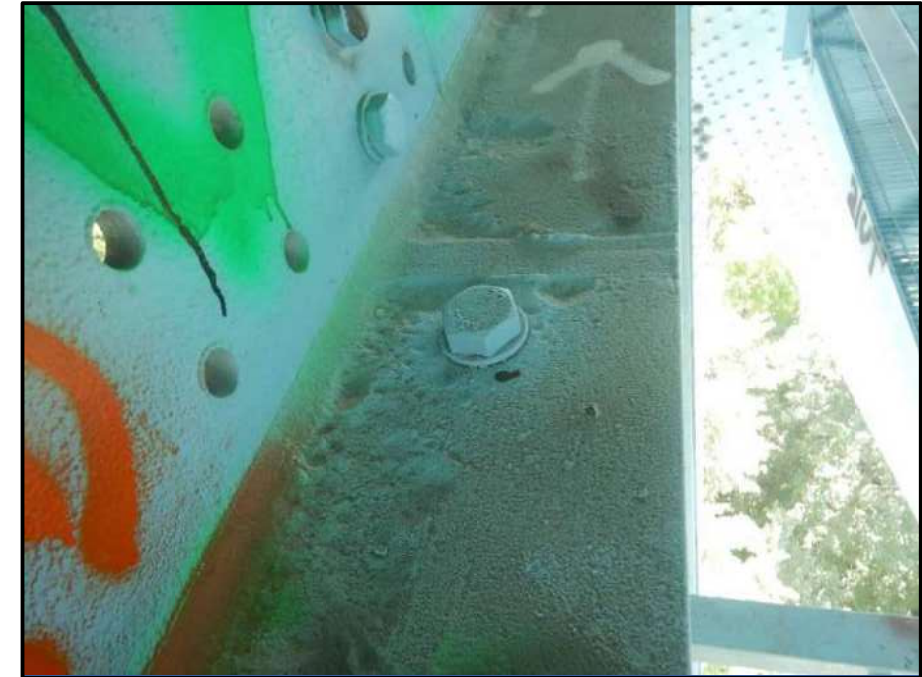
Photo 26 – Looking northeast at stringer 8 connection angle to south face of floorbeam 28, span 3. Note: two loose bolts.

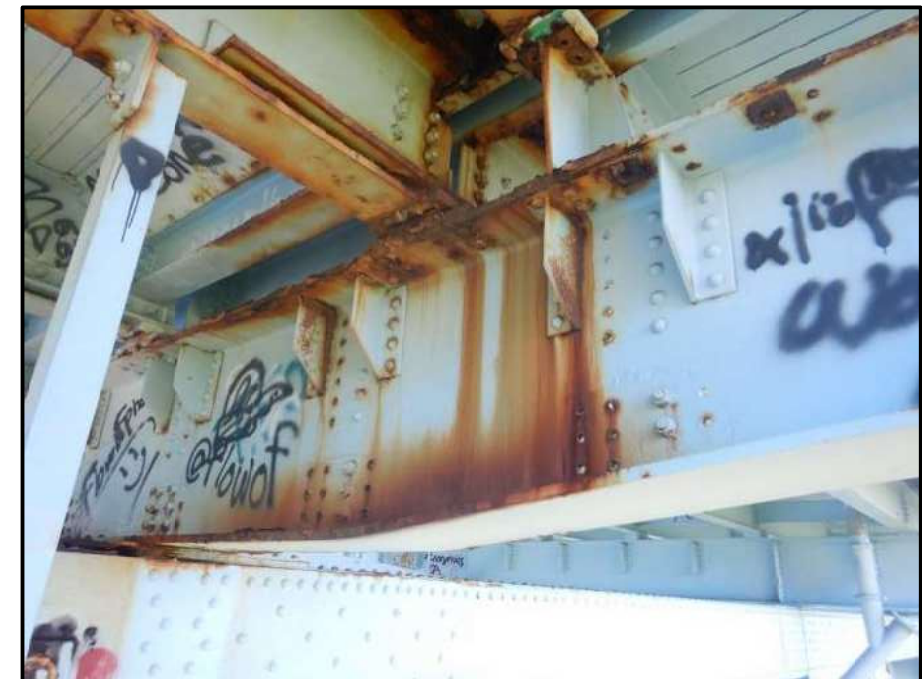
Photo 27 – Looking east along top of bottom flange of floorbeam 23, south face, span 3. Note: painted over section loss typically 3/16 inch deep.

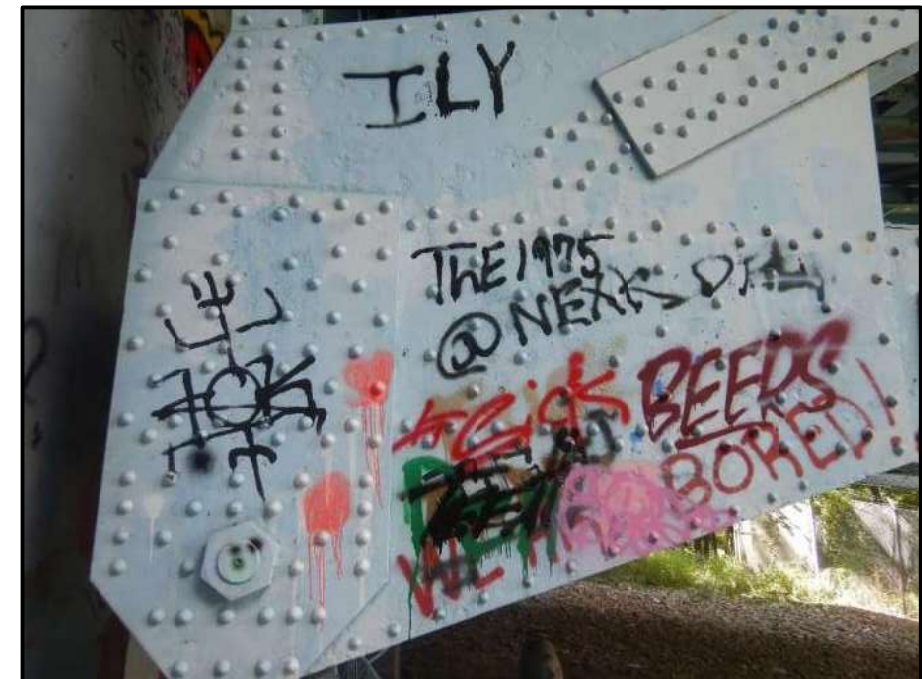
Photo 35 – Looking south at west L0L1 at the rear abutment, span 1. Note: heavy corrosion and peeling paint along bottom flange plate interior.

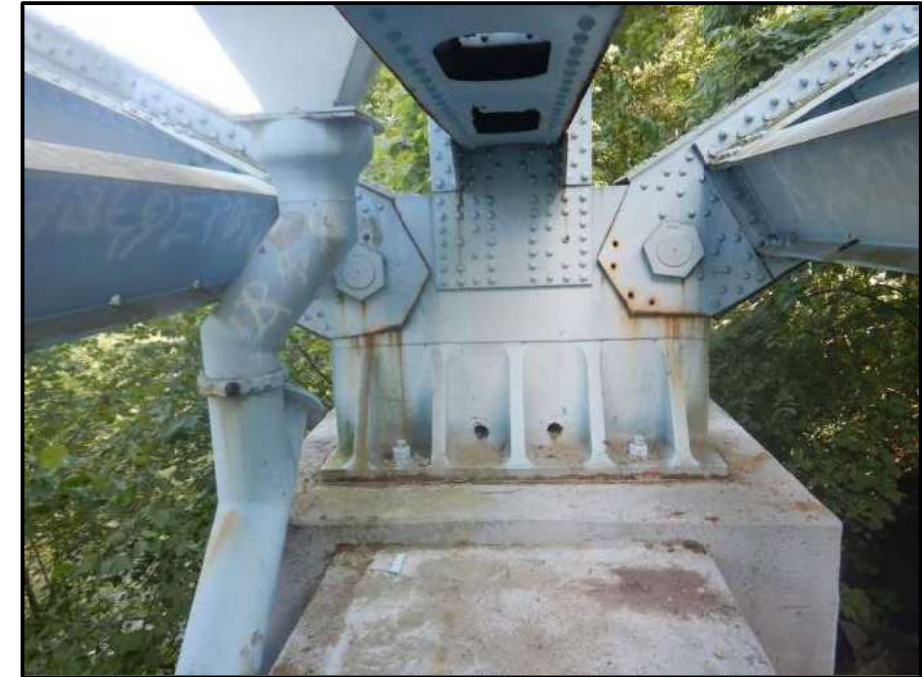
Photo 38 – Looking east at west truss bearing at forward abutment. Note: surface corrosion around edges of masonry plate with 1-inch deep wear into bearing seat.

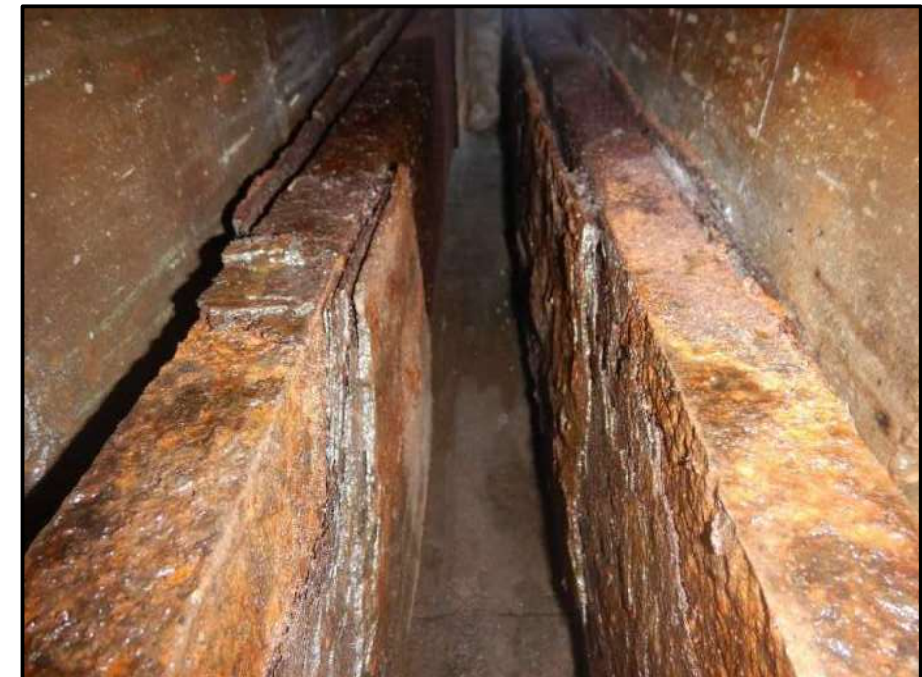
Photo 39 – Looking east at west face of east truss bearing at pier 1. Note: surface corrosion around masonry plate.

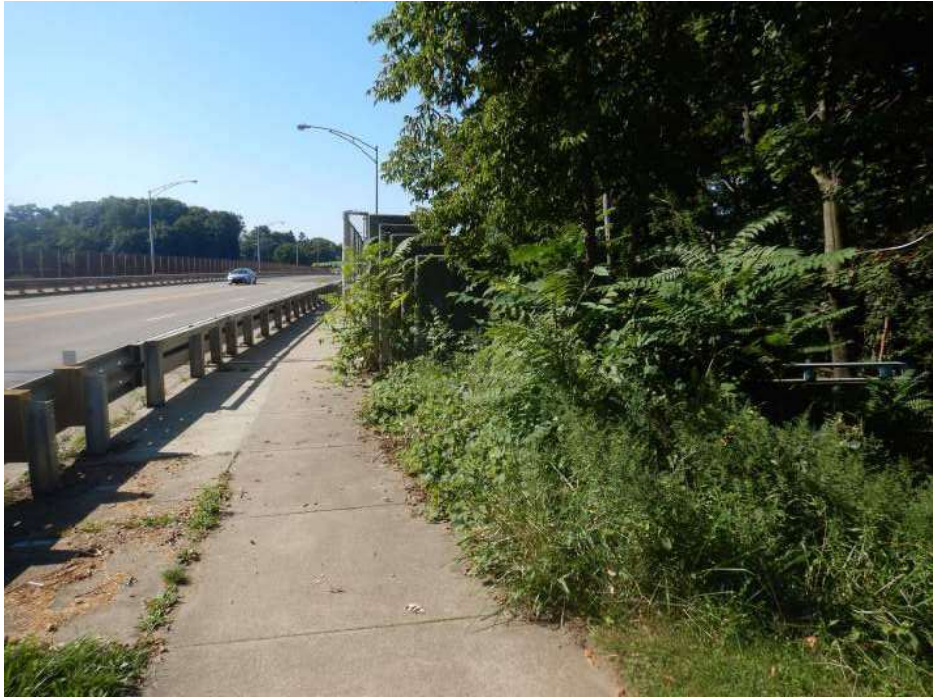
PHOTO 6 Condition
Description Overgrown trees onto sidewalk at northwest corner, looking south.

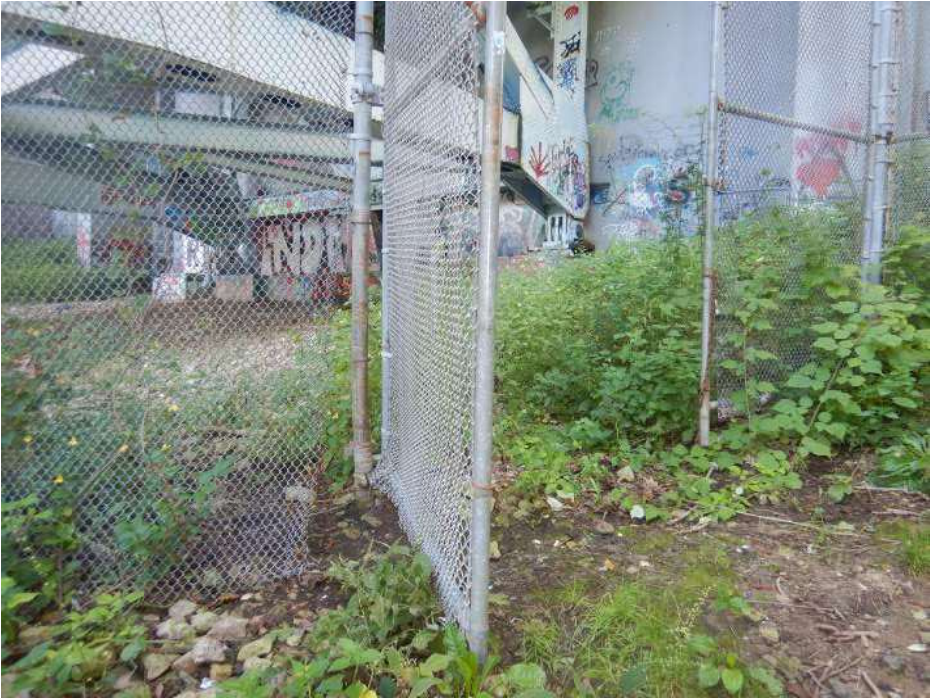
PHOTO 7 Condition
Description Hole in chain link fence by gate at southwest corner, looking southeast.

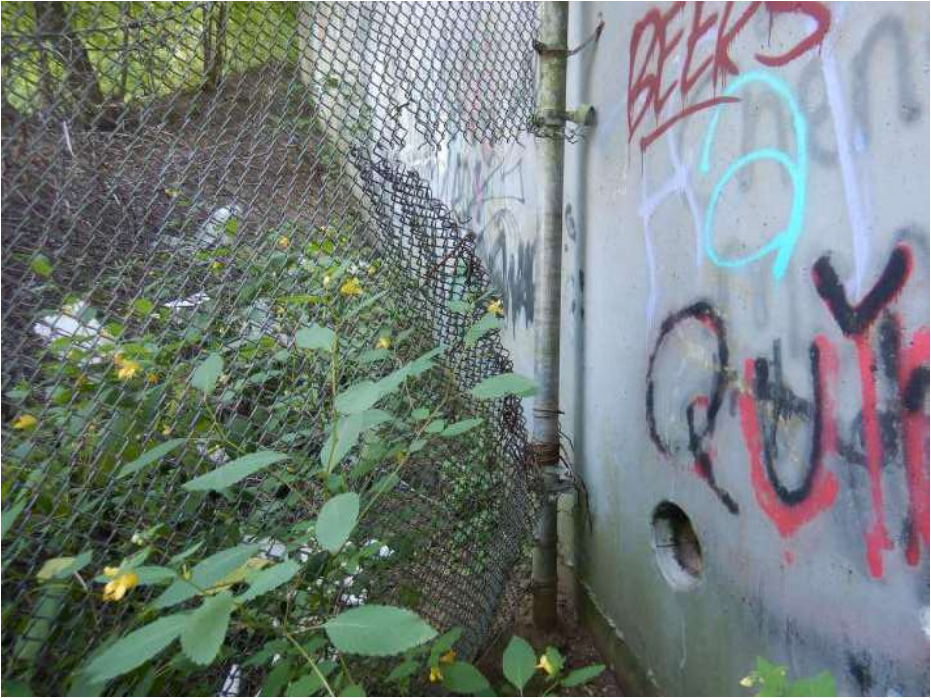
PHOTO 8 Condition
Description Hole in chain link fence at southeast corner, looking southeast.

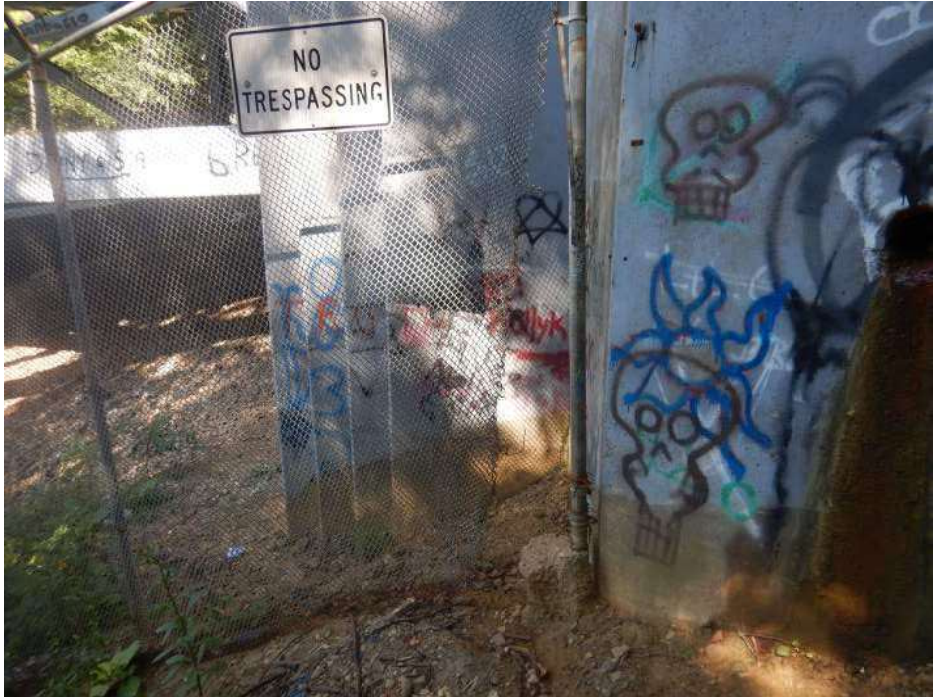
PHOTO 9 Condition
Description Hole in chain link fence at northeast corner, looking west.

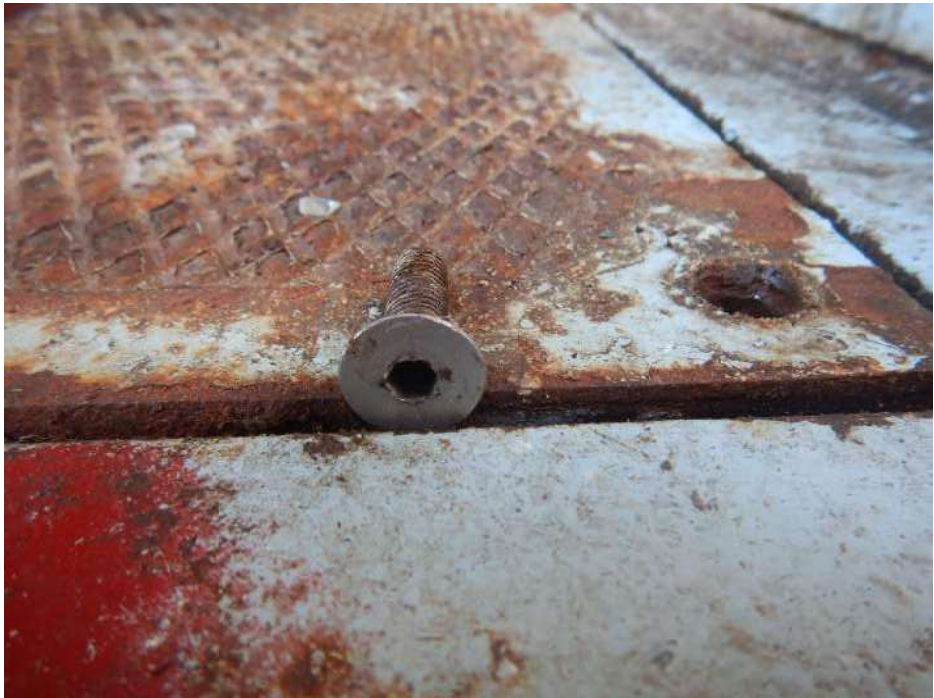
PHOTO 10 Condition
Description Stripped hex head screws for hatches to eyebar linkages at abutments looking west.

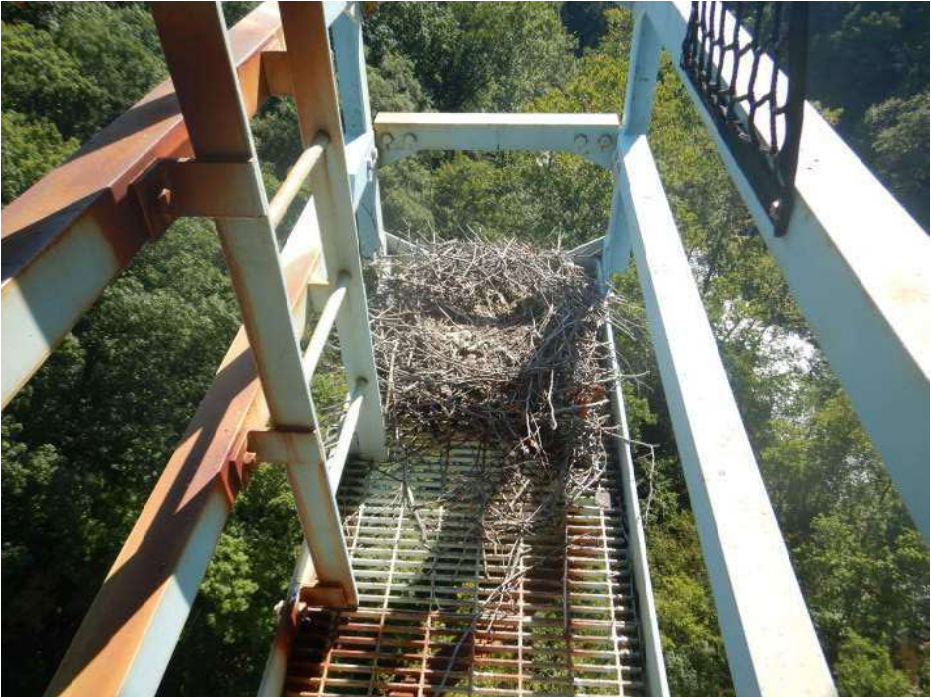
PHOTO 11 Condition
Description Bird's nest at east end of catwalk at Floorbeam 17, looking east.

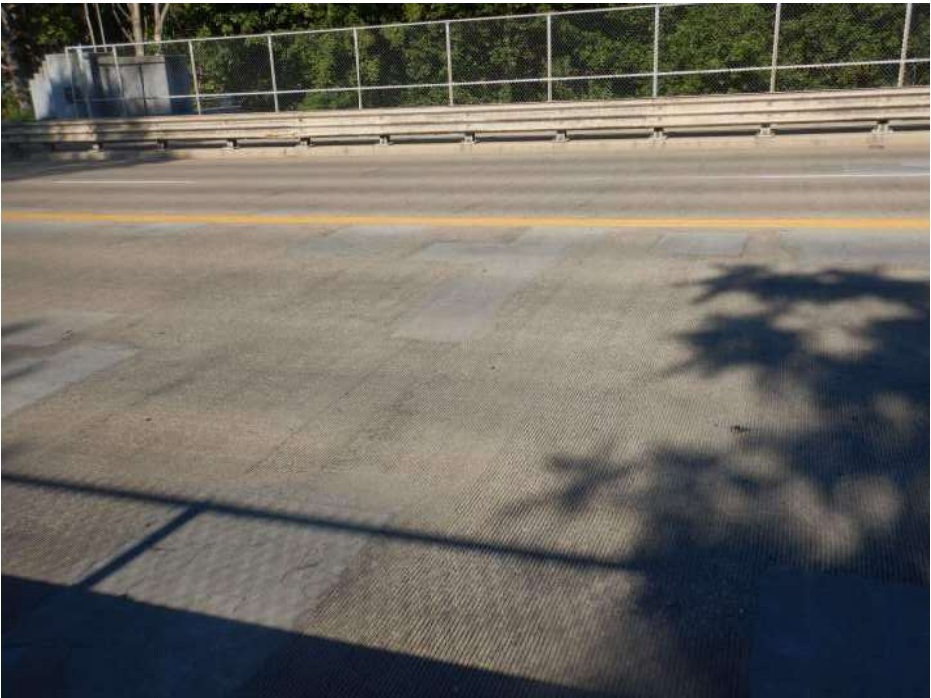
PHOTO 12 Condition
Description Concrete patches in NB lanes, Span 1 shown, looking southwest. Note: Some patches exhibit cracking.

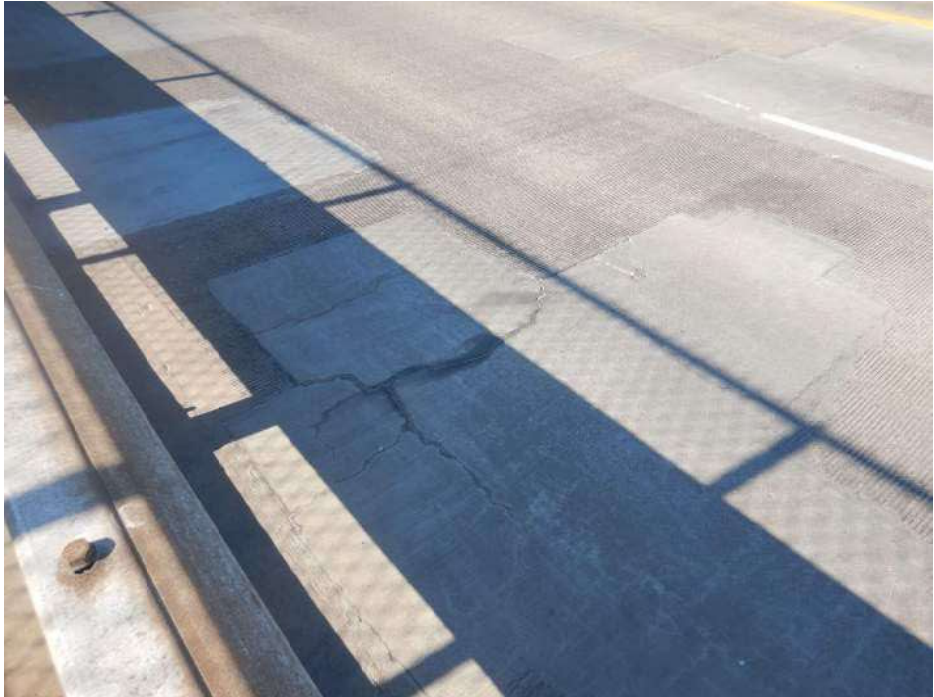
PHOTO 13 Condition
Description Cracking in concrete patch in NB lanes of Span 1, looking southwest.

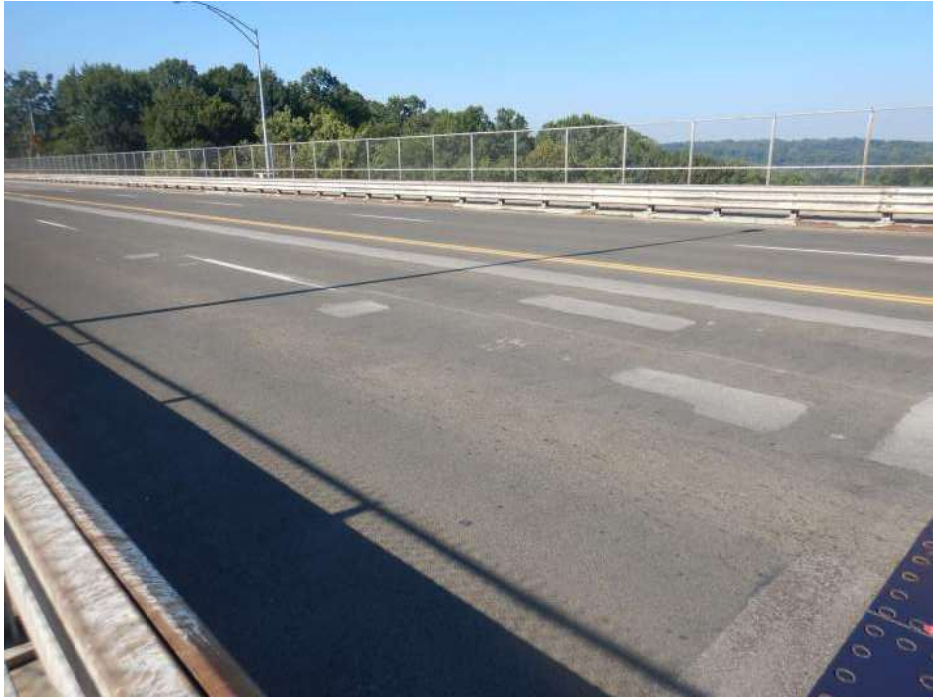
PHOTO 14 Condition
Description Overall of deck wearing surface in Span 2, looking southwest. Note: Epoxy overlay and patches.

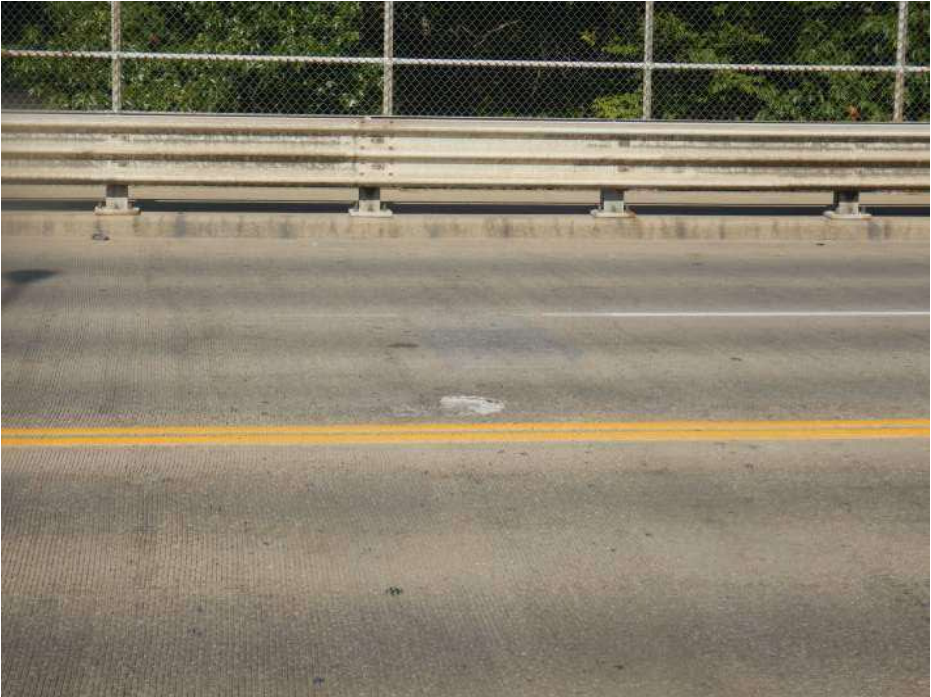
PHOTO 15 Condition
Description 2-square-foot x 1-inch deep spall in SB lanes near centerline, Span 3, looking west.

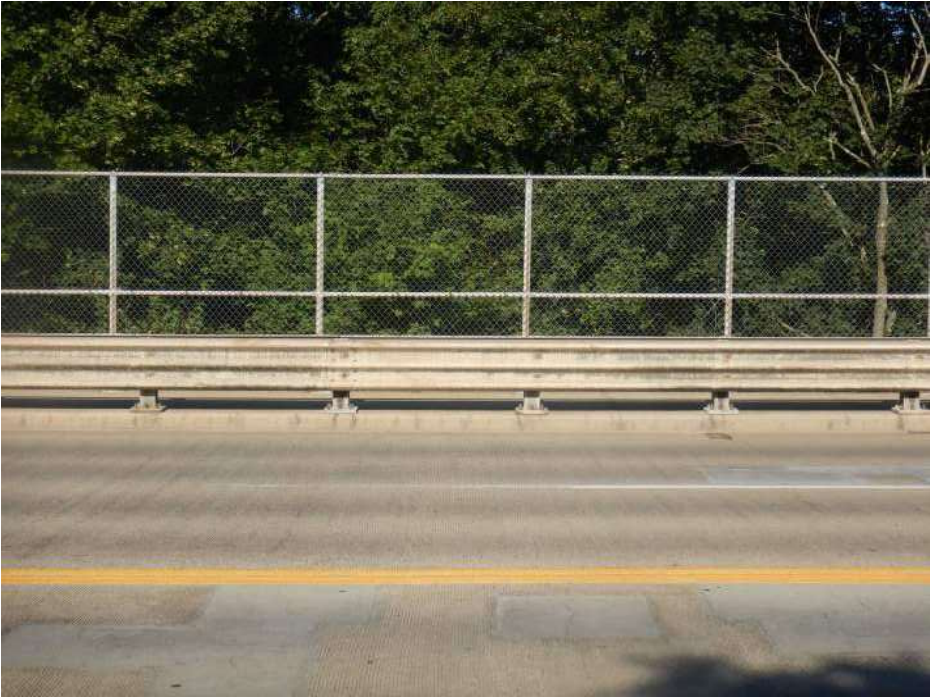
PHOTO 16 Condition
Description Typical bridge railing with minor corrosion throughout, west railing shown, looking west.

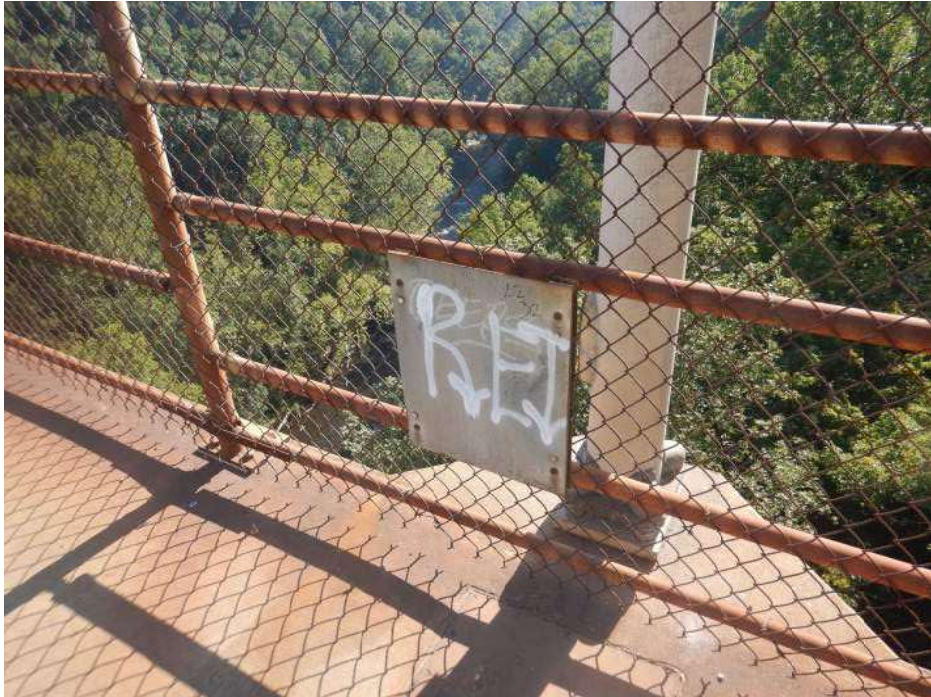
PHOTO 17 Condition
Description Typical steel plate repair to east pedestrian fencing, looking east.

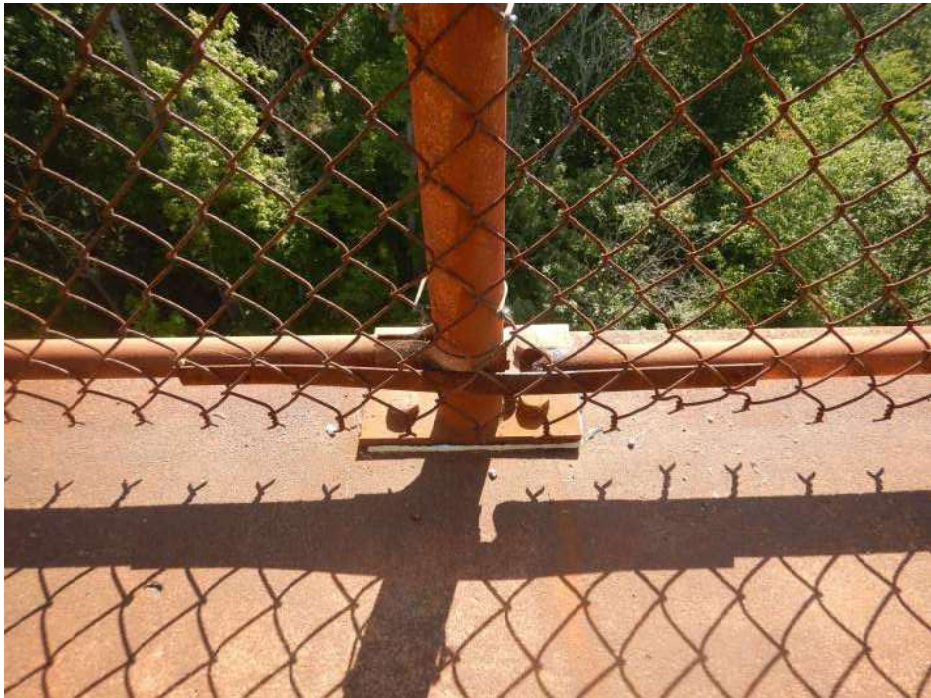
PHOTO 18 Condition
Description Repair to corroded horizontal piping for east pedestrian fence, typical, looking east.

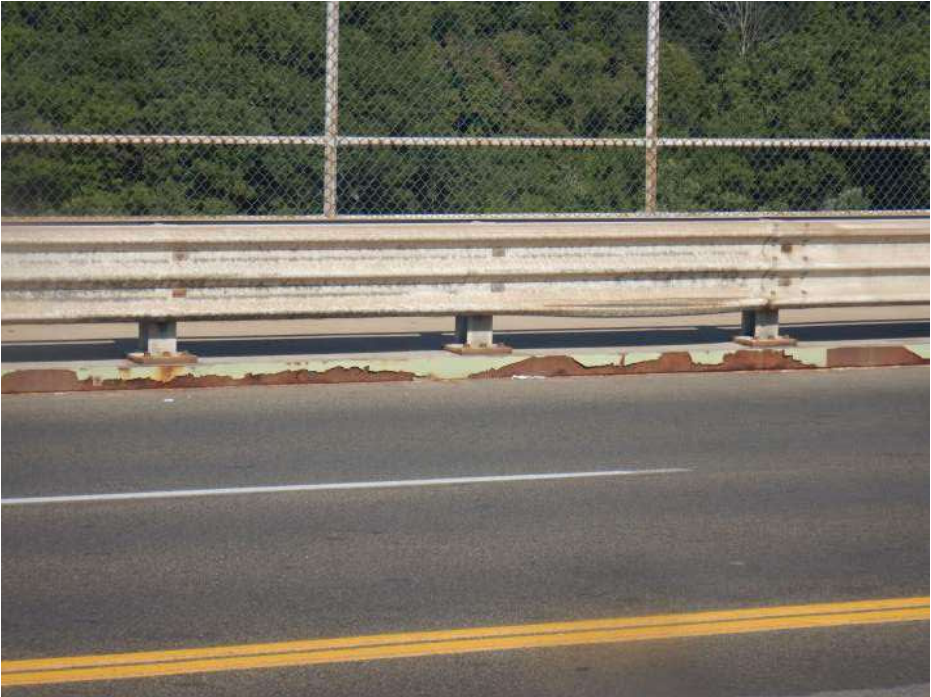
PHOTO 19 Condition
Description Surface corrosion typical throughout longitudinal steel plate along curb, looking west.

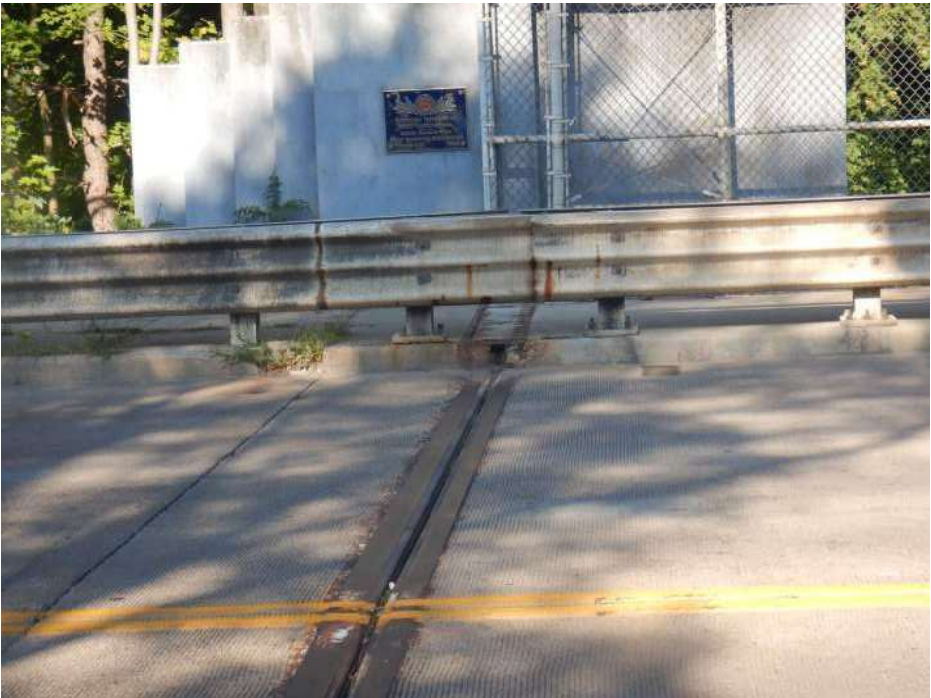
PHOTO 20 Condition
Description Spalling in curb at at end of Rear Abutment joint, looking west.

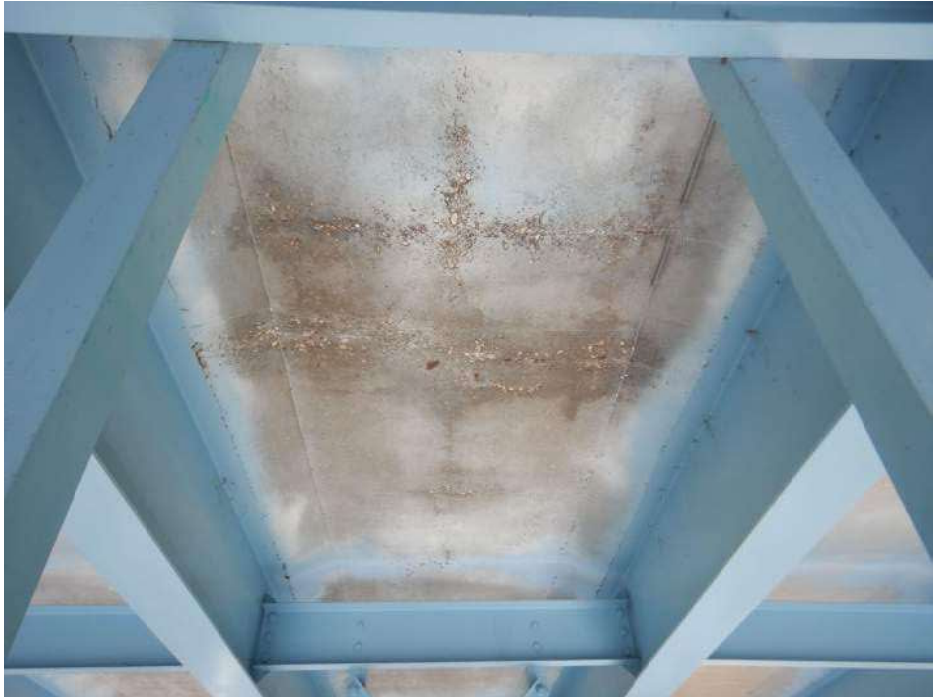
PHOTO 21

Isolated transverse cracks with minor efflorescence in Span 1 deck soffit, looking south.

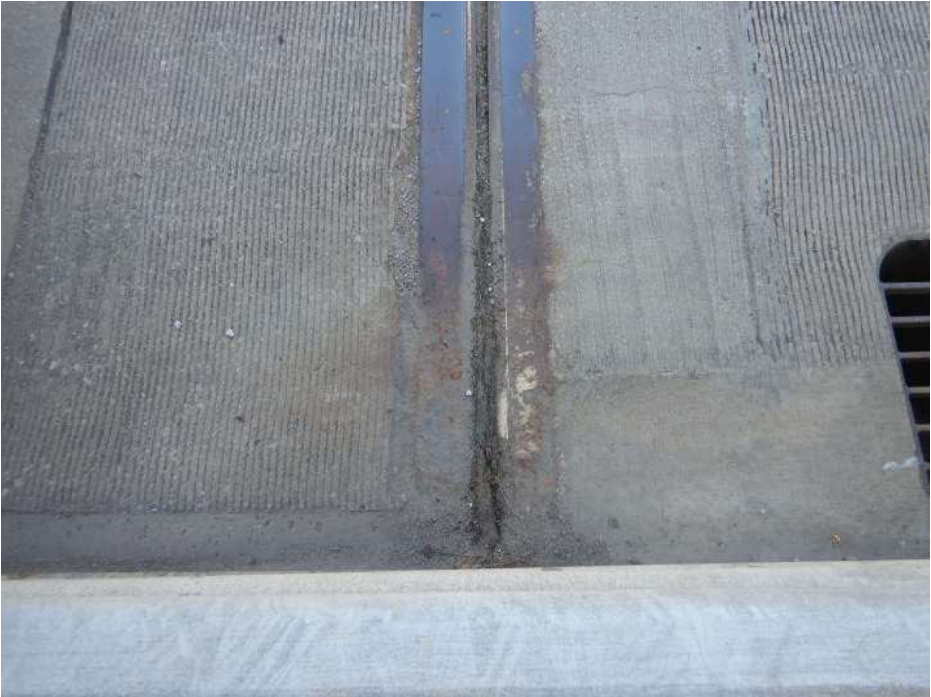
PHOTO 23

Surface corrosion and minor section loss to joint armor from debris, Rear Abutment joint at east end, looking west.

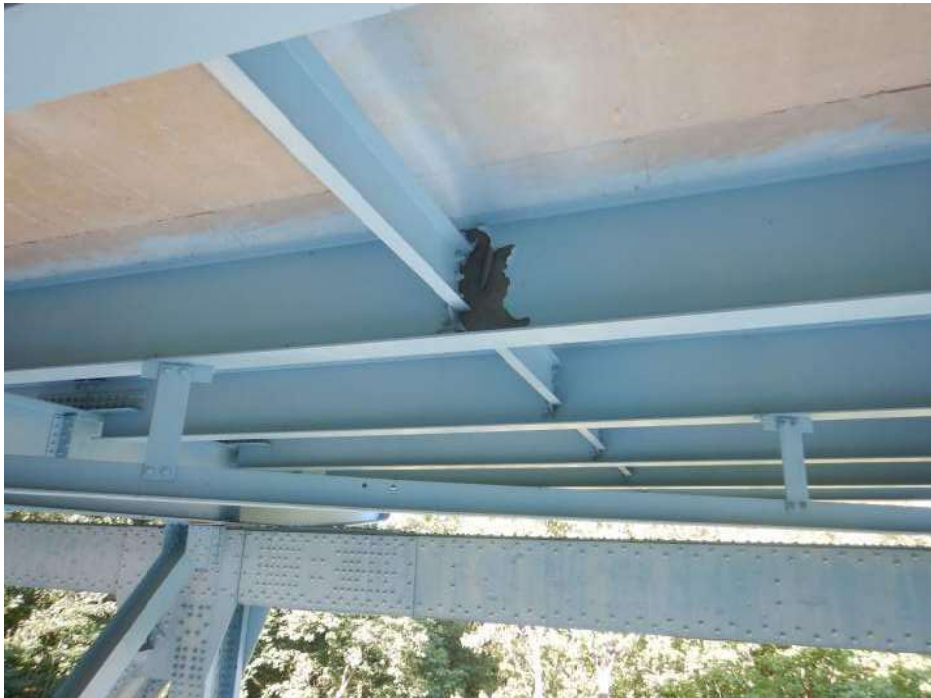
PHOTO 26 Condition
Description 2-square-feet of peeling paint on Stringer 5 between Floorbeams 5 and 6, Span 1, looking west.

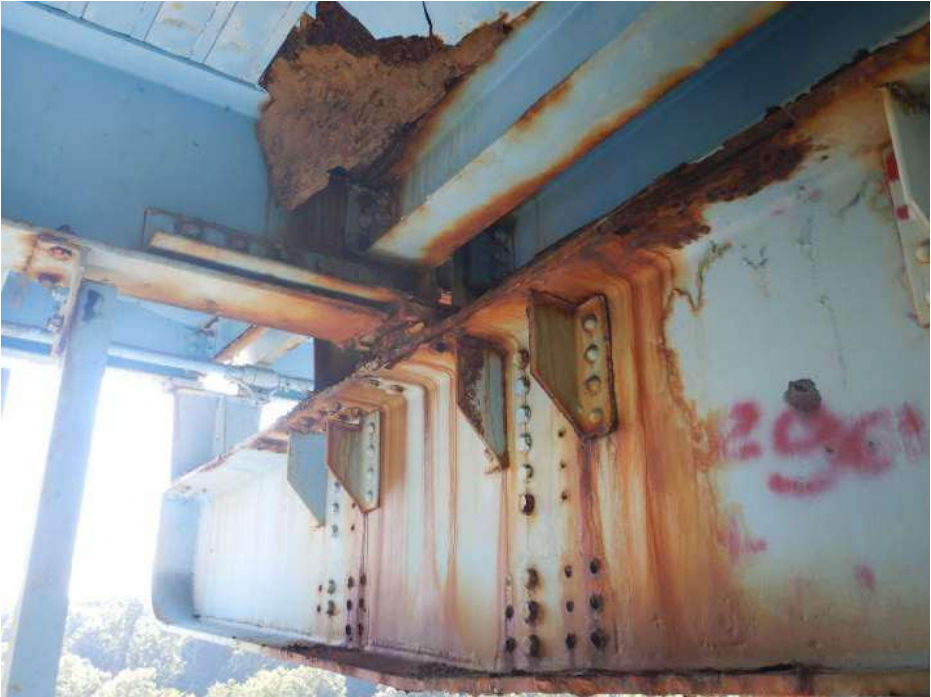
PHOTO 27 Condition
Description Heavy corrosion and pack rust under Stringer 11 bearing over Floorbeam 11, Span 2, looking southeast.

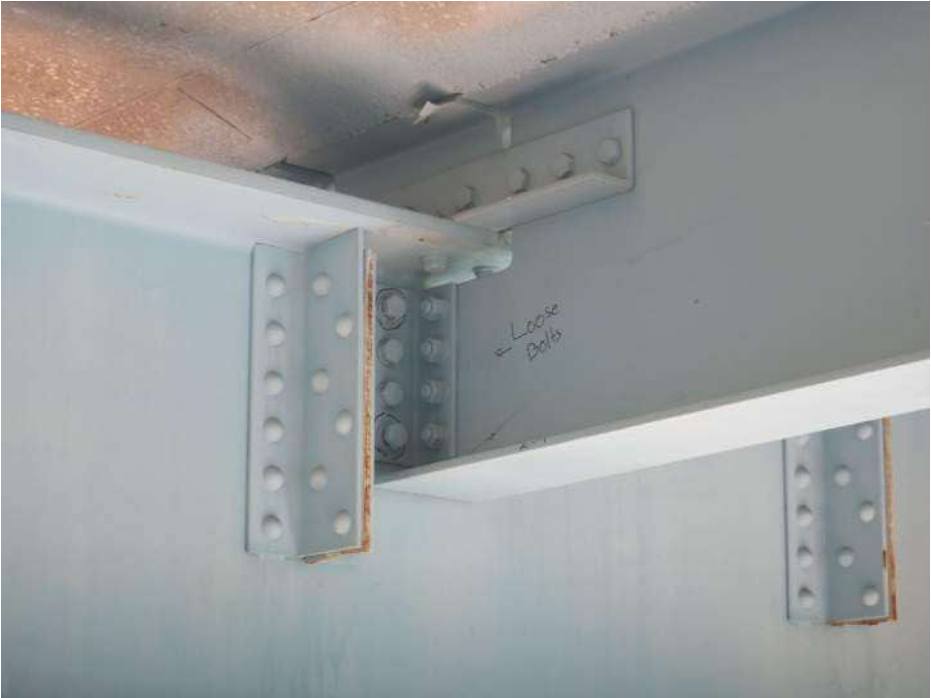
PHOTO 28 Condition
Description Two loose bolts on Stringer 8 connection to Floorbeam 28, Span 3, looking northeast.

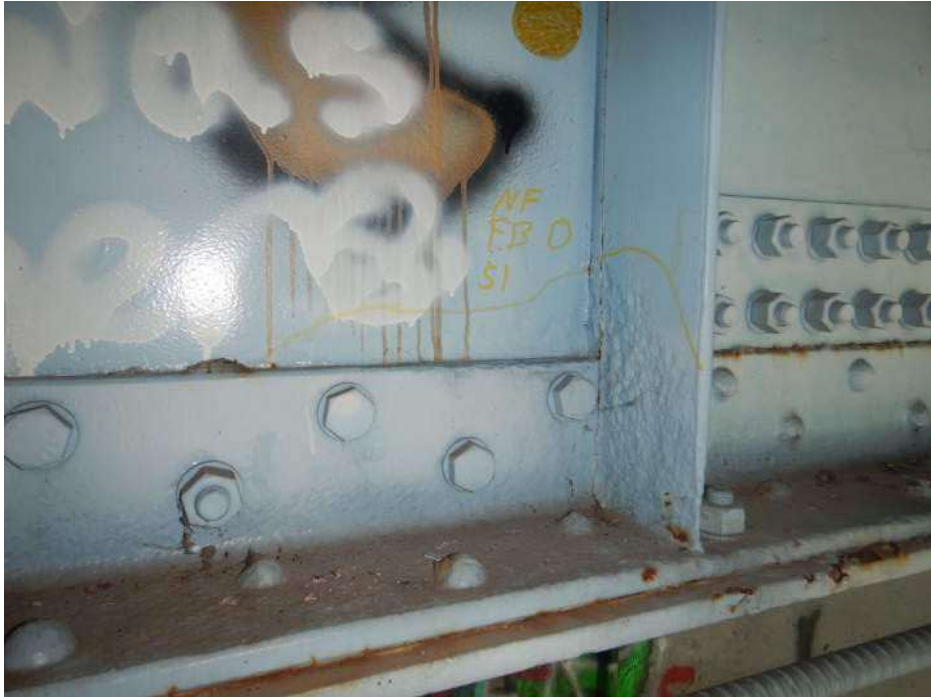
PHOTO 29 Condition
Description Painted over pitting and section loss in bottom of web, typical, Floorbeam 0 shown, looking south.

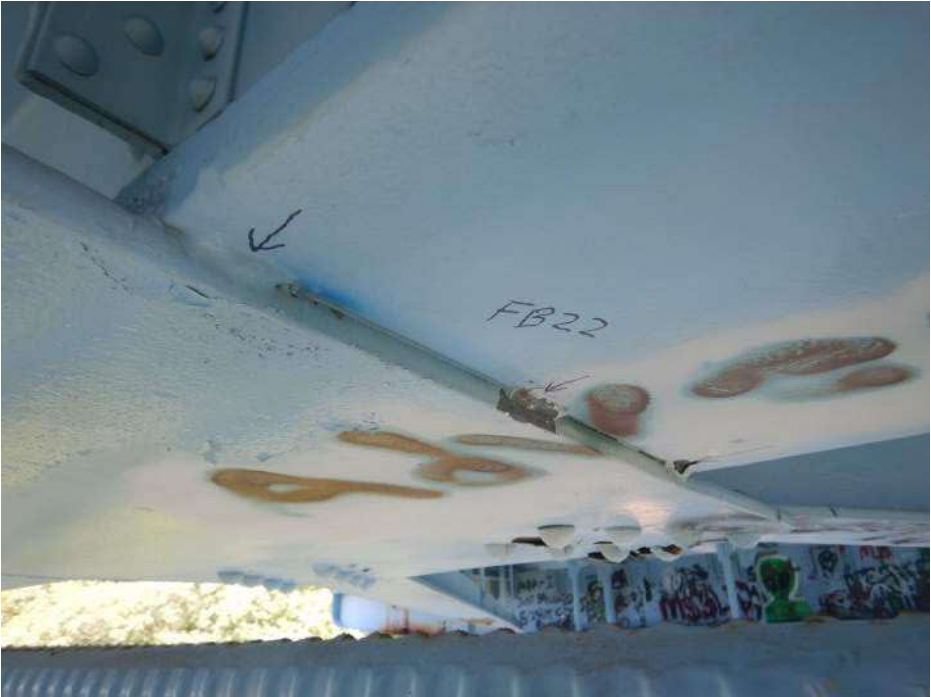
PHOTO 31 Condition
Description Typical upper lateral bracing gusset plate connection to floorbeam tack welds, looking northwest.

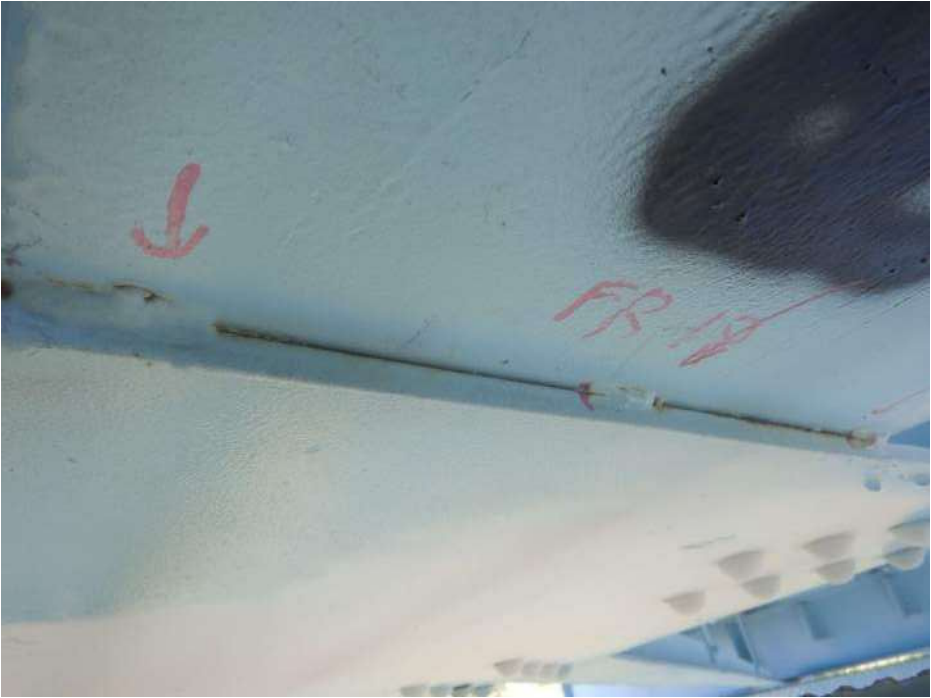
- Cracks exist in tack welds connecting lateral bracing connection plates to the floorbeam bottom (tension zone) flange at the roadway centerline. The cracks have not extended into floorbeam base metal (**photo 29**). The cracks should continue to be checked during in-depth inspections to make sure any noted cracks or new cracks do not propagate into the floorbeam base metal.

PHOTO 32 Condition
Description Cracked bottom flange to upper lateral bracing gusset plate connection tack weld at Floorbeam 18, looking northwest.

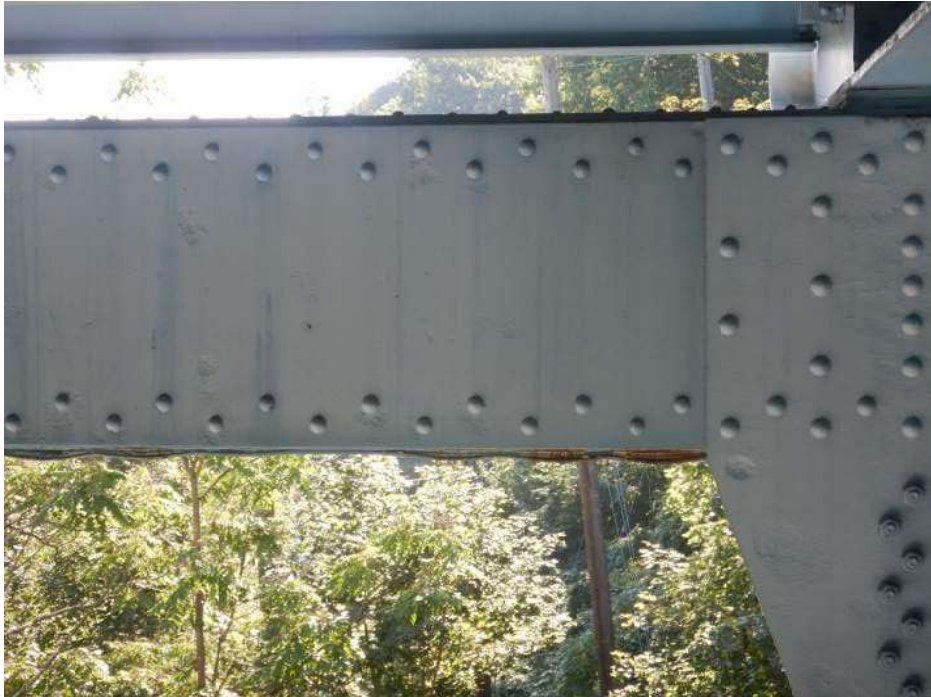
PHOTO 33 Condition

Description Pack rust between bottom flange plate and fill plate up to 1-inch thick causing distortion, looking east at East U3U4 at U3.
