2023 Routine Bridge Inspection Report

North Main Street High Level Bridge

SUM-M008-00908
SFN: 7730306

October 19, 2023

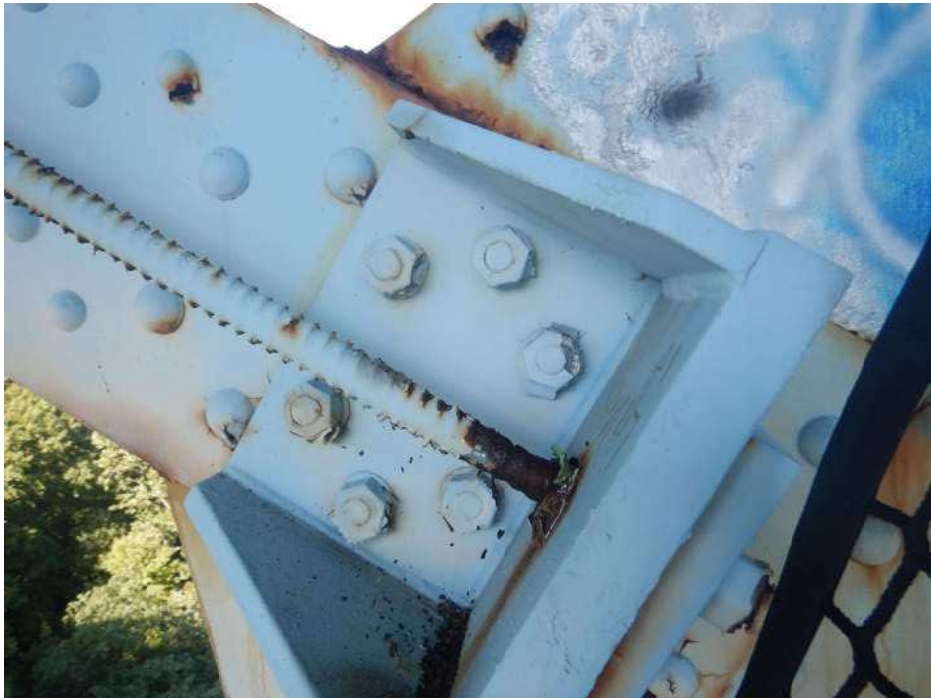
PHOTO 34 Condition

- The post-tensioning rods for west U12L13 and U18L17 exhibit section loss reducing the diameter up to 30% at the lower panel point anchor **(photo 32)**. The joints at floorbeams 13 and 17 have leaked deck drainage in the past and the plastic bushing insert between the rod and anchor retains moisture. This condition has not significantly changed the past few inspections and the corrosion does not currently appear active.

Description PT rod exhibits moderate corrosion with up to 30% section loss, looking west at West U12L13.

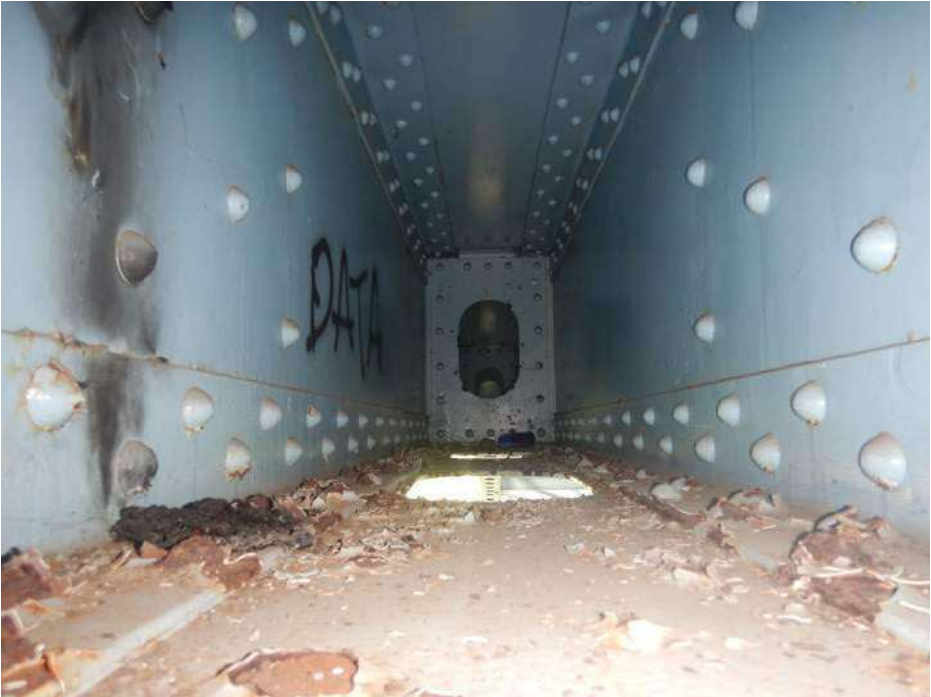
PHOTO 35 Condition

Description Typical inside of lower chord with peeling paint and surface corrosion, heaviest along bottom flange, looking north.

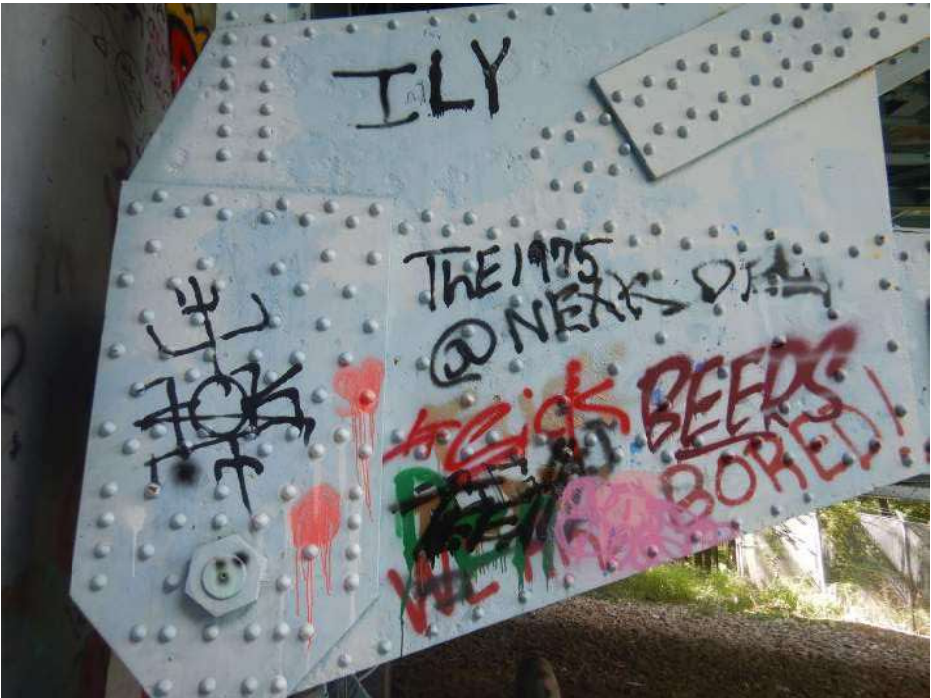
PHOTO 36 Condition

Description Isolated areas of painted over pitting and section loss, looking west at OB gusset plate at East L0.

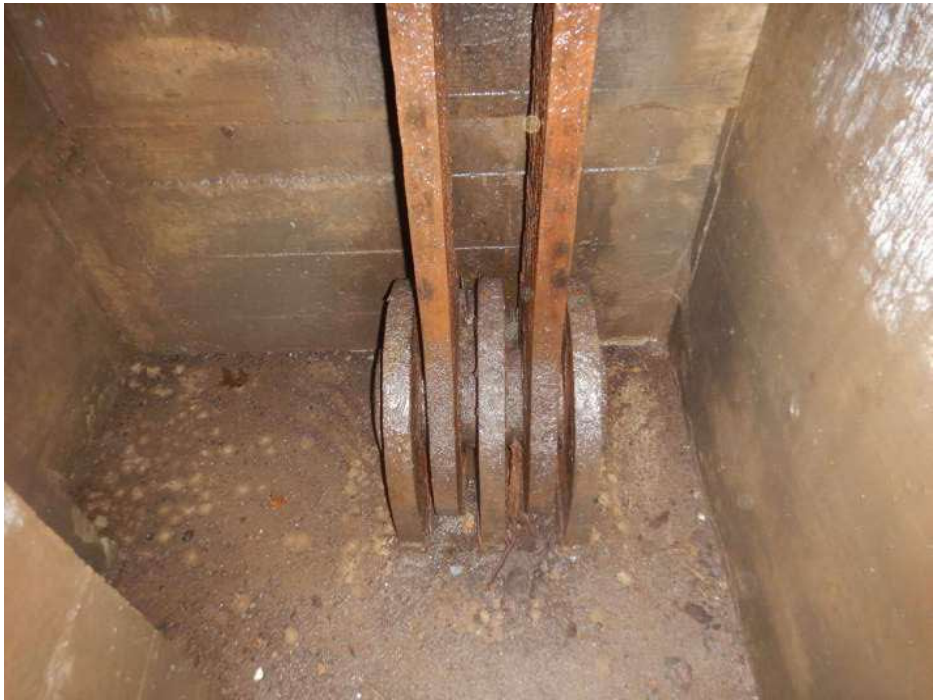
PHOTO 38 Condition

Description Eyebar tie-down anchorage with 1/16-inch deep pitting and laminating corrosion at Forward Abutment, looking north.

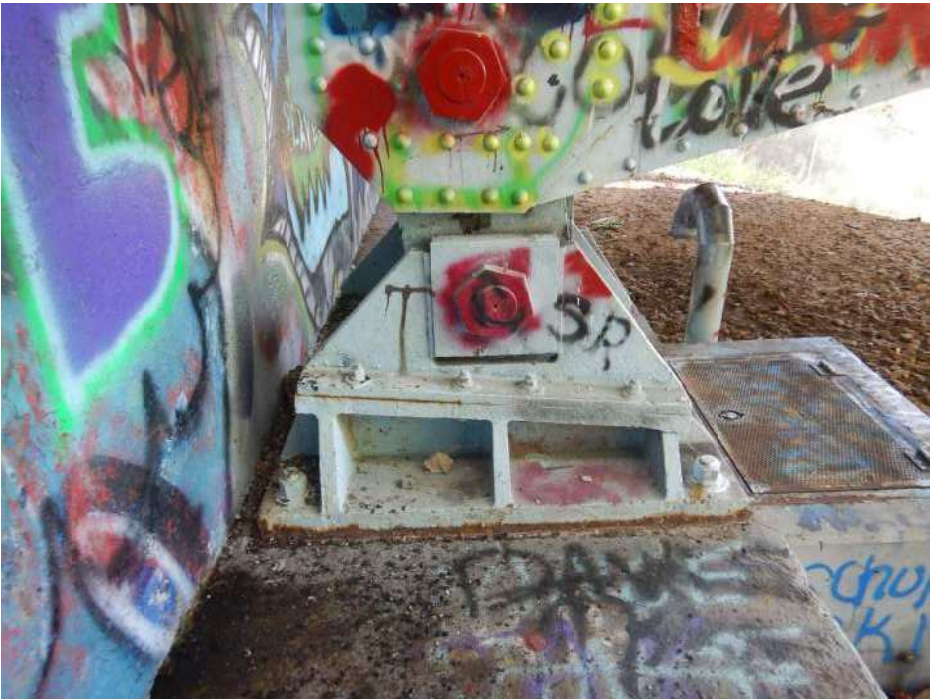
PHOTO 40 Condition

Description Typical surface corrosion around masonry plate and 1-inch deep wear into bearing seat, looking east at west truss bearing Forward Abutment.

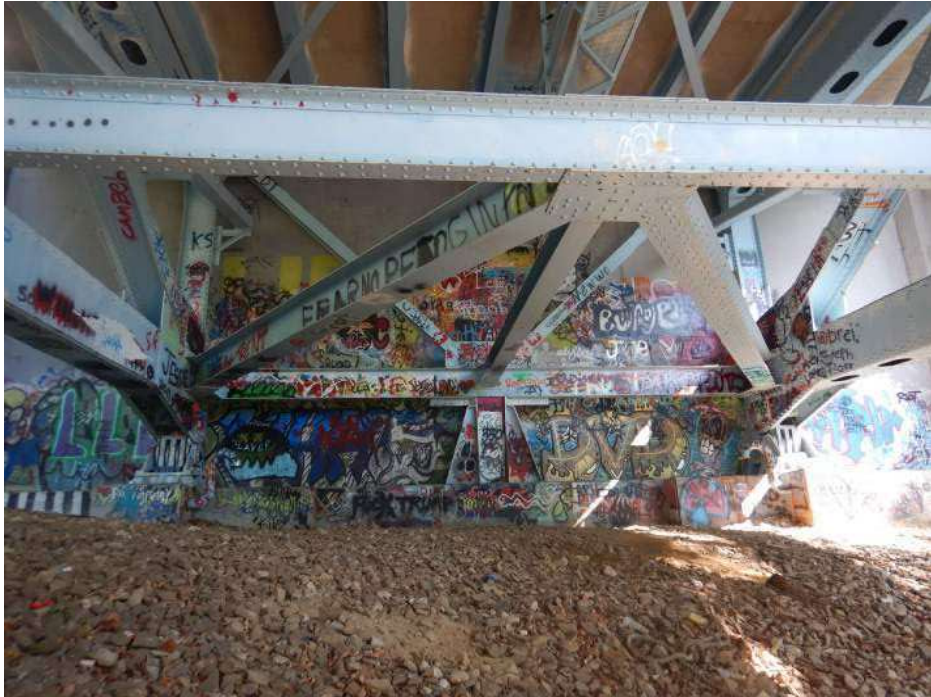
PHOTO 41 Condition
Description Overall of Forward Abutment, looking north. Note: Backwall and breastwall covered with graffiti.

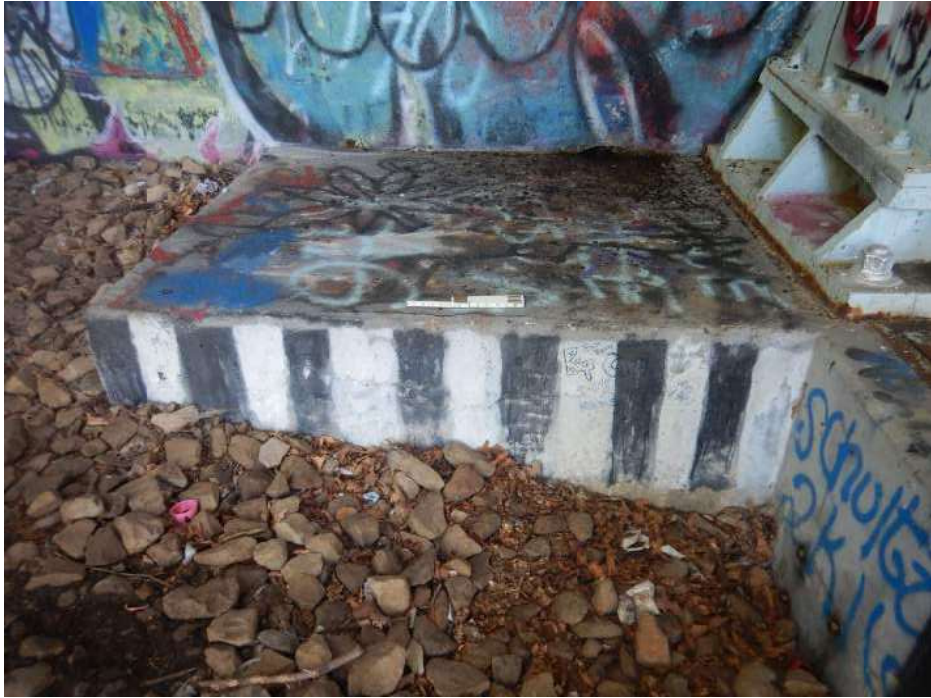
PHOTO 42 Condition
Description 4-foot long x 1-foot tall delamination along top of breastwall, looking north at west end of Forward Abutment.

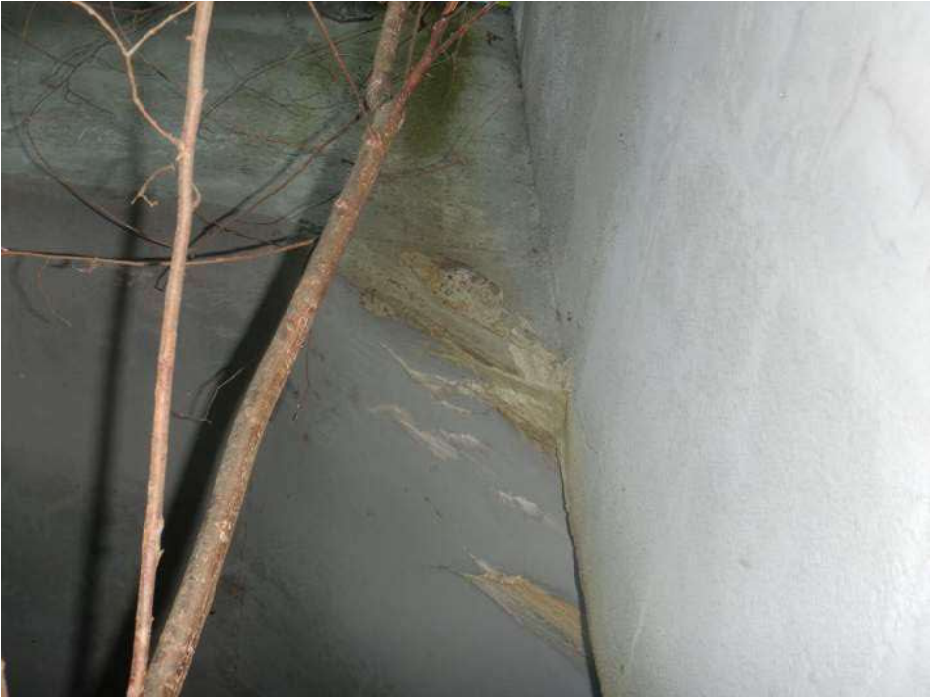
PHOTO 43 Condition
Description 2-foot long x 1-foot wide x 1-inch deep spall with adjacent efflorescence in north face of west end of Pier cap 1, looking south.

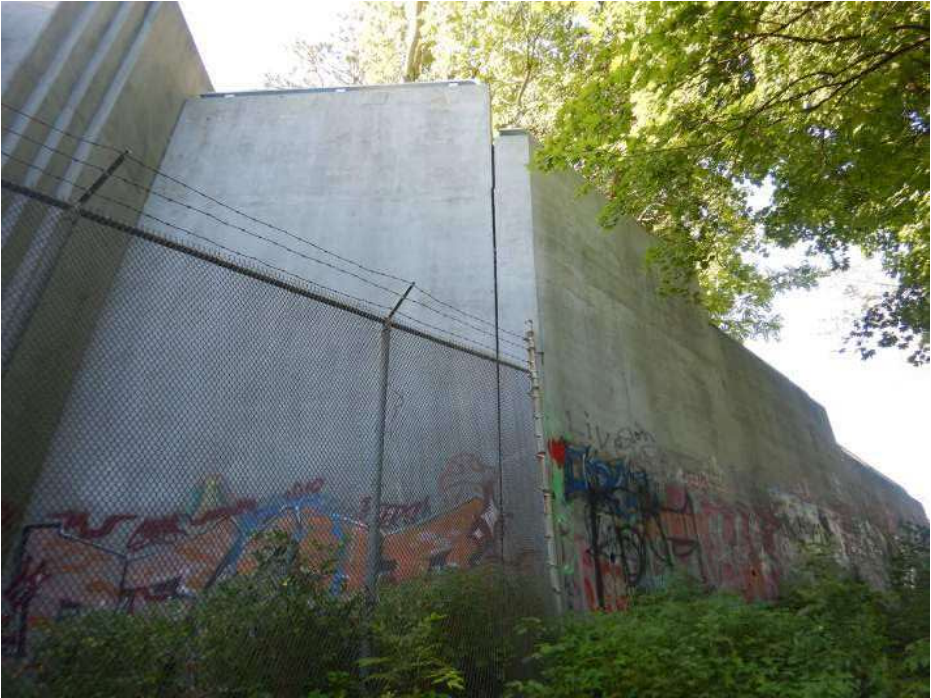
PHOTO 44 Condition
Description Southwest wingwall rotating away from Rear Abutment, looking south.

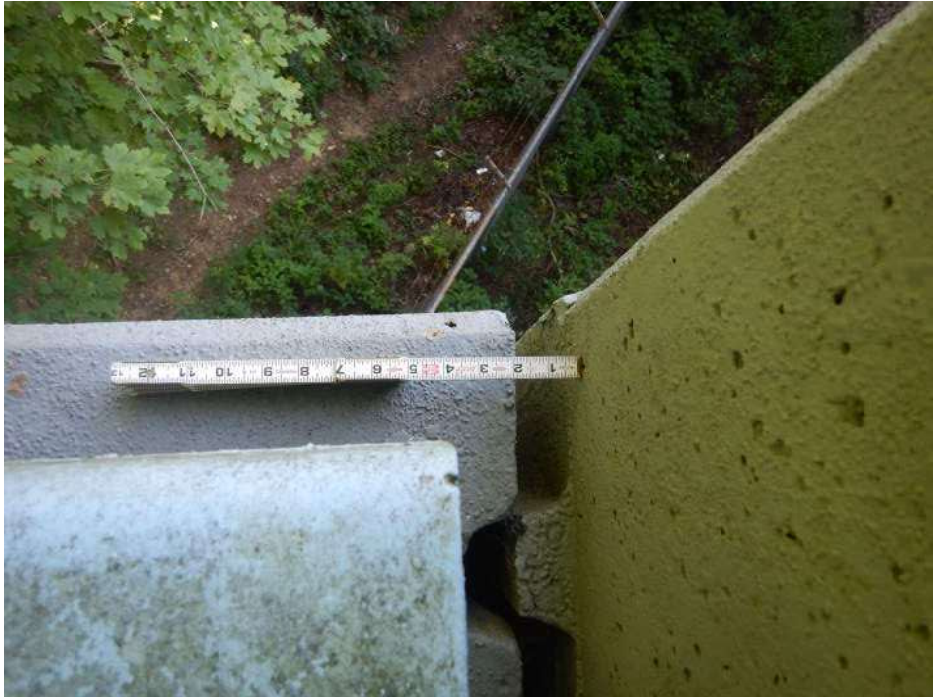
PHOTO 45 Condition
Description Southwest wingwall has rotated away from Rear Abutment, 1 3/4 inches measured at top, looking north.

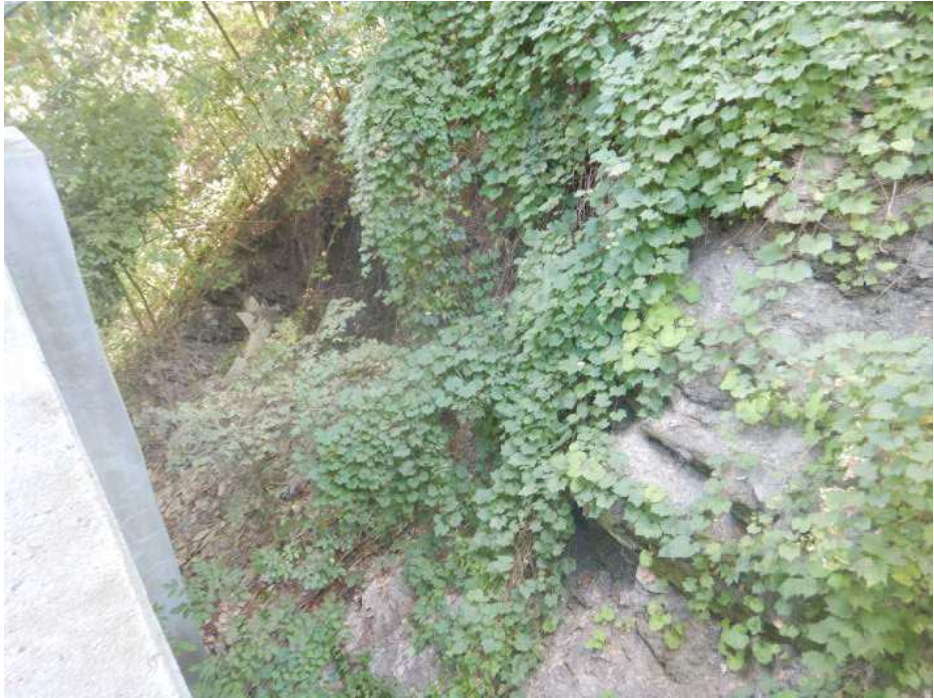
PHOTO 46 Condition
Description South embankment is steep from erosion around Pier 1, looking southeast.

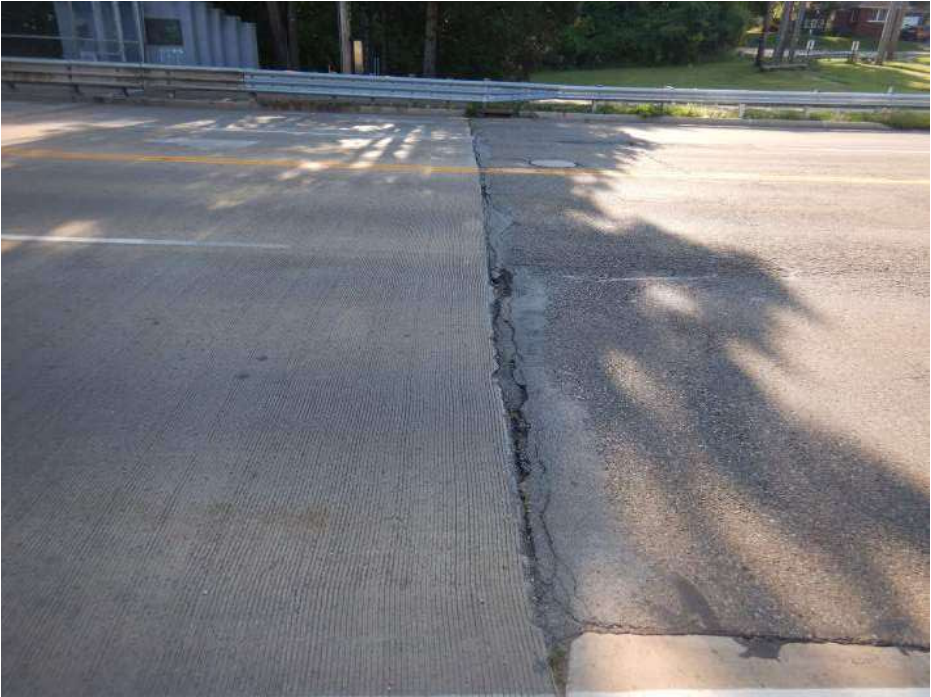
PHOTO 47 Condition
Description Spalling along edge of asphalt roadway at Rear Approach slab with failing patches, looking east.
