INNOVATIVE IDEAS EXCEPTIONAL DESIGN UNMATCHED CLIENT SERVICE Springfield Lake No. 1 Outlet Structure & Channel Study Task B – Preliminary Plan

APPENDIX B – Field Walk Photo Log – August 1, 2023

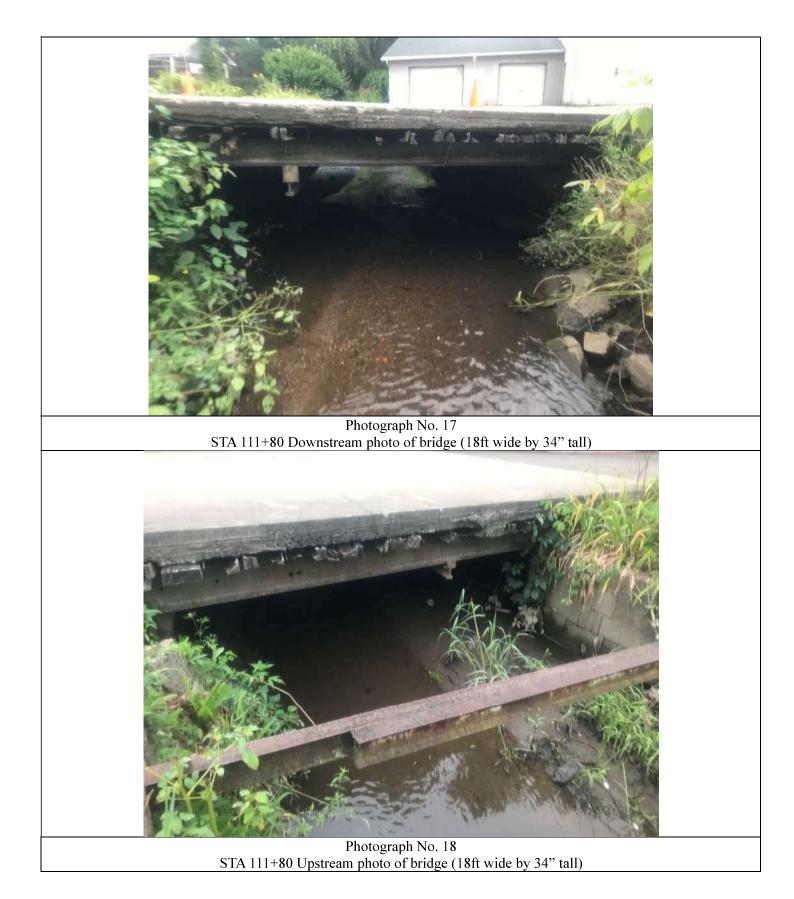
There is 1 steel pipe between the bridges at STA 111+80 and 112+55 and the channel is 10 ft wide concrete walls.

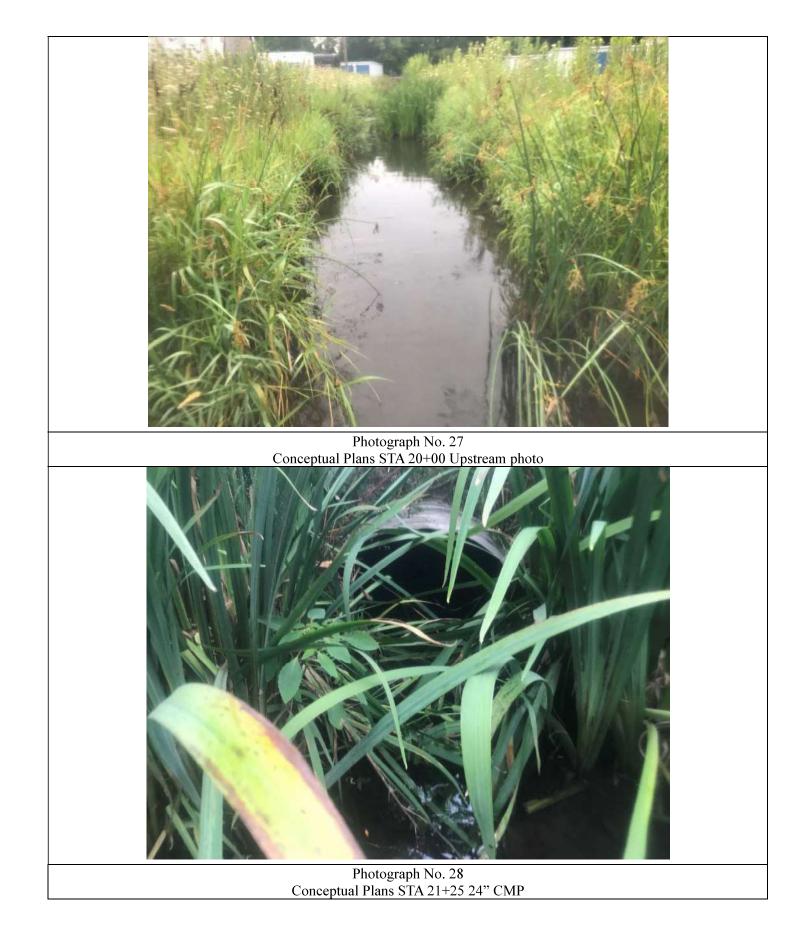
There is a 6" PVC pipe at STA 20+50

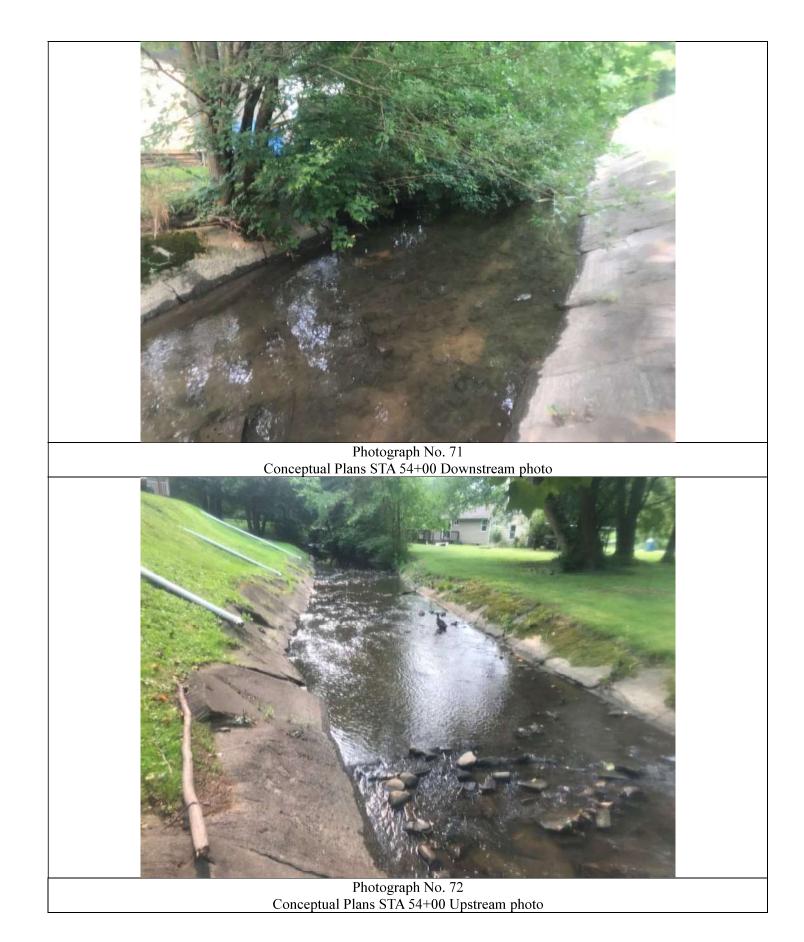
After road crossing at Conceptual Plans STA 51+00 creek is 12ft wide lined with concrete

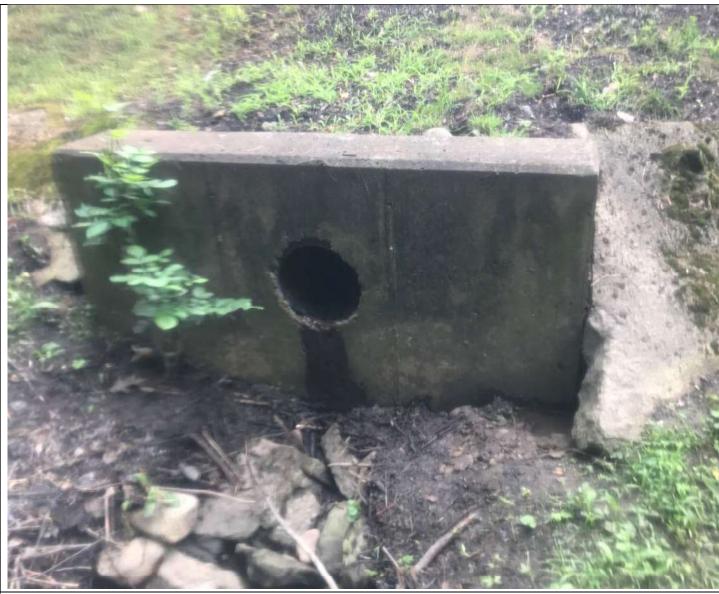
Photograph No. 75 Conceptual Plans STA 56+00 12" metal pipe just past county line
