Cuyahoga River Watershed Study

Summit County Surface Water Management District

April 11, 2025

Tetra Tech

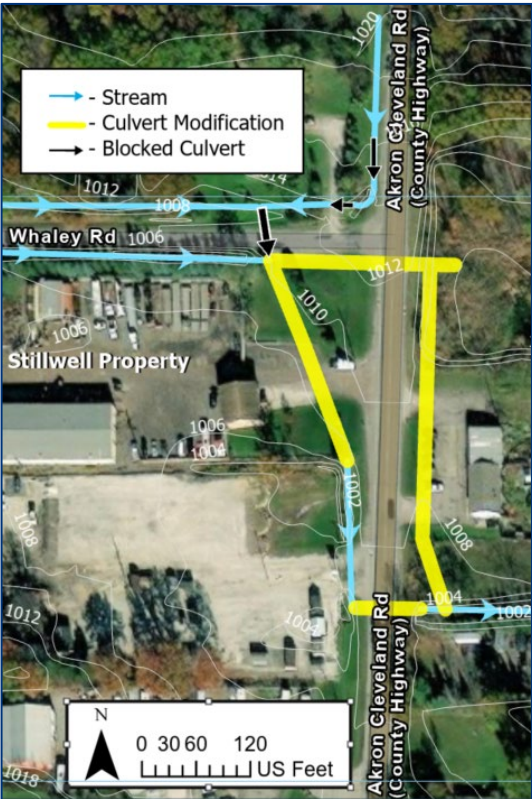
Figure 8. Stormwater drainage schematic.

Summary of Problem Area #1 (ACDC_AOI_1)		
Location	5440 Akron Cleveland Road	Boston Township
HUC12 Watershed	Mud Brook (Stefans Run)	
Problems	Blocked and undersized road and driveway culverts	
Recommended Actions	Reconfigure/upsized stormwater drainage system

- A culvert north of Whaley Road that runs parallel to Akron-Cleveland Road, is blocked.
 - Gravel blocks the inlet.
 - Vegetation blocks the outlet.
- A culvert under a driveway off Whaley Road is undersized and partially blocked (Figure 9).
- A culvert under Whaley Road is blocked with vegetation.

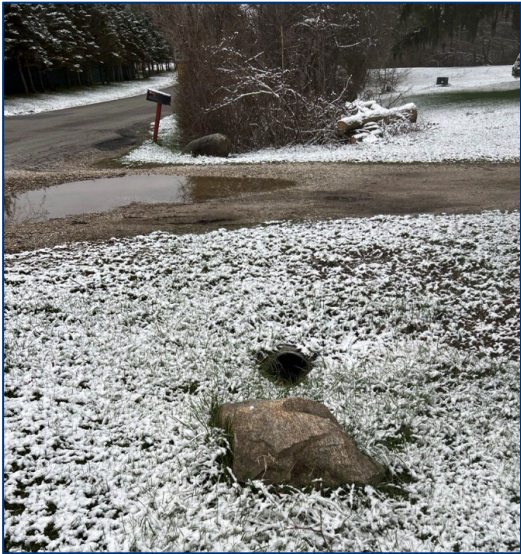
The second component of this problem area involves a drainage way that is in poor condition on private property. More specifically, Tetra Tech observed the following in March 2024 during a site visit:

Figure 9. Partially blocked driveway culvert.

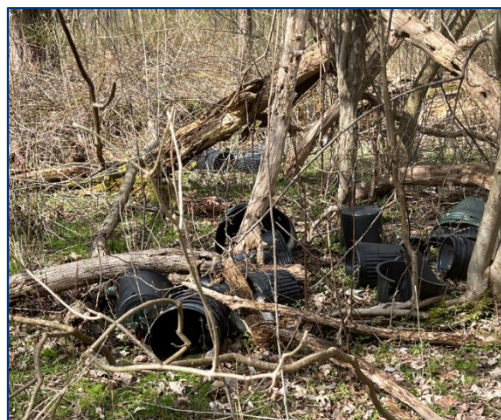
Figure 10. Plant pots along streambank.

Tetra Tech recommends SCE notify the Summit SWCD to investigate the potential dumping of waste along Brandywine Creek and to enforce the 75-foot riparian setback on the left bank of Brandywine Creek as specified in section 937.05 of the Codified Ordinances of Summit County⁶. The discarded material should be removed from the riparian corridor.

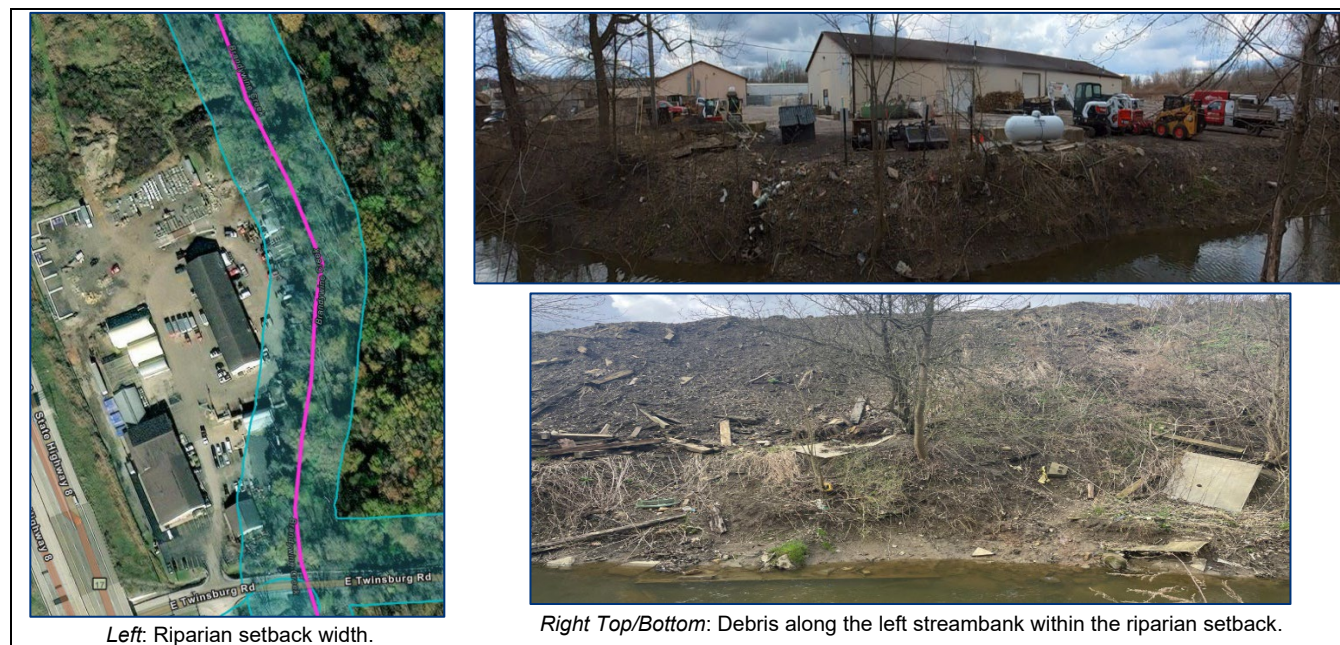
Left: Riparian setback width.

Right Top/Bottom: Debris along the left streambank within the riparian setback.

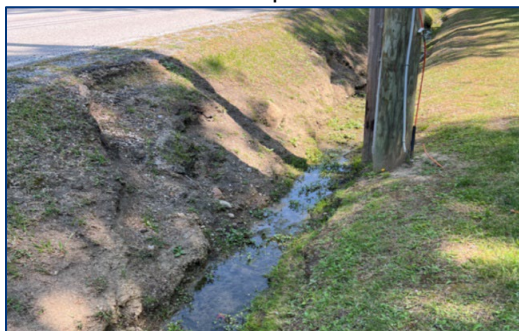
Figure 14. Erosion of roadside ditch

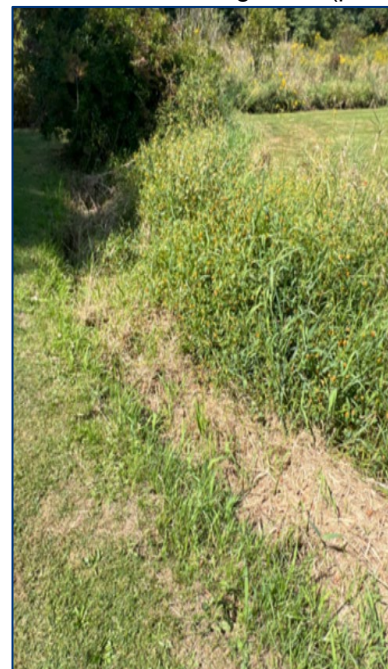
Figure 13. Stream blocked with invasive vegetation.

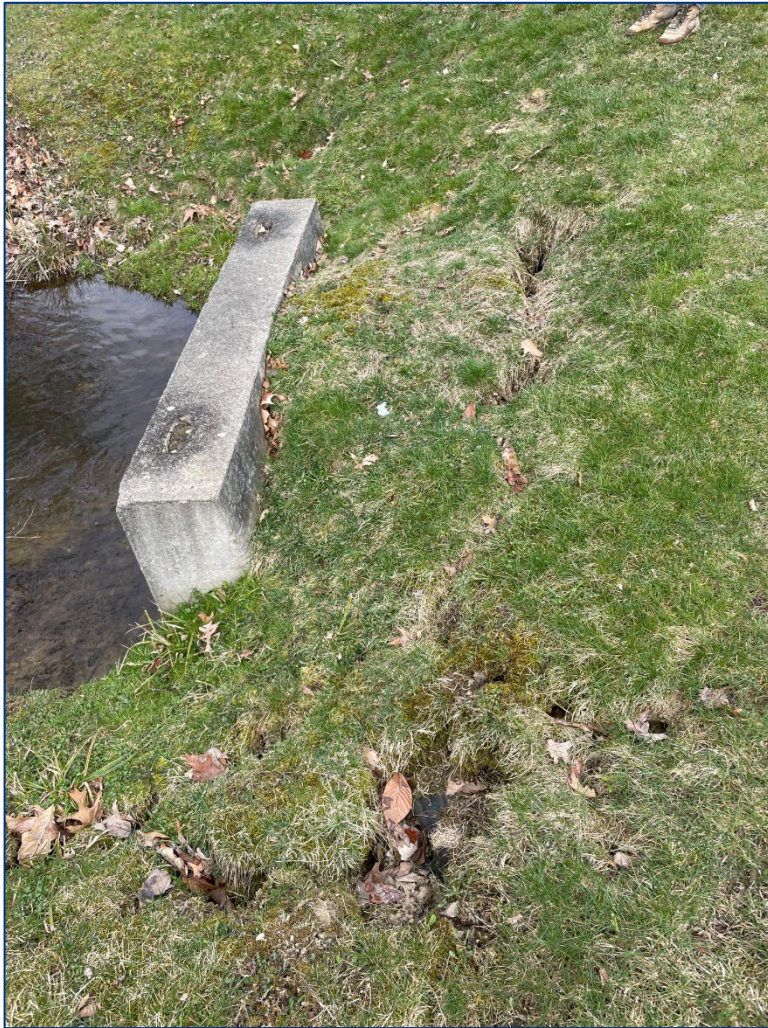
Summary of Problem Area #4 (AST_AOI_3)		
Location	Crossings Drive	Reminderville
HUC12 Watershed	Pond Brook	
Problems	Erosion behind culvert headwall, soil slumping	
Recommended Actions	Advise the city of Reminderville to monitor erosion

Soil slumping and minor erosion were observed behind the downstream headwall of a culvert beneath Crossings Drive, which an unnamed tributary flows through (Figure 15). Tetra Tech, in consultation with SCE, recommends that the city of Reminderville be notified of the erosion and that the headwall be regularly monitored to ensure the condition does not become worse.

Figure 15. Erosion and slumping behind headwall.

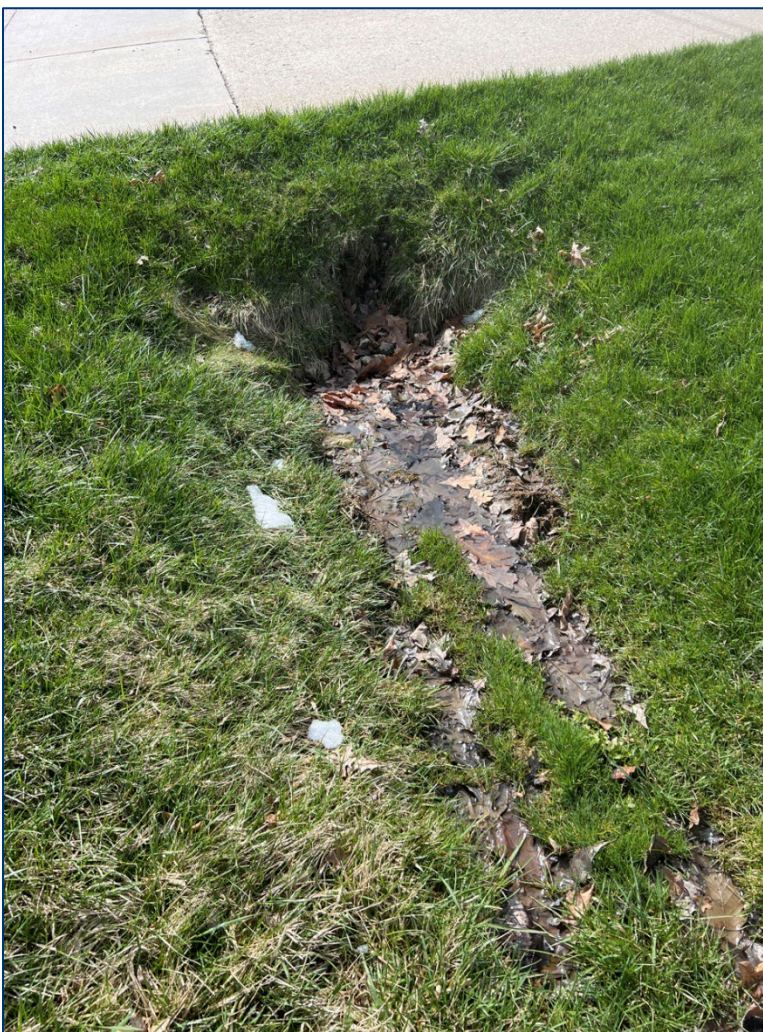
Figure 16. Blocked driveway culvert.

Summit County SWMD does not fund roadway or driveway projects but can aid in the funding of stream and/or ditch improvements outside of the roadway. The SWMD can also provide recommendations for stormwater projects that are under the purview of participating cities, townships, and villages; in this case the city of Reminderville. This problem area would be a good candidate for the SWMD to provide this recommendation.

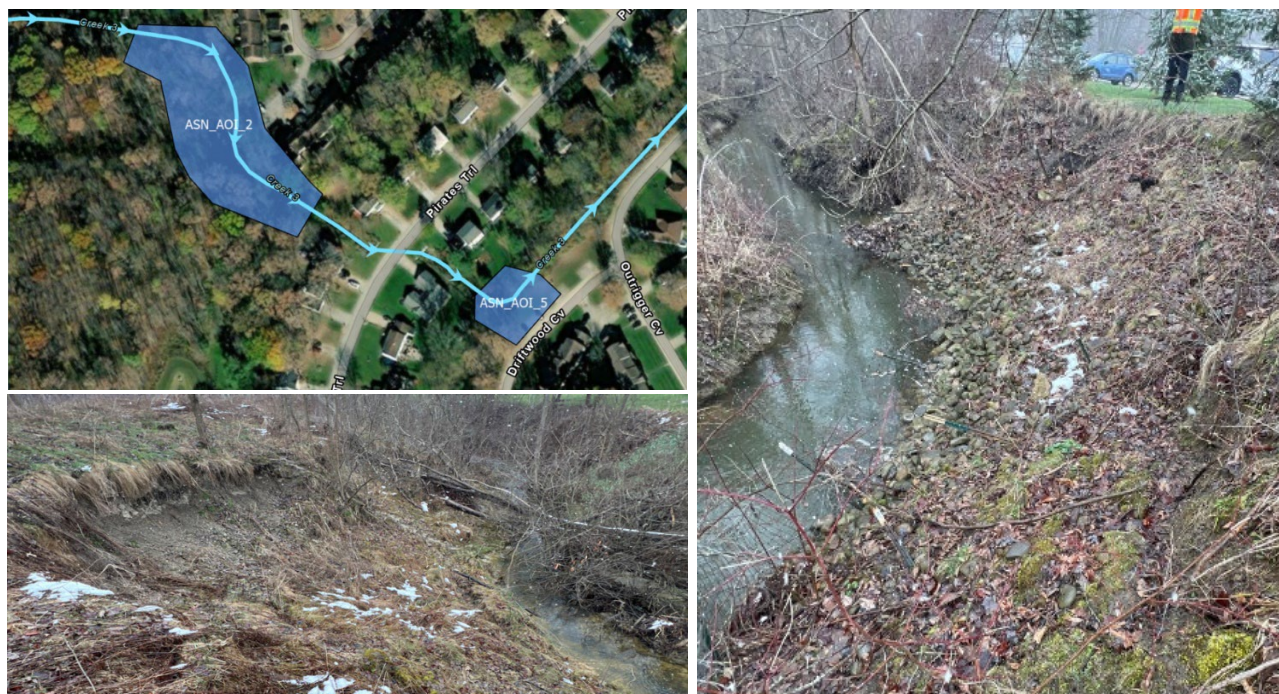
Top Left: Location of ASN_AOI_2 and ASN_AOI_5.

Bottom Left: Looking upstream - right bank erosion at ASN_AOI_2

The restored downstream reaches of Pond Brook would also benefit from remediation of this erosion as these recommendations will provide protection from sedimentation. Tetra Tech has provided SCE with a concept plan (Appendix G) and the associated costs for the recommended actions in ASN_AOI_2 and ASN_AOI_5 as separate supporting documents to this report.

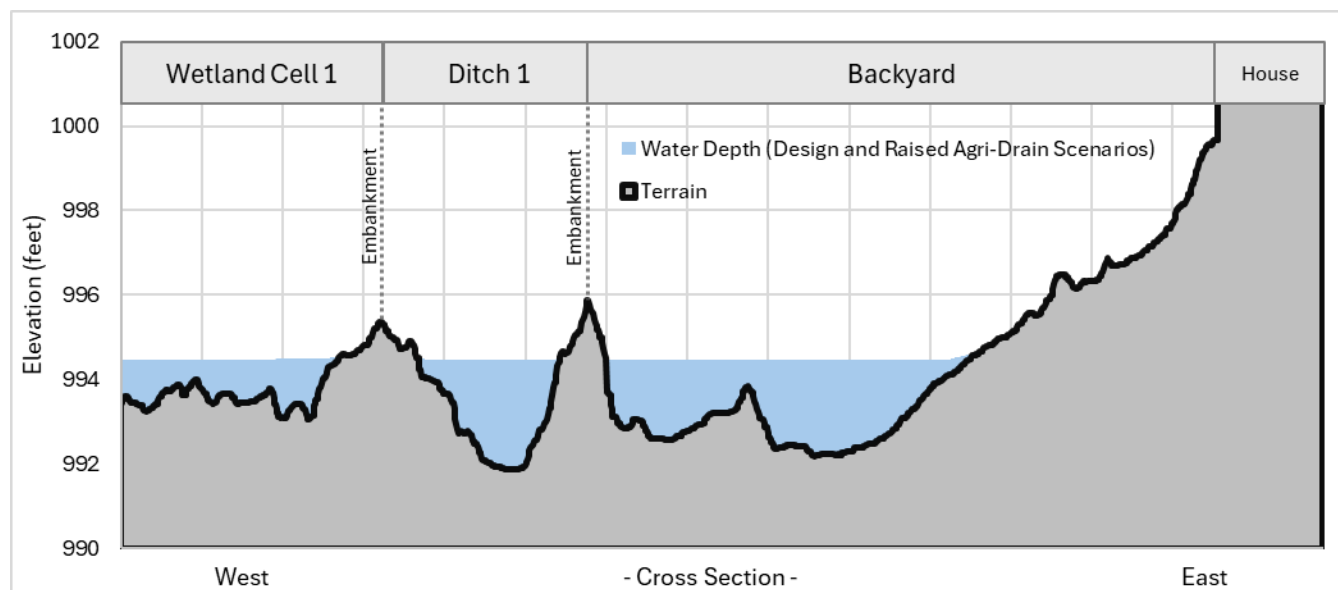
- A review of historic maps circa 1963 and 1906 shows that roads and buildings in the Aurora Shores neighborhood, specifically where the flooding of recent years has been observed, were built in low areas historically dominated by natural wetlands and swamps. Additionally, the increase in impervious area from the development of Aurora Shores increases runoff which is not fully offset by the limited number of detention basins in the neighborhood. The footprint of Aurora Lake has also approximately doubled in response to a four-foot increase in water surface elevation between 1906 and 1963.

Figure 18. Cross section of terrain and water surface elevations downstream of the Agri-Drain and embankment structure.

To address this flooding issue, three alternatives have been developed which are discussed in depth in concept plans (Appendix G), cost estimates, and the Aurora Shores 2-D HEC-RAS Model memorandum (Tetra Tech, 2025a). In short, the three alternatives are as follows: (1) maintain the existing conditions and allow the backyards to flood within the FEMA 100-year floodplain; (2) install a system of field drains in an east-west direction to convey water to the adjacent ditch; and (3) install a system of field drains in a north-south direction to convey water to two constructed retention basins which are then emptied to the adjacent ditch via a pump station.

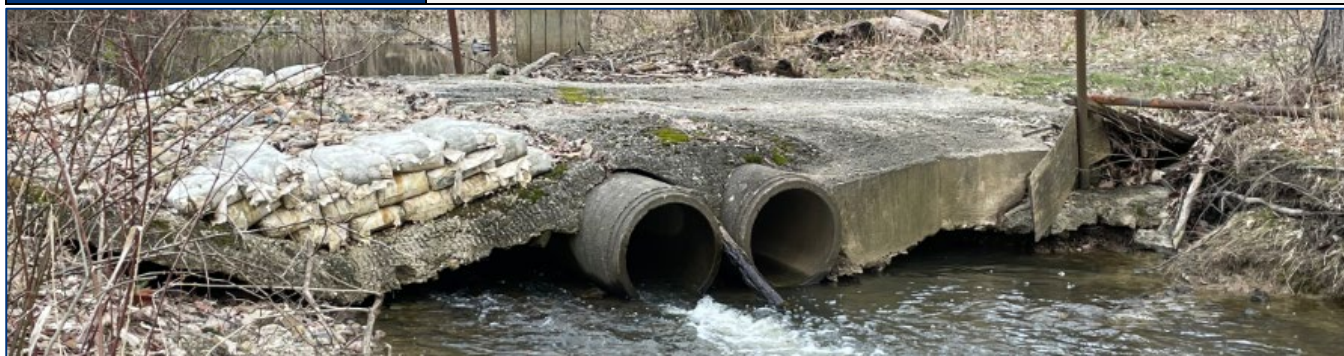
Summary of Problem Area #7 (AST_AOI_2)		
Location	Upstream of Glenwood Blvd.	Reminderville
HUC12 Watershed	Pond Brook	
Problems	Failed bridge crossing (water bypasses culvert), upstream ponding	
Recommended Actions	Install new crossing; opportunity for wetland creation

Figure 19. Downstream side of failing bridge crossing.

A bridge crossing over Channel Brook, upstream of Glenwood Boulevard and northwest of Crisfield Court is failing (Figure 19). The bridge crossing is on a gravel road that is not open to the public. Along the right bank, some of the streamflow is bypassing the double barrel culvert and undermining the crossing. Someone placed sandbags in an attempt to mitigate the bypassing streamflow. Channel Brook is ponding upstream of the bridge crossing (Figure 20). Several years ago, SCE staff had not observed any ponding at this site.

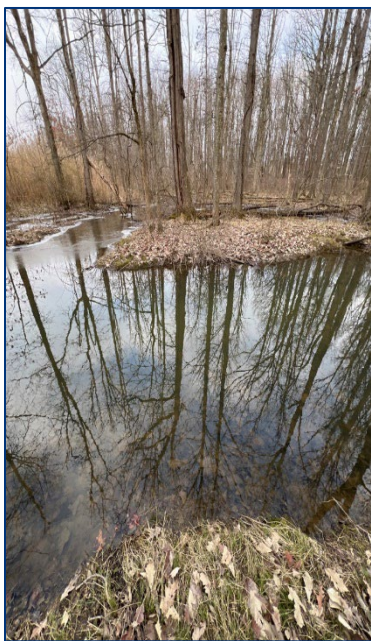
Figure 20. Ponding upstream of the bridge crossing.

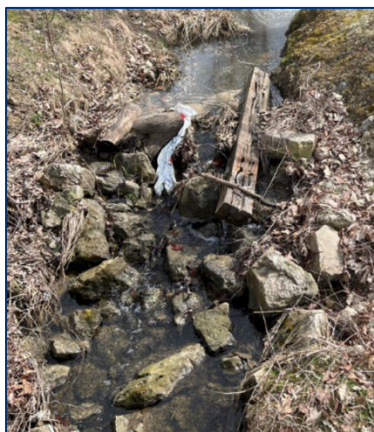
Figure 23. Grade control.

Fourth, the downstream end of this reach, just east of Maryland Avenue contains haphazardly placed rip rap and debris (Figure 23). These materials function as grade control

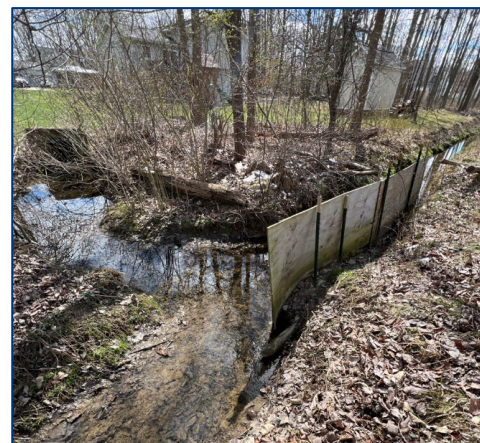
Figure 21. Homemade revetment with culvert outlet of tributary in background.

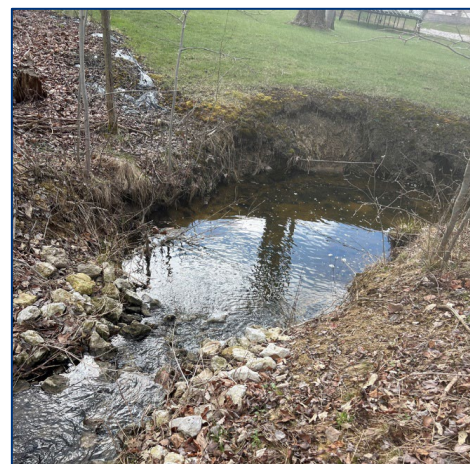
Third, the left cutbank of a rerouted ditch is eroding (3-feet tall by 25-feet long) at a 90-degree turn (Figure 22). The ditch was likely rerouted with the 90-degree turn as homes were built over the last decade. The floodplain along the left bank is a residential grassed yard. No woody vegetation is at the 90-degree turn that could stabilize the left cutbank. Tetra Tech recommends stabilizing this erosion.

Figure 22. Erosion along left cutbank.

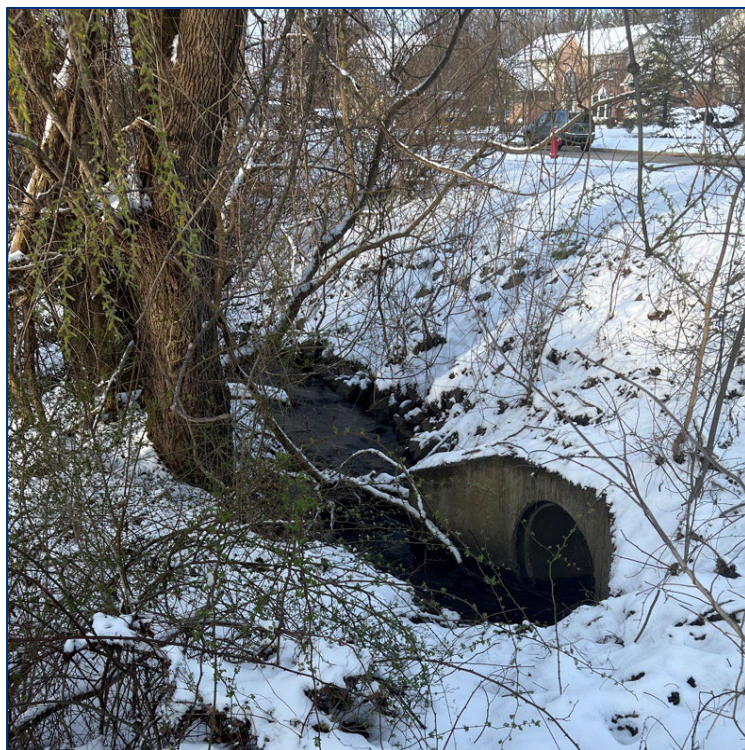
Location	Troubadour Drive	Sagamore Hills Township
HUC12 Watershed	Willow Lake-Cuyahoga River (Sagamore Run)	
Problems	Misaligned and undersized road culvert	
Recommended Actions	Replace and upsize the culvert and realign the culvert inlet

Figure 24. Looking upstream; culvert below Troubadour Drive.

The culvert below Troubadour Drive is made of concrete with a 36-inch diameter. The culvert is misaligned with the natural direction of the unnamed stream (Figure 24); the culvert inlet is perpendicular to streamflow. This skew angle is not in compliance with the Technical Requirements - Section 8.2 of the Stormwater Drainage Manual (SCE, 2020).

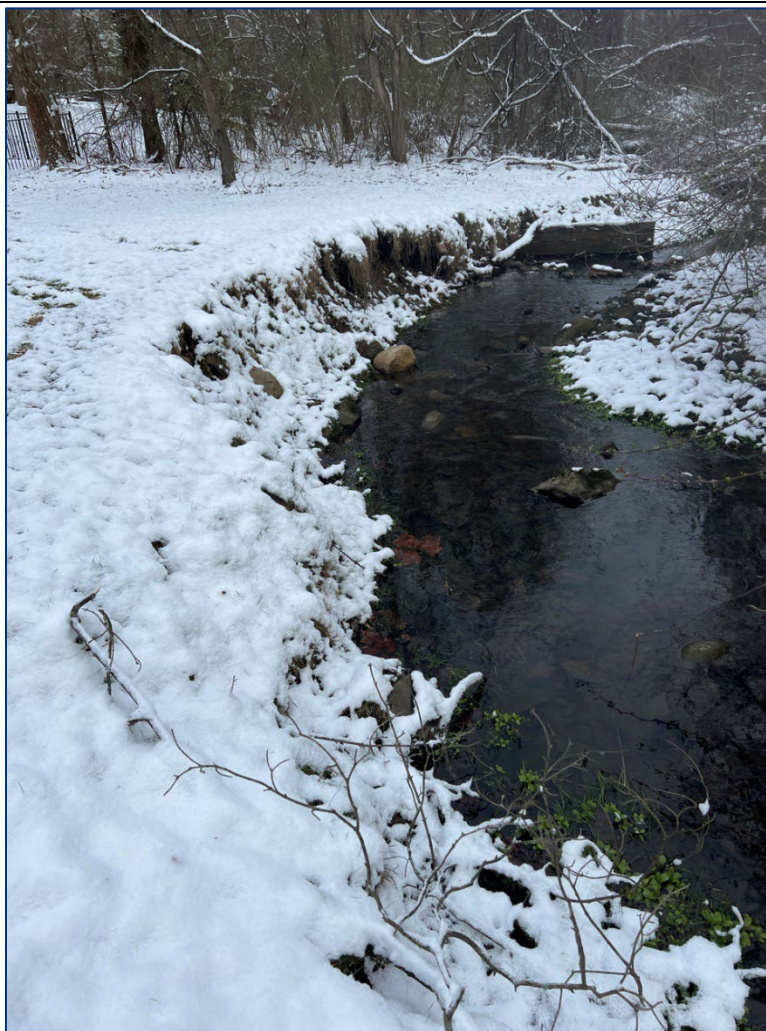
Figure 25. Looking downstream; erosion along left streambank.

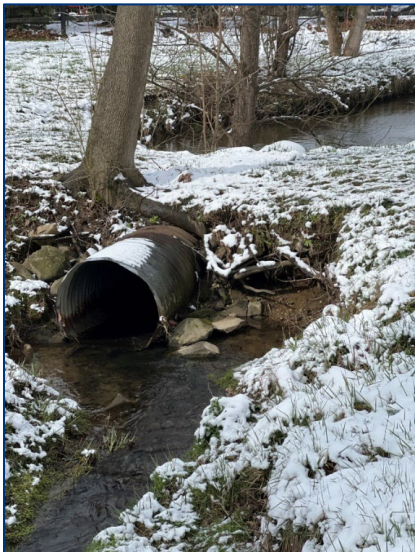
A second culvert (corrugated metal pipe; 2-foot diameter) is 20-feet downstream from the first culvert and further constricts flow (Figure 27). This culvert is beneath a small causeway that connects two grass yards. The causeway does not appear to serve any purpose. Tetra Tech recommends this culvert be removed to improve conveyance and restore the natural course of the stream.

Figure 27. Culvert recommended for removal.

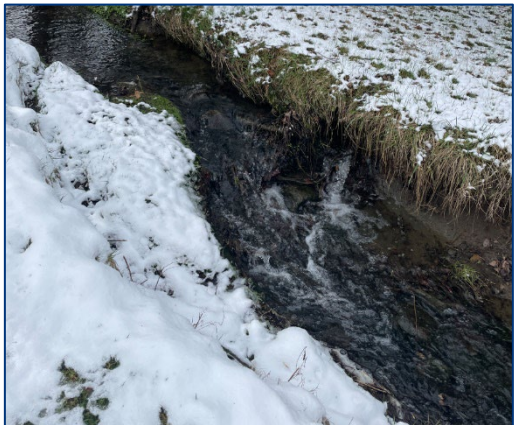
The final component of this problem area on Sagamore Run is the incised reach along a flat, grassed yard with headcut erosion downstream of these two culverts (Figure 28). Tetra Tech recommends stabilizing the headcut to prevent further channel degradation from migrating upstream to the culvert under Walton Road.

Figure 28. Headcut erosion.

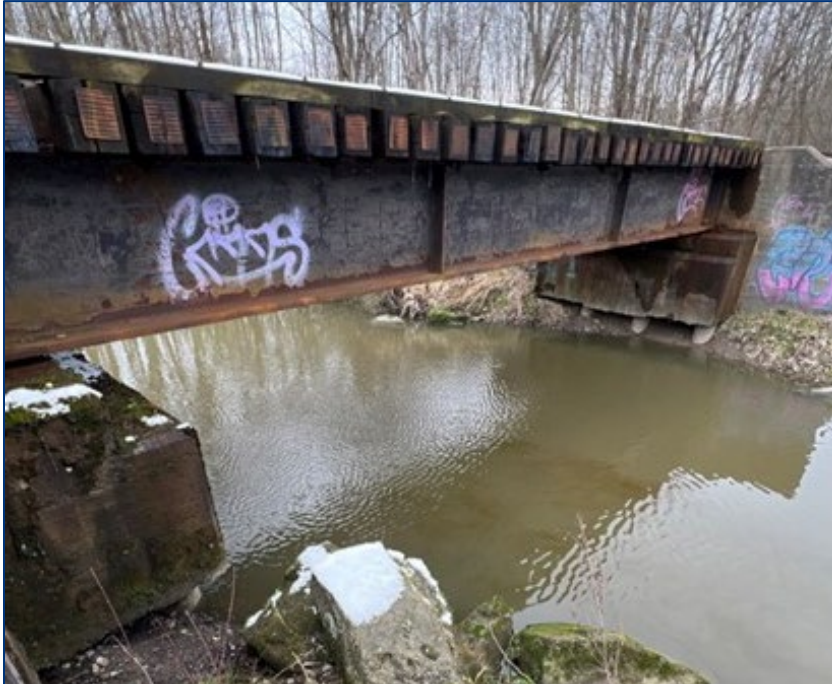
Summary of Problem Area #13 (PBTC_AOI_3)		
Location	near Old Mill Road	Twinsburg Township
HUC12 Watershed	Pond Brook	
Problems	Railroad bridge abutments on left and right streambanks are undercut	
Recommended Actions	Notify railroad

The abutments of the Wheeling and Lake Erie Railway Company⁹ bridge over Pond Brook are undercut at their bases on the left and right streambanks (Figure 30).

Tetra Tech recommends SCE notify the Wheeling and Lake Erie Railway Company of the undercut abutments because the bridge is owned by the railway. SCE could also contact the Public Utilities Commission of Ohio, which has jurisdiction over railroad companies and railways in Ohio.

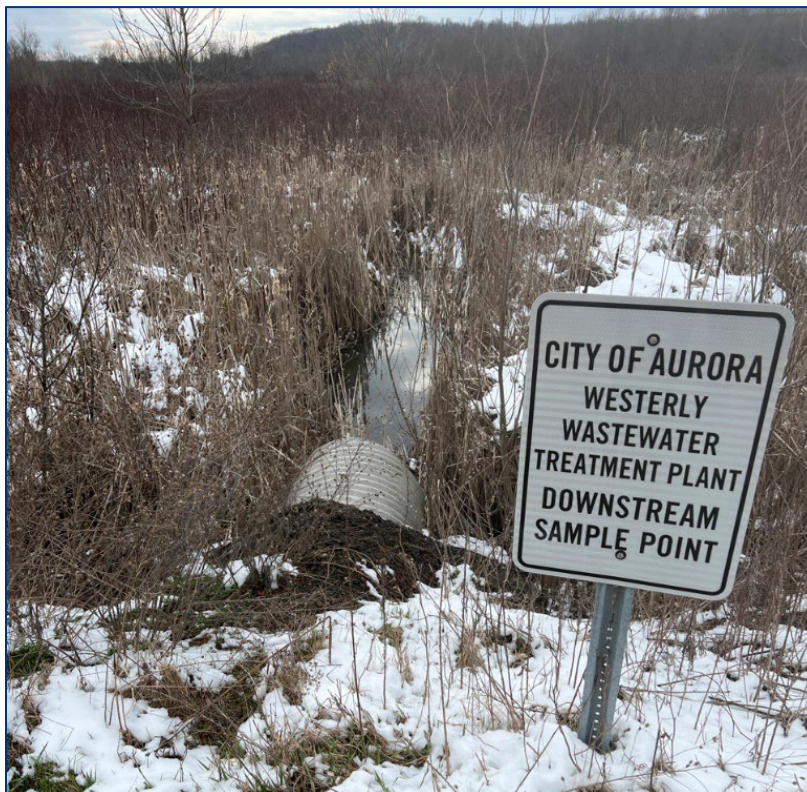
A sign indicates that the downstream monitoring site (outfall 901 in permit 3PD00045*GD) is downstream of the blocked culvert (Figure 31). Tetra Tech recommends SCE notify the City of Aurora to inform them that the culvert blockage may affect water chemistry samples of the monitoring site.

Figure 31. Aurora WWTP monitoring site.

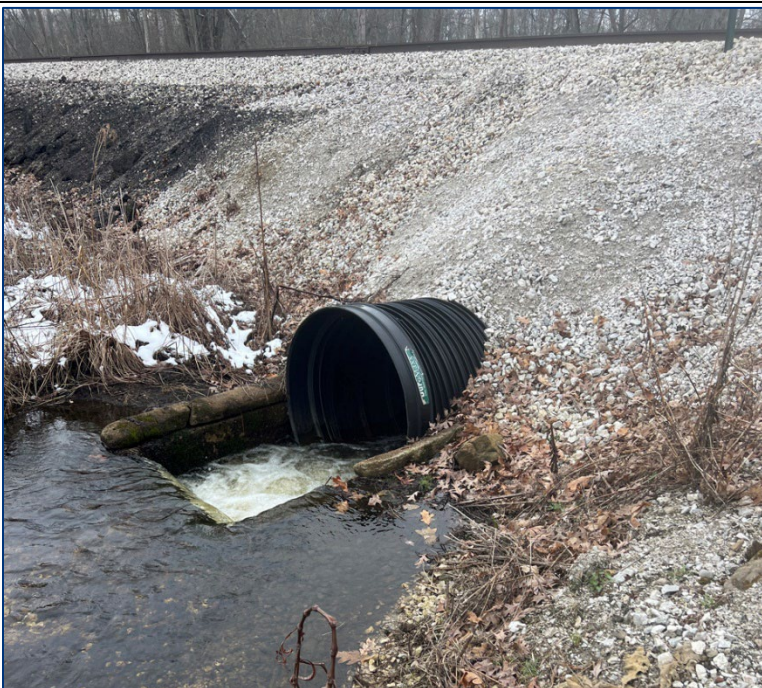
Cursory review of historic aerial imagery and anecdotal information do indicate that wetland water levels have lowered and the wetlands appear to be draining.

Figure 32. New culvert that crosses railroad tracks.

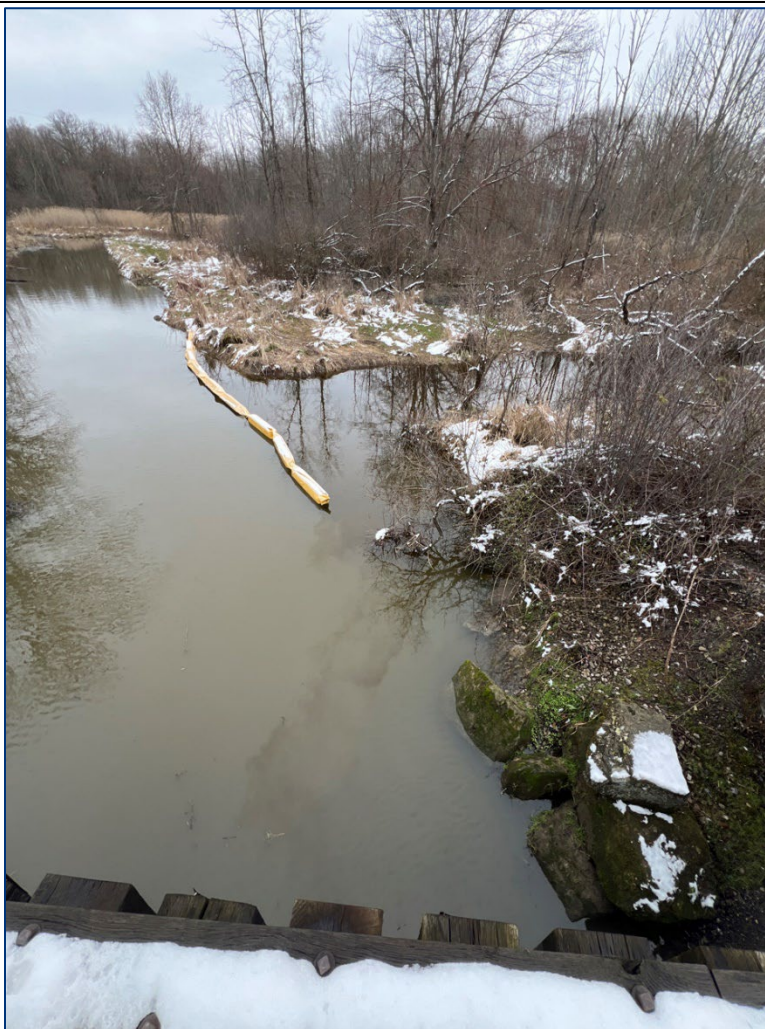
Figure 33. Containment boom on Pond Brook.

Tetra Tech recommends SCE notify Summit SWCD to investigate this spill. Summit County has notified Ohio EPA's Division of Environmental Response and Revitalization in 2024.

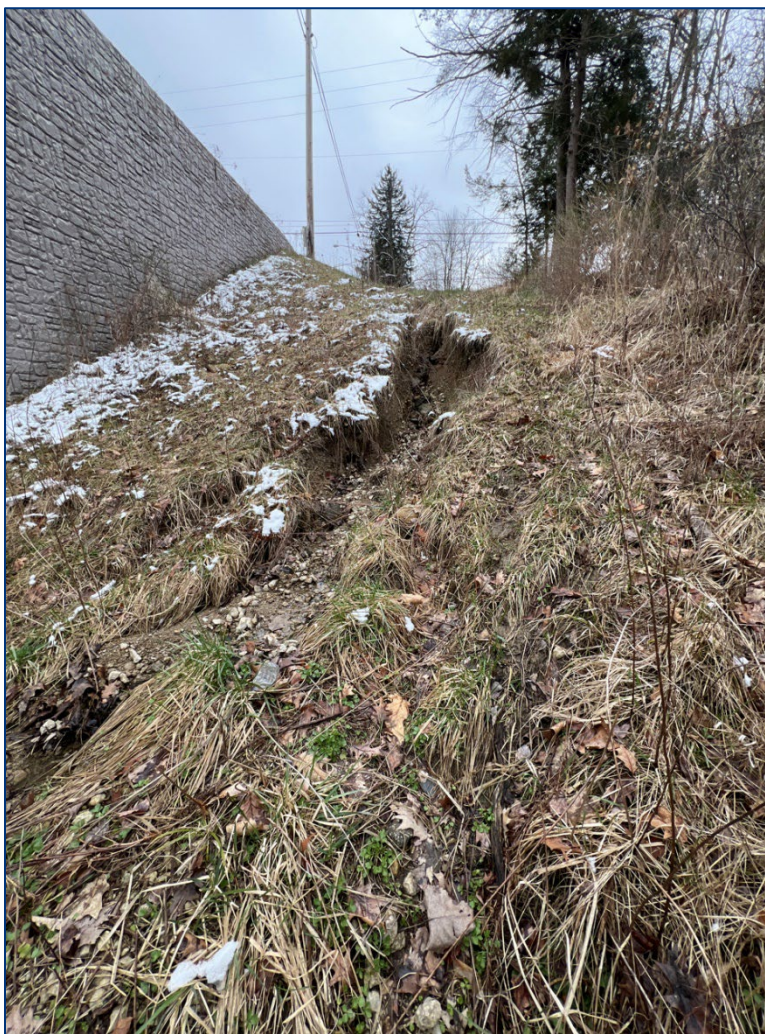
Figure 34. Gully formation.
