Cuyahoga River Watershed Study

Summit County Surface Water Management District

Summit County Engineer

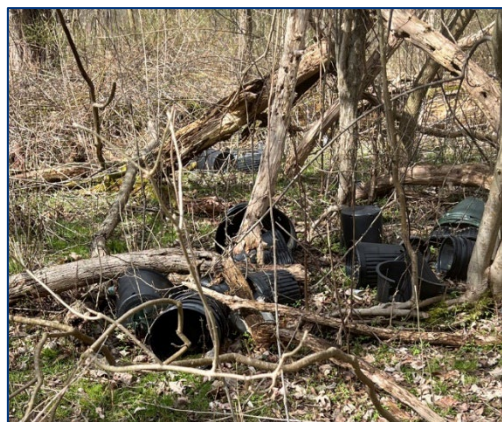
Figure 10. Plant pots along streambank.

Tetra Tech recommends SCE notify the Summit SWCD to investigate the potential dumping of waste along Brandywine Creek and to enforce the 75-foot riparian setback on the left bank of Brandywine Creek as specified in section 937.05 of the Codified Ordinances of Summit County⁶. The discarded material should be removed from the riparian corridor.

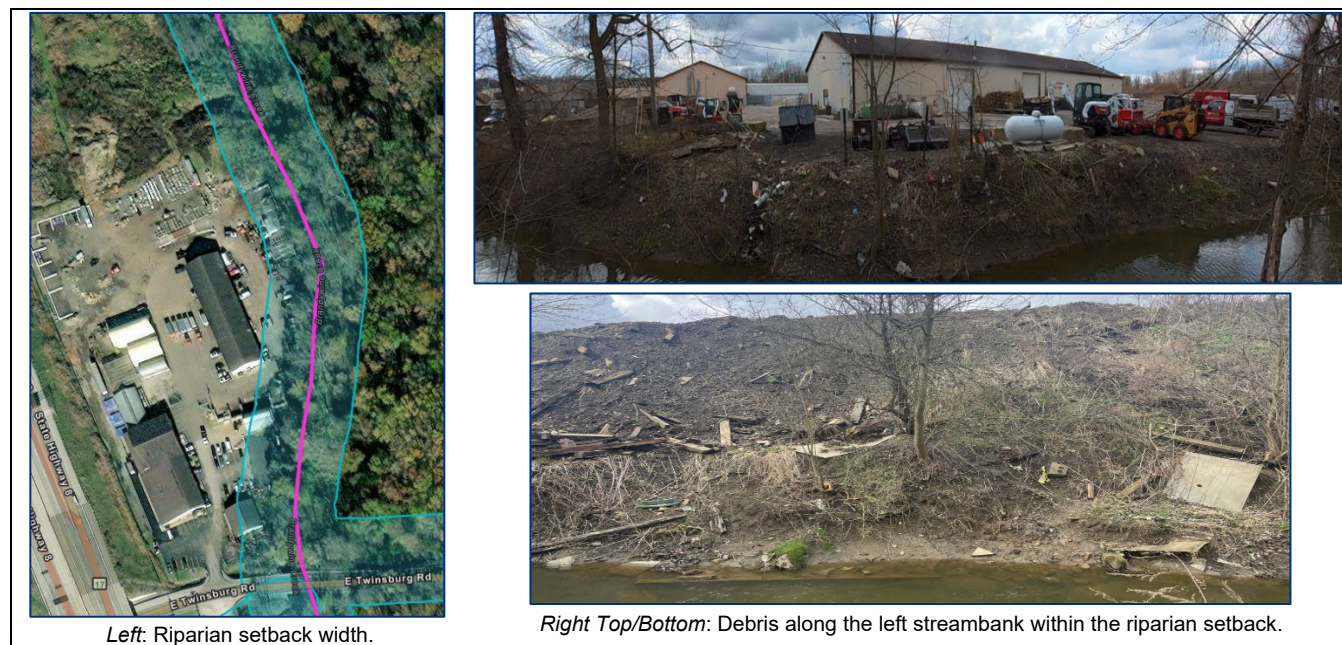
Left: Riparian setback width.

Right Top/Bottom: Debris along the left streambank within the riparian setback.

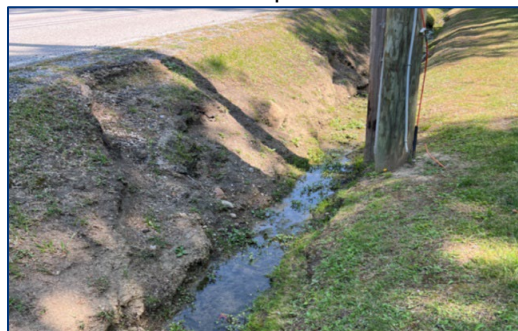
Figure 14. Erosion of roadside ditch

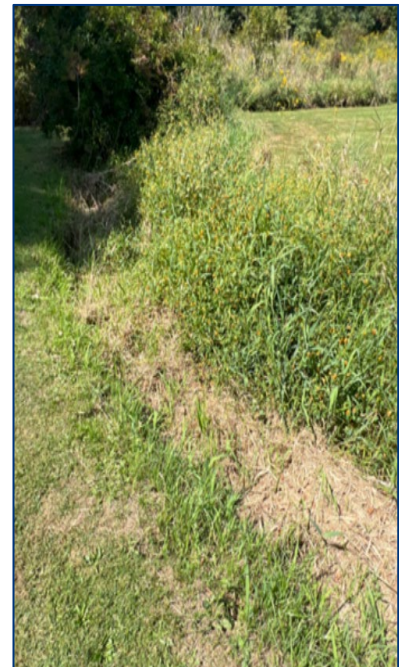
Figure 13. Stream blocked with invasive vegetation.

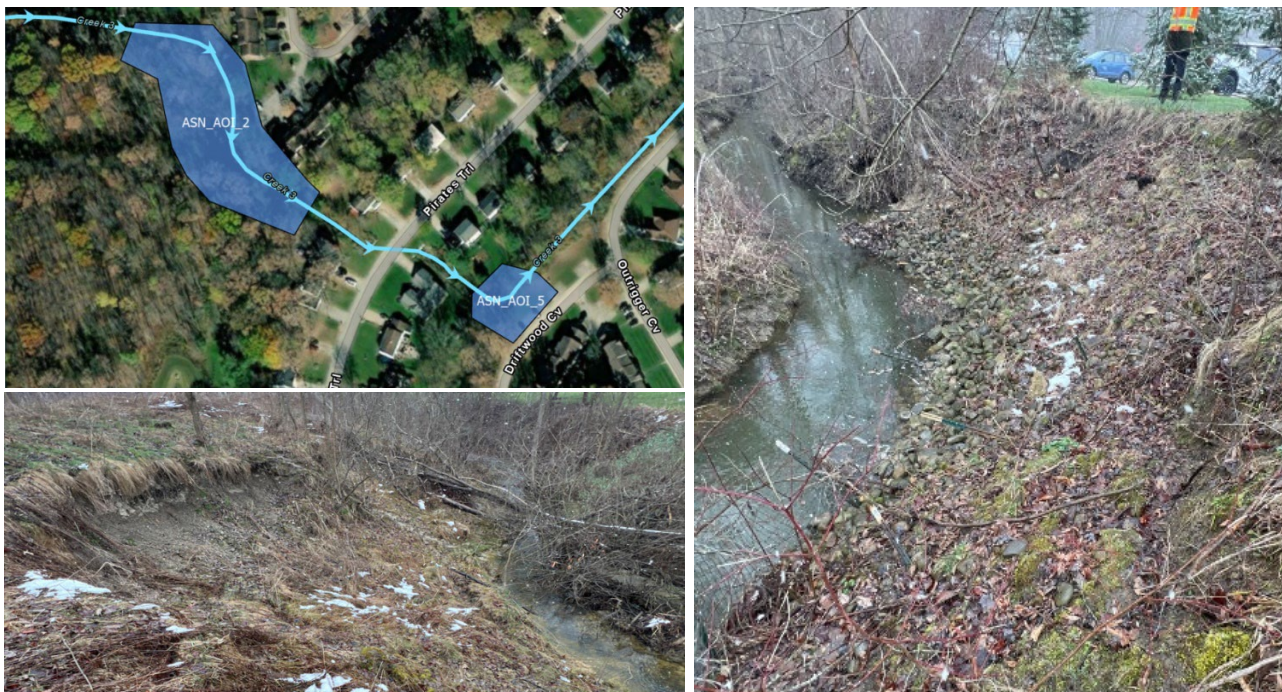
Top Left: Location of ASN_AOI_2 and ASN_AOI_5.

Bottom Left: Looking upstream - right bank erosion at ASN_AOI_2

The restored downstream reaches of Pond Brook would also benefit from remediation of this erosion as these recommendations will provide protection from sedimentation. Tetra Tech has provided SCE with a concept plan (Appendix G) and the associated costs for the recommended actions in ASN_AOI_2 and ASN_AOI_5 as separate supporting documents to this report.

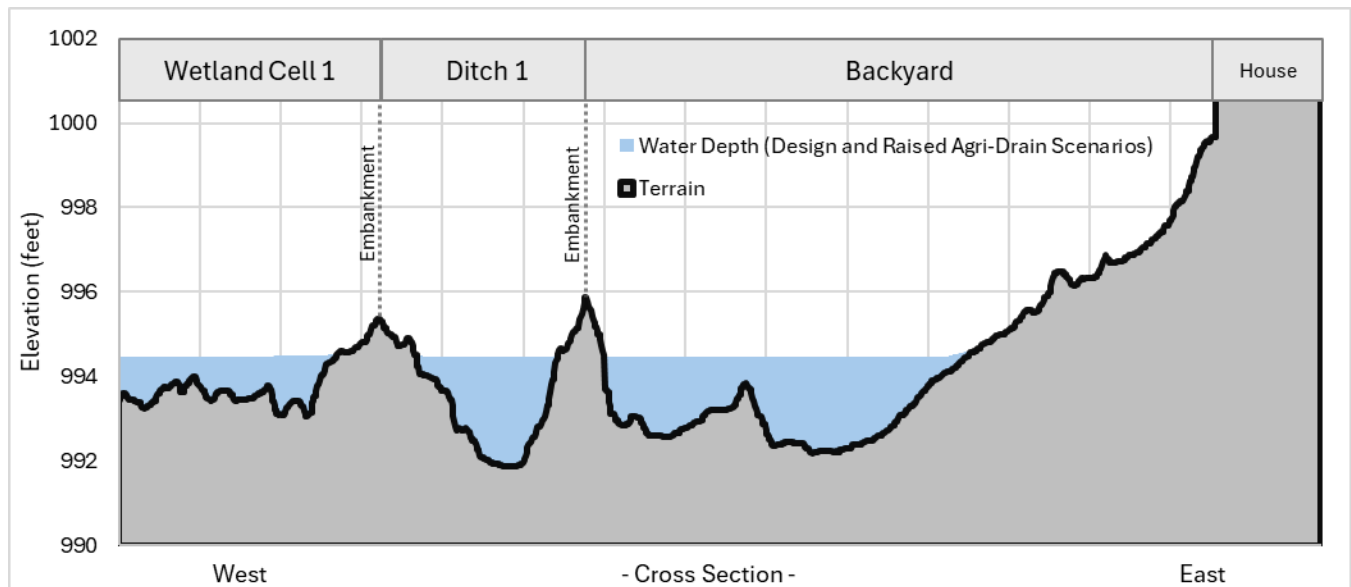
- A review of historic maps circa 1963 and 1906 shows that roads and buildings in the Aurora Shores neighborhood, specifically where the flooding of recent years has been observed, were built in low areas historically dominated by natural wetlands and swamps. Additionally, the increase in impervious area from the development of Aurora Shores increases runoff which is not fully offset by the limited number of detention basins in the neighborhood. The footprint of Aurora Lake has also approximately doubled in response to a four-foot increase in water surface elevation between 1906 and 1963.

Figure 18. Cross section of terrain and water surface elevations downstream of the Agri-Drain and embankment structure.

To address this flooding issue, three alternatives have been developed which are discussed in depth in concept plans (Appendix G), cost estimates, and the Aurora Shores 2-D HEC-RAS Model memorandum (Tetra Tech, 2025a). In short, the three alternatives are as follows: (1) maintain the existing conditions and allow the backyards to flood within the FEMA 100-year floodplain; (2) install a system of field drains in an east-west direction to convey water to the adjacent ditch; and (3) install a system of field drains in a north-south direction to convey water to two constructed retention basins which are then emptied to the adjacent ditch via a pump station.

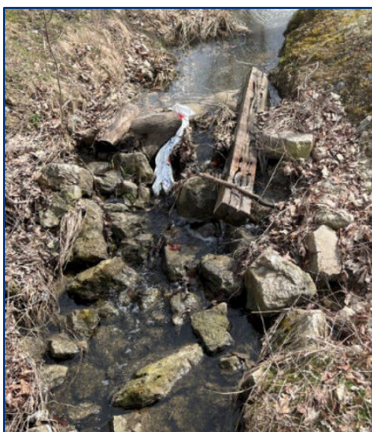
Figure 23. Grade control.

Fourth, the downstream end of this reach, just east of Maryland Avenue contains haphazardly placed rip rap and debris (Figure 23). These materials function as grade control

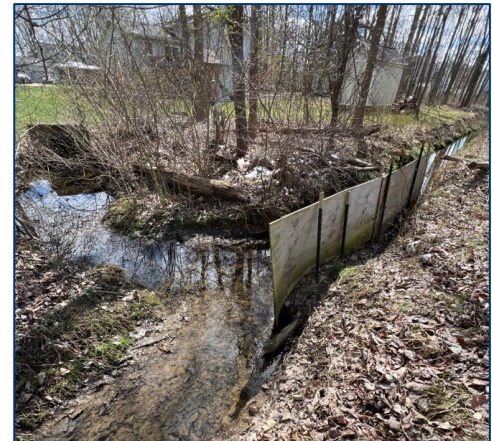
Figure 21. Homemade revetment with culvert outlet of tributary in background.

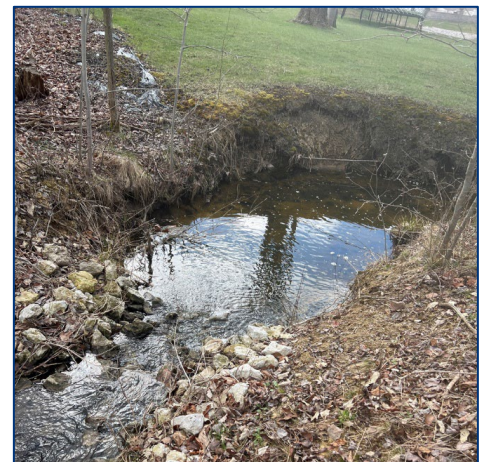
Third, the left cutbank of a rerouted ditch is eroding (3-feet tall by 25-feet long) at a 90-degree turn (Figure 22). The ditch was likely rerouted with the 90-degree turn as homes were built over the last decade. The floodplain along the left bank is a residential grassed yard. No woody vegetation is at the 90-degree turn that could stabilize the left cutbank. Tetra Tech recommends stabilizing this erosion.

Figure 22. Erosion along left cutbank.

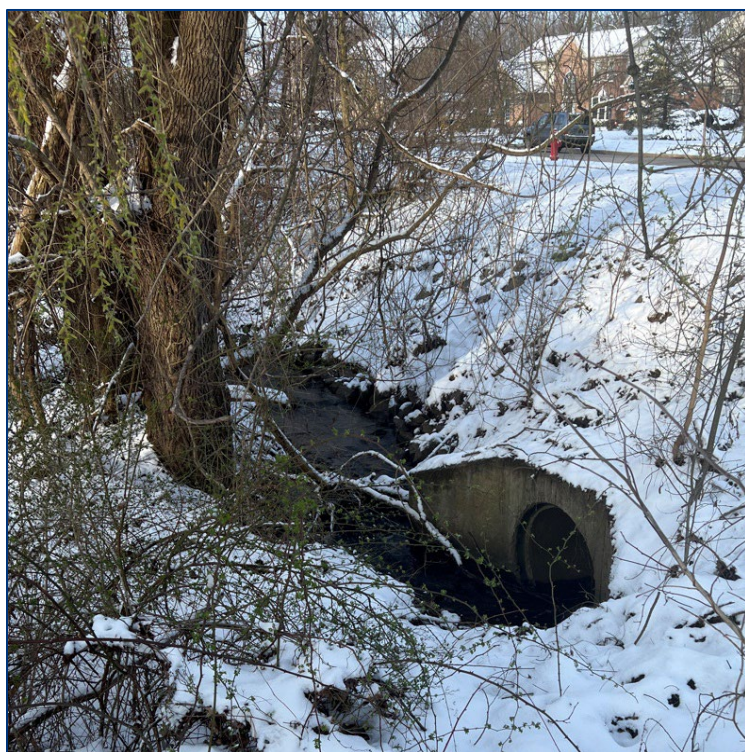
Figure 24. Looking upstream; culvert below Troubadour Drive.

The culvert below Troubadour Drive is made of concrete with a 36-inch diameter. The culvert is misaligned with the natural direction of the unnamed stream (Figure 24); the culvert inlet is perpendicular to streamflow. This skew angle is not in compliance with the Technical Requirements - Section 8.2 of the Stormwater Drainage Manual (SCE, 2020).

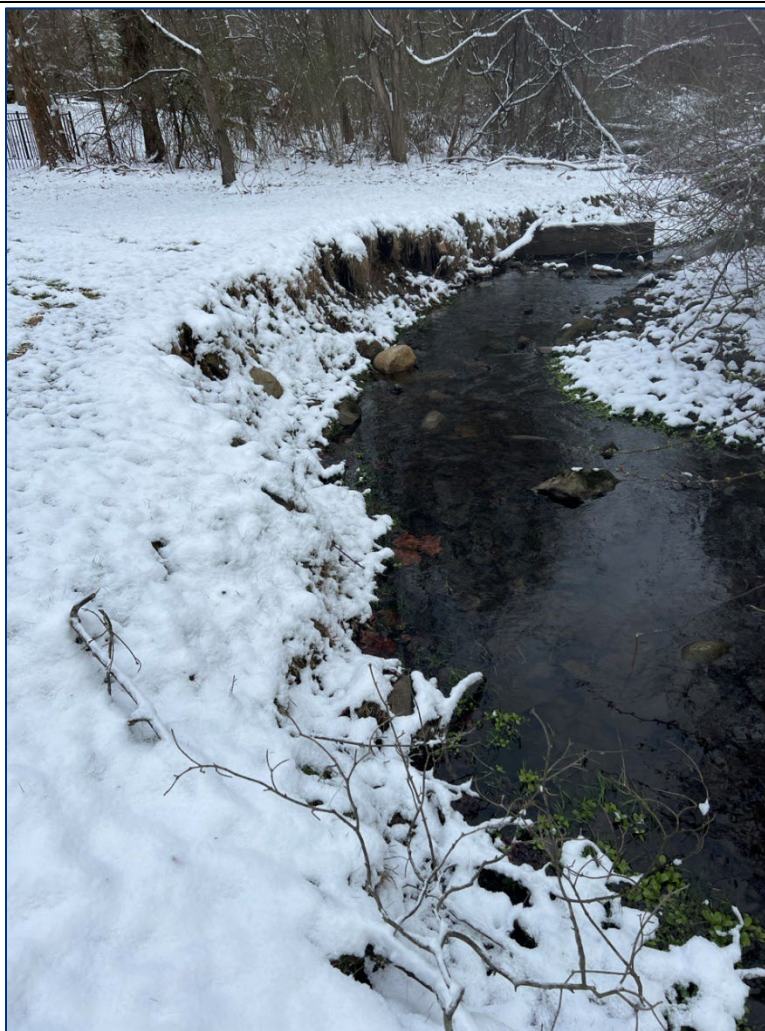
Figure 25. Looking downstream; erosion along left streambank.

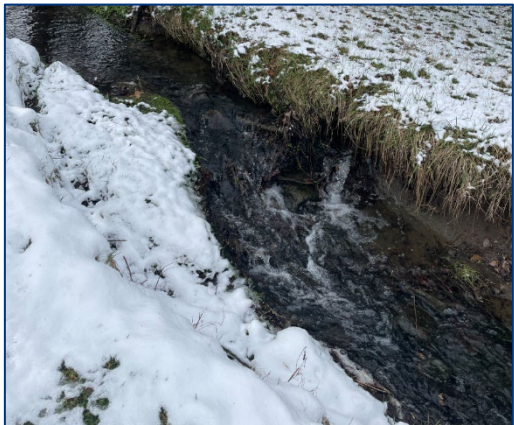
The final component of this problem area on Sagamore Run is the incised reach along a flat, grassed yard with headcut erosion downstream of these two culverts (Figure 28). Tetra Tech recommends stabilizing the headcut to prevent further channel degradation from migrating upstream to the culvert under Walton Road.

Figure 28. Headcut erosion.

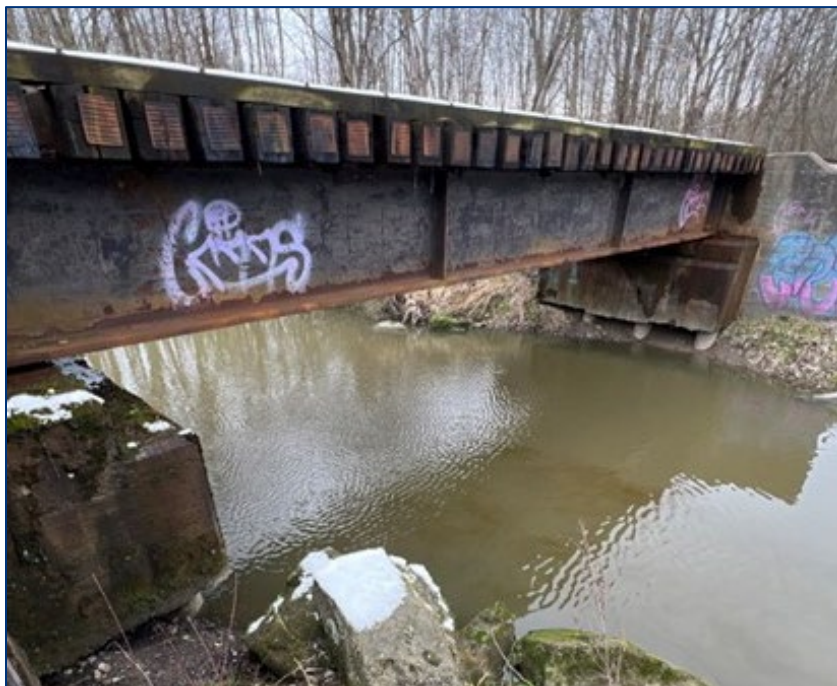
The abutments of the Wheeling and Lake Erie Railway Company⁹ bridge over Pond Brook are undercut at their bases on the left and right streambanks (Figure 30).

Tetra Tech recommends SCE notify the Wheeling and Lake Erie Railway Company of the undercut abutments because the bridge is owned by the railway. SCE could also contact the Public Utilities Commission of Ohio, which has jurisdiction over railroad companies and railways in Ohio.

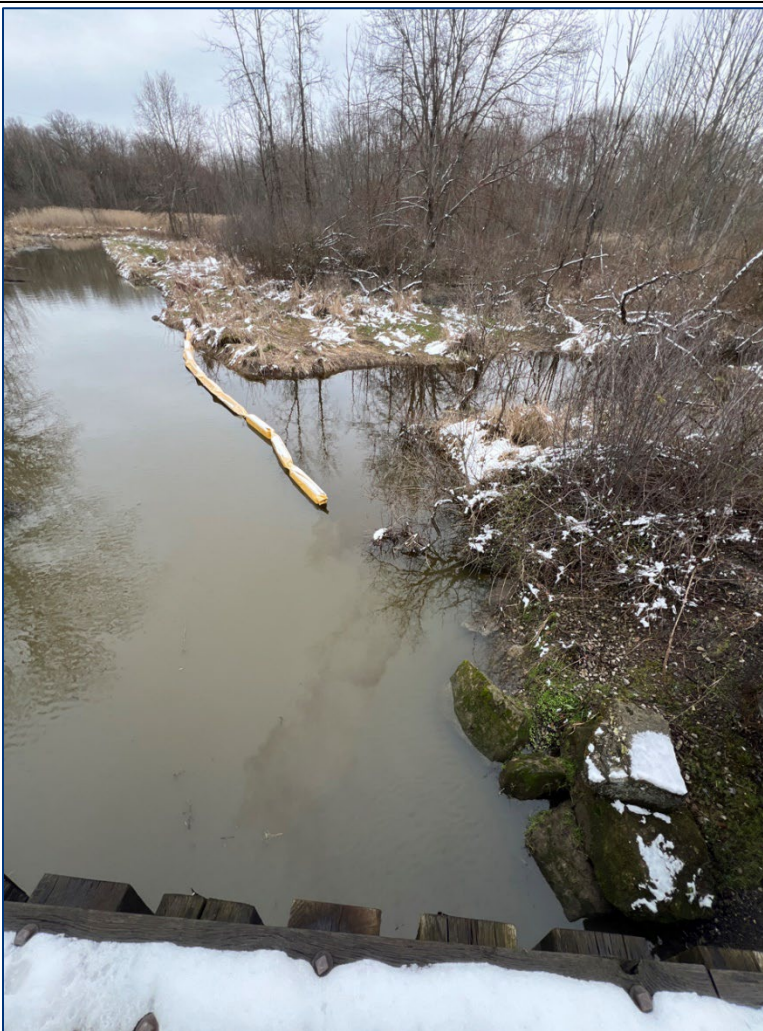
Figure 33. Containment boom on Pond Brook.

Tetra Tech recommends SCE notify Summit SWCD to investigate this spill. Summit County has notified Ohio EPA's Division of Environmental Response and Revitalization in 2024.

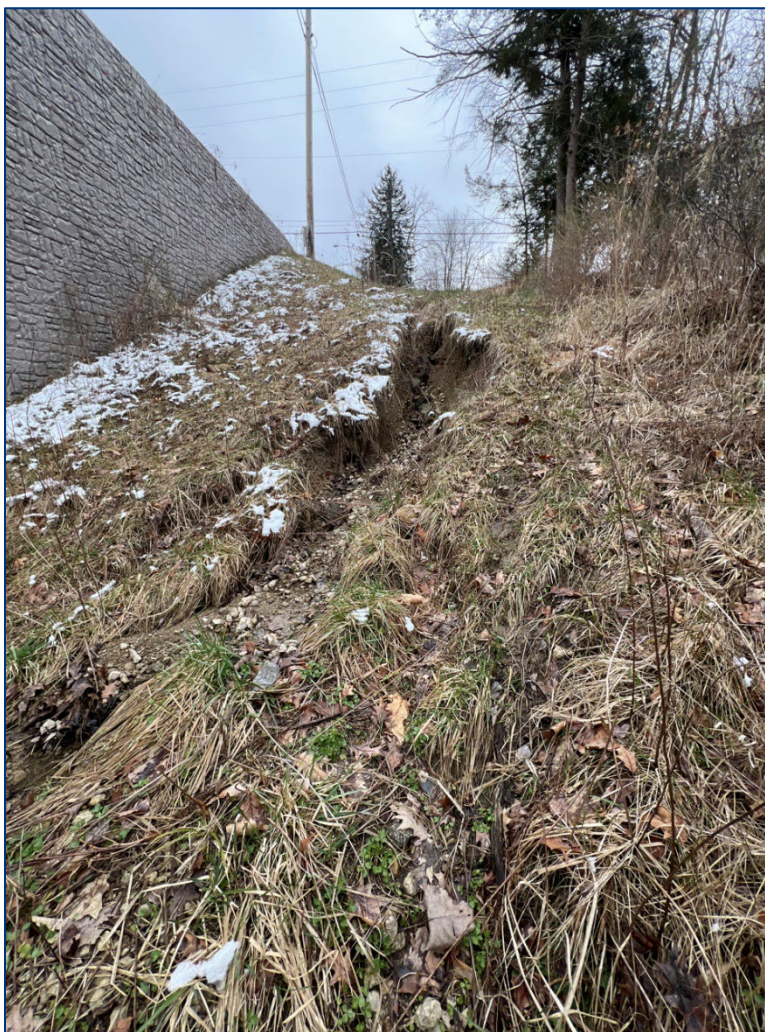
Figure 34. Gully formation.
