Norwood Lake Storm Sewer Outlet Improvements

Cherry Lane and Beechwood Drive
Northfield Center Township, Summit County

DRAINAGE MEMO

Palmer Engineering Company
3745 Medina Rd, Suite A
Medina, OH 44256

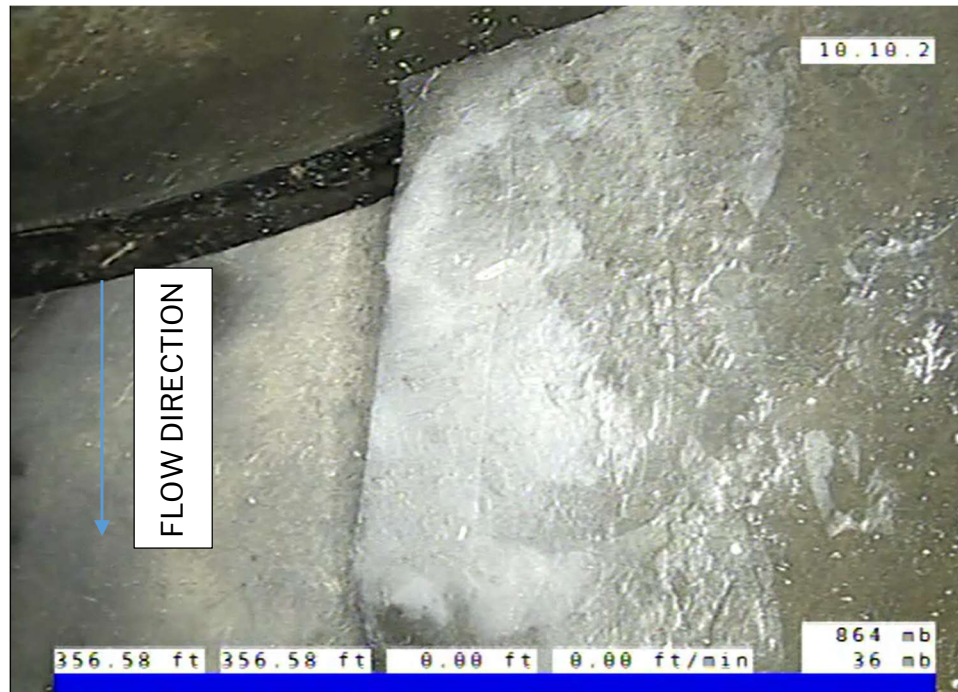
Figure 1: Broken Section of Pipe under Cherry Lane

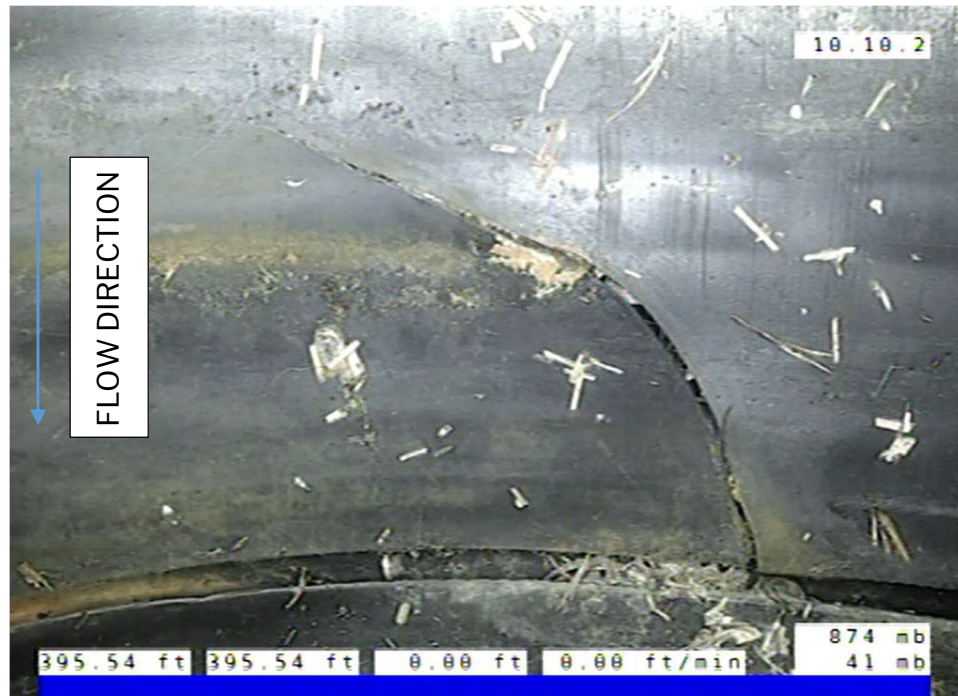
Figure 2: Longitudinal Crack in Pipe under Cherry Lane

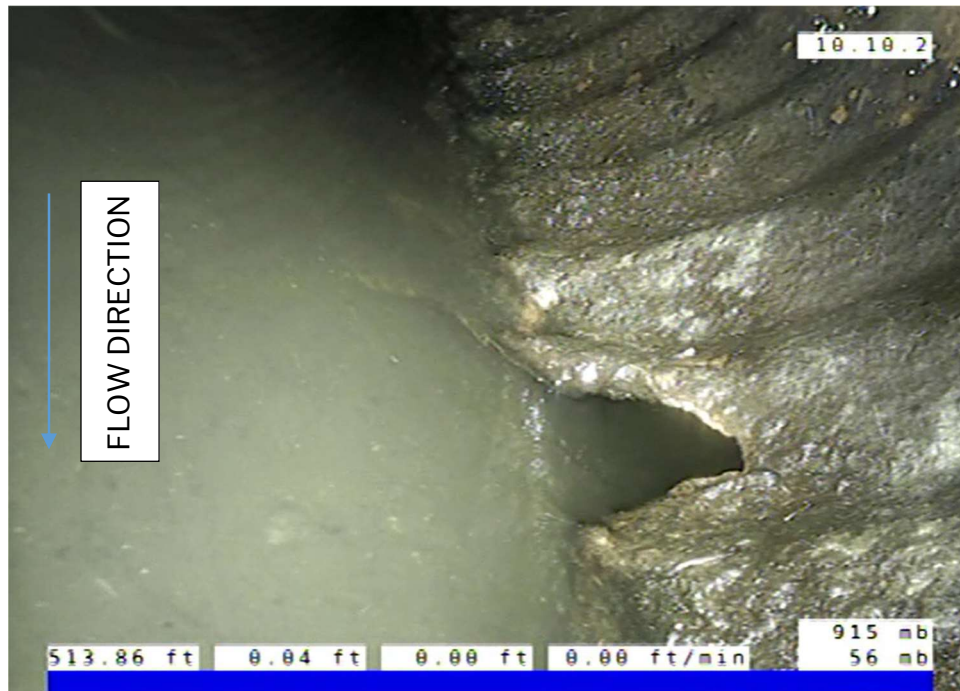
Figure 3: Perforation of corrugated metal pipe section

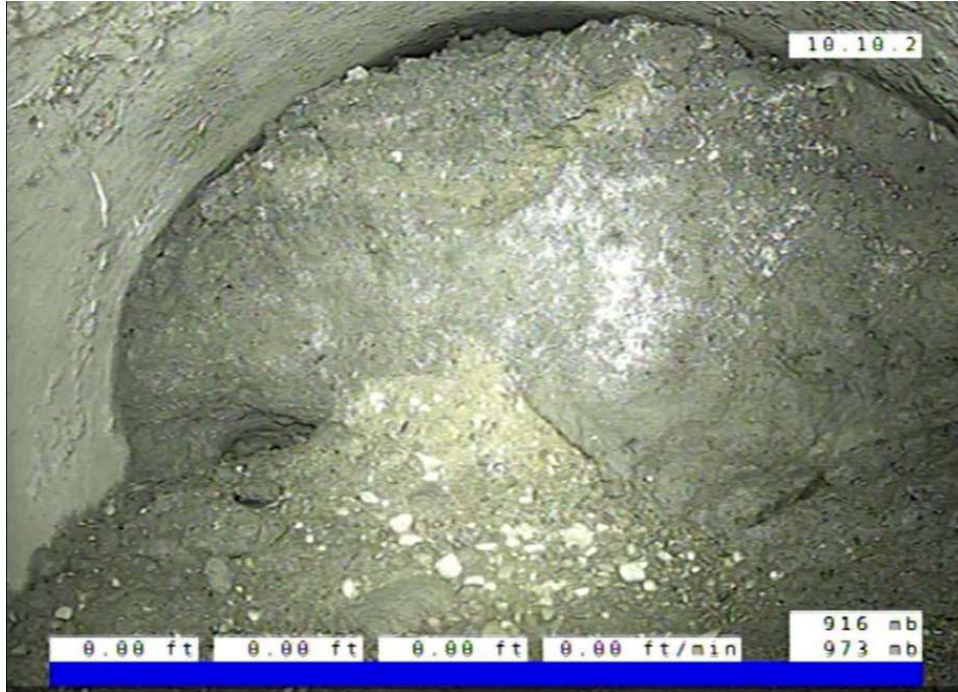
- East of D3, high standing water levels prevented GPRS equipment from accessing downstream pipes. Standing water was also observed in the next downstream catch basin (D4) located in the roadside ditch. Silt build-up exceeding 4 inches was noted in the sump of both D3 and D4.
- GPRS attempted to access the pipe from its SR-82 connection, however, that connection has been blocked off (see Figure 4).

Figure 4: Blockage of storm sewer connection to the ODOT system at D8 (looking north towards D7)

- Located in brushy area, buried, approx. 17.5-ft north of basin D8.
- Structure: 28" x28" square junction box with grateless lid.
- Located on ODOT drainage easement; end of Norwood Lake storm sewer system
- Current condition: Connection to D8 has been blocked (Figure 4); flow has been bypassed via 18" pipe southeast toward ODOT Basin D9.

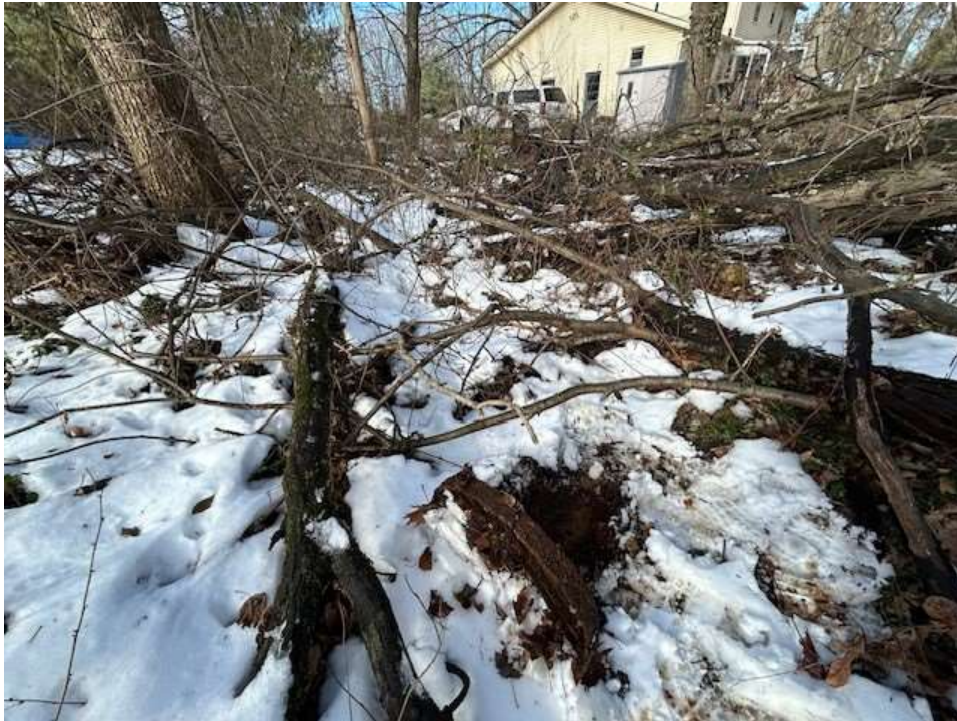
- Condition: Completed silted in; SCE records indicate original depth was approx. 3 ft.
- Observations: Standing water with clay residue; large piles of fallen timber debris surrounding the basin

Figure 5: Basin D6 (shown in the foreground), looking NW.

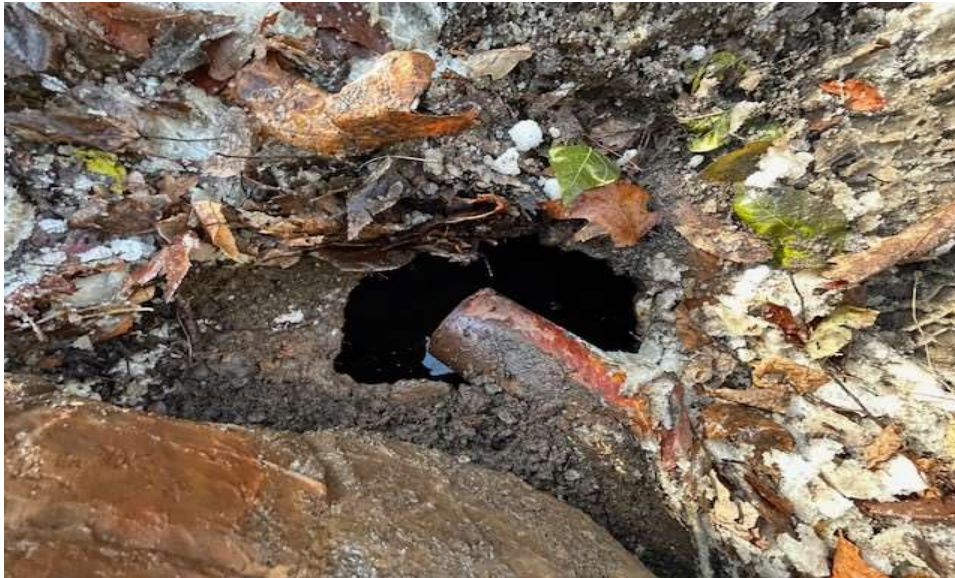
Figure 6: Gap in Pipe (denoted as Node D5), looking NW.

Connectivity Concerns: There is likely a discontinuity or blockage in the pipe between D5 and D7. Water level between D4 and D7 did not correlate. Basin D6 is silted in, suggesting water may be diverting into the surrounding soil or elsewhere.

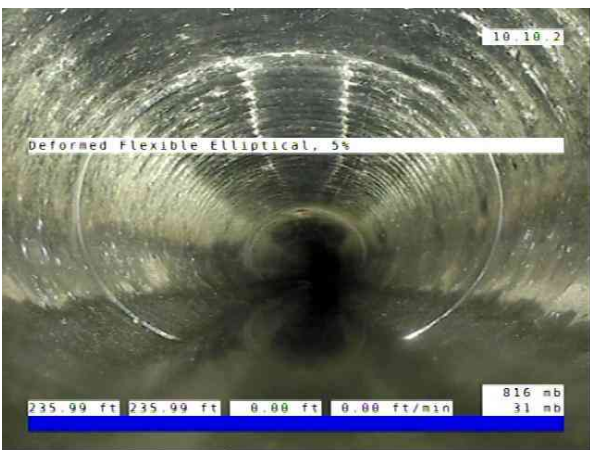
Inlet03-Inlet
04_301b1426-a370-405d-bf88-4df1a5b1fa77_20251010_0831
52_618.jpg, 00:09:19, 235.99ft
Deformed Flexible Elliptical, 5%

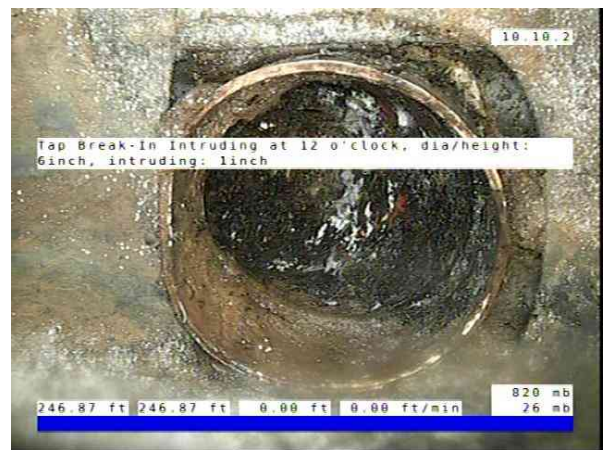
Inlet03-Inlet
04_e4ceac8e-e1ce-4ae5-bc7d-48c141ca7f75_20251010_0832
38_056.jpg, 00:09:52, 246.87ft
Tap Break-In Intruding at 12 o'clock, dia/height: 6inch, intruding: 1inch

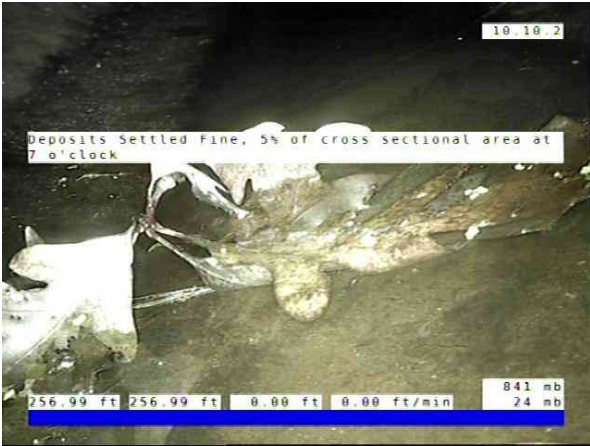
Inlet03-Inlet
04_9a3dac02-c805-4a2b-acf4-5ed19167fc32_20251010_0838
25_603.jpg, 00:10:26, 257.00ft
Deposits Settled Fine, 5% of cross sectional area at 7 o'clock

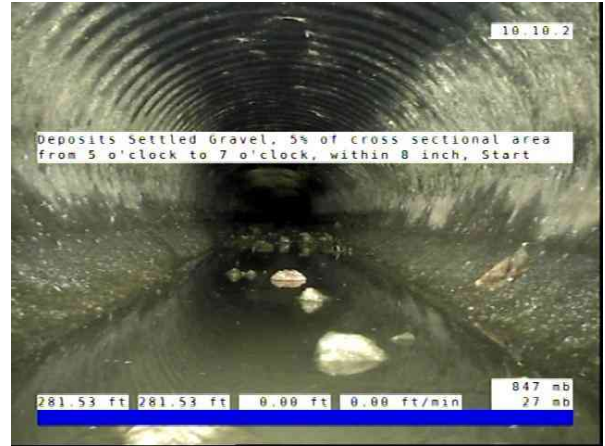
Inlet03-Inlet
04_bf9a5931-bfff-40e0-b26e-9b6862334d95_20251010_0839
37_187.jpg, 00:11:26, 281.53ft
Deposits Settled Gravel, 5% of cross sectional area from 5 o'clock to 7 o'clock, within 8 inch, Start

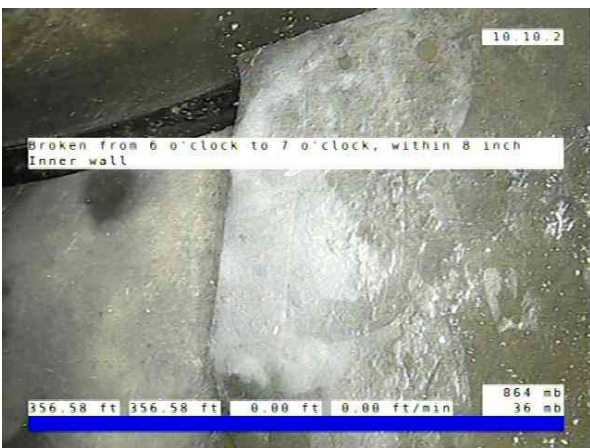
Inlet03-Inlet
04_2249918f-bb70-4c64-bd79-ce2412f1396b_20251010_0843
57_045.jpg, 00:15:21, 356.58ft
Broken from 6 o'clock to 7 o'clock, within 8 inch / Inner wall

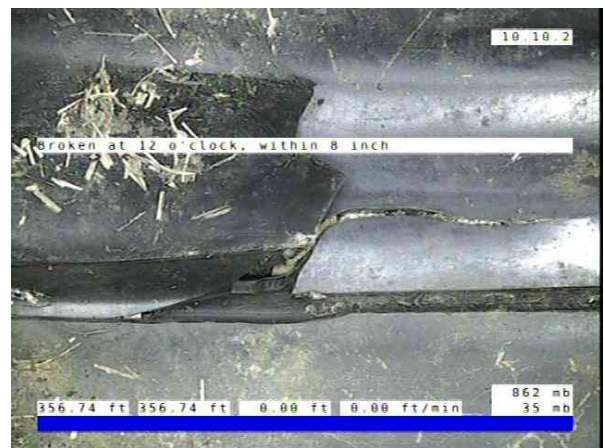
Inlet03-Inlet
04_e6c106fa-ce9d-409c-b7eb-d8a09dee563b_20251010_084
311_167.jpg, 00:14:47, 356.74ft
Broken at 12 o'clock, within 8 inch

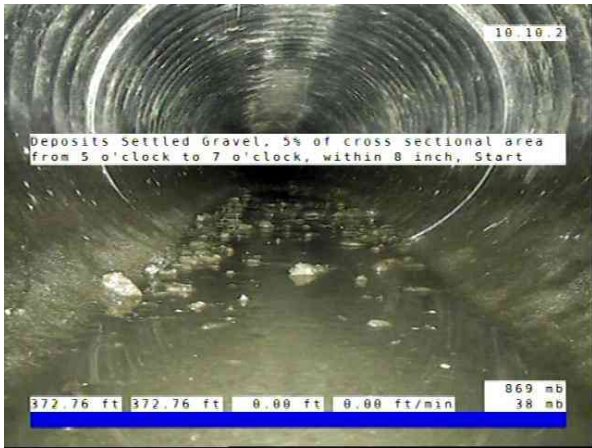
Inlet03-Inlet
04_ab22c8df-7f35-4172-bfd6-4f8122662604_20251010_084500_792.jpg, 00:16:12, 372.76ft
Deposits Settled Gravel, 5% of cross sectional area from 5 o'clock to 7 o'clock, within 8 inch, Start

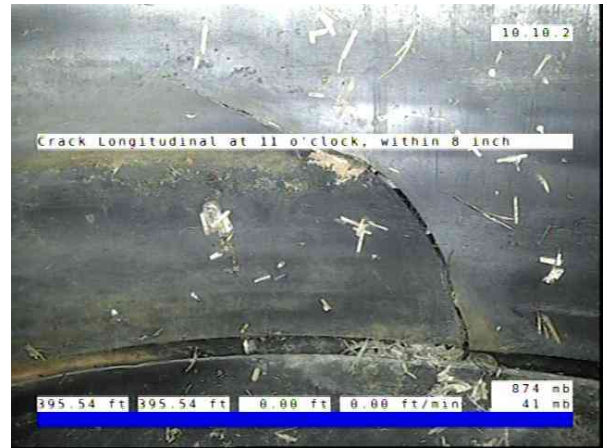
Inlet03-Inlet
04_1620e0c9-613f-49ce-823f-d7f66df169a2_20251010_084620_301.jpg, 00:17:23, 395.54ft
Crack Longitudinal at 11 o'clock, within 8 inch

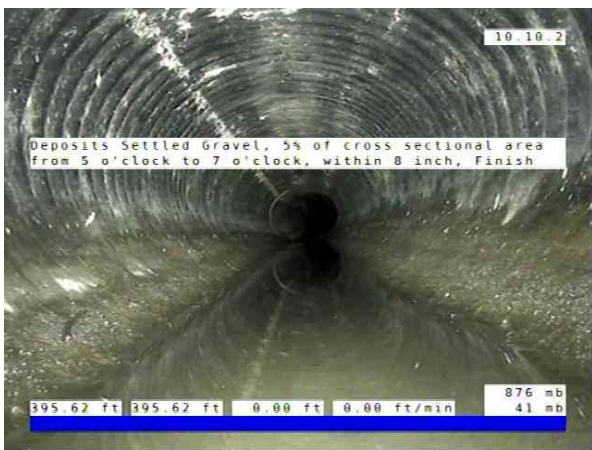
Inlet03-Inlet
04_14c9d8de-826d-41d1-a7b7-b5afc1421f57_20251010_084645_089.jpg, 00:17:42, 395.62ft
Deposits Settled Gravel, 5% of cross sectional area from 5 o'clock to 7 o'clock, within 8 inch, Finish

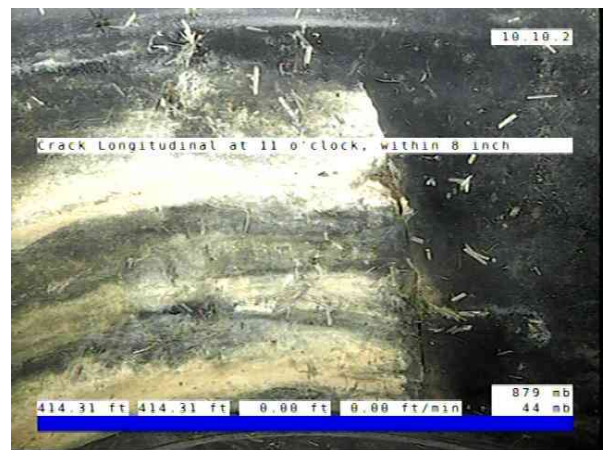
Inlet03-Inlet
04_d4728e8b-59c1-45ec-acbb-4fb24ba5e040_20251010_084748_747.jpg, 00:18:36, 414.31ft
Crack Longitudinal at 11 o'clock, within 8 inch

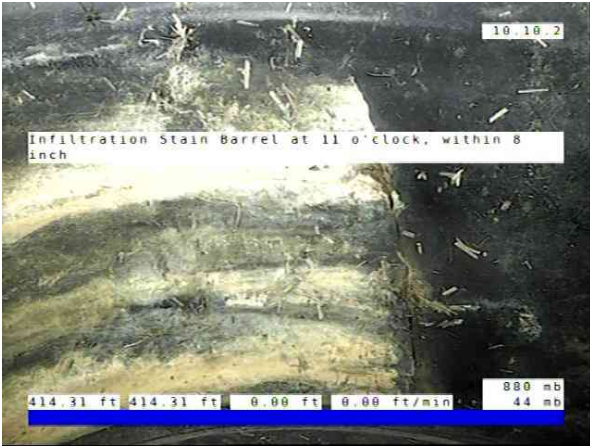
Inlet03-Inlet
04_e2809933-88e8-42e6-9239-637797dbe4f1_20251010_084
801_425.jpg, 00:18:41, 414.31ft
Infiltration Stain Barrel at 11 o'clock, within 8 inch

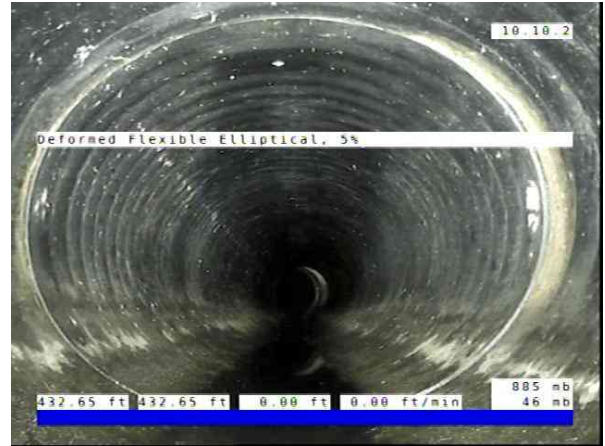
Inlet03-Inlet
04_7b49c65a-3867-4ab5-b404-749a917ac628_20251010_084
920_317.jpg, 00:19:44, 432.65ft
Deformed Flexible Elliptical, 5%

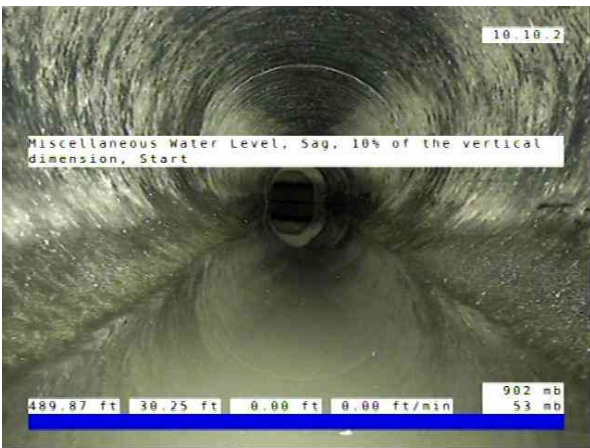
Inlet02-Inlet
03_8d970817-64fb-49c6-9842-ee47ccf6d737_20251010_0854
15_887.jpg, 00:01:45, 30.25ft
Miscellaneous Water Level, Sag, 10% of the vertical dimension,
Start

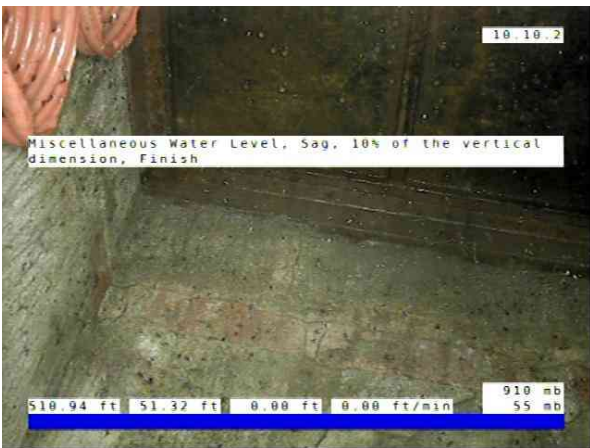
Inlet02-Inlet
03_b95ad3d4-e88c-4833-9959-994b44d98212_20251010_085
759_394.jpg, 00:04:40, 51.32ft
Miscellaneous Water Level, Sag, 10% of the vertical dimension, Finish

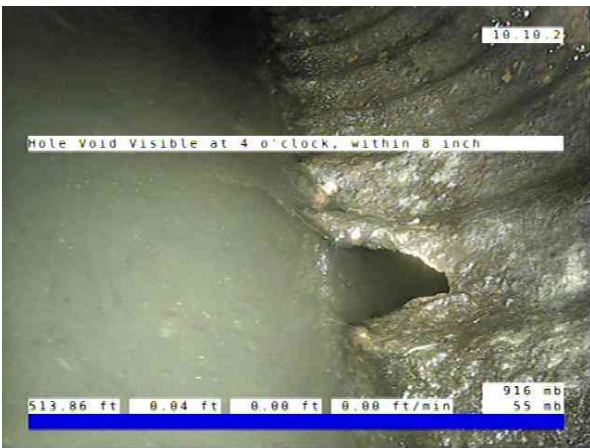
Inlet01-Inlet
02_6184eb40-fb5d-40c0-abf2-17b0dc0b82ab_20251010_0900
23_389.jpg, 00:00:27, 0.04ft
Hole Void Visible at 4 o'clock, within 8 inch

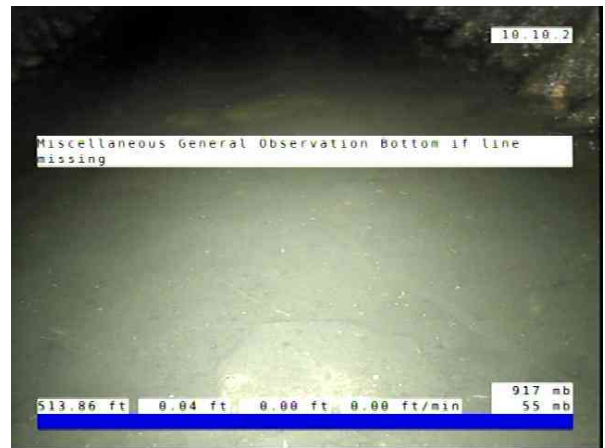
Inlet01-Inlet
02_1412f4ed-031a-452d-87f4-f99925acb638_20251010_0901
07_646.jpg, 00:00:42, 0.04ft
Miscellaneous General Observation / Bottom if line missing

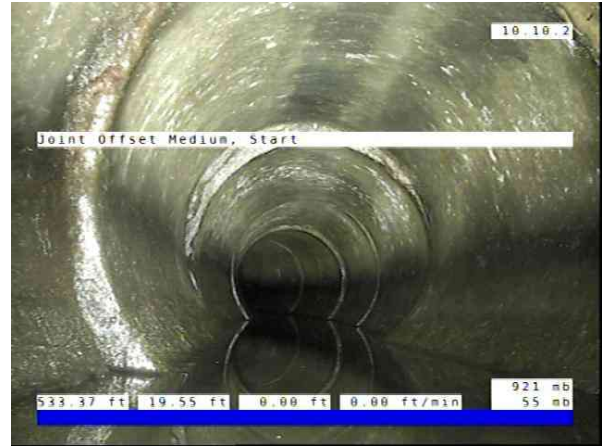
Inlet01-Inlet
02_b087f79d-6333-44a5-aa5c-0431f36e8aa6_20251010_0903
02_990.jpg, 00:02:20, 19.55ft
Joint Offset Medium, Start

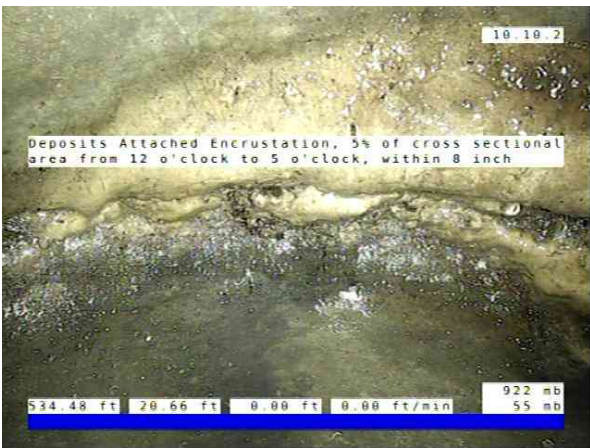
Inlet01-Inlet
02_e20c1c36-448b-4eb5-b83c-9f6c7296de66_20251010_090
334_265.jpg, 00:02:40, 20.66ft
Deposits Attached Encrustation, 5% of cross sectional area
from 12 o'clock to 5 o'clock, within 8 inch

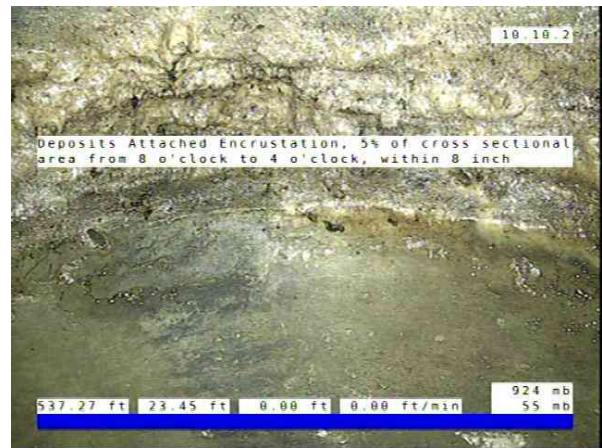
Inlet01-Inlet
02_5a08e344-e137-4ace-adff-32d12ace4808_20251010_0904
10_146.jpg, 00:03:05, 23.45ft
Deposits Attached Encrustation, 5% of cross sectional area
from 8 o'clock to 4 o'clock, within 8 inch

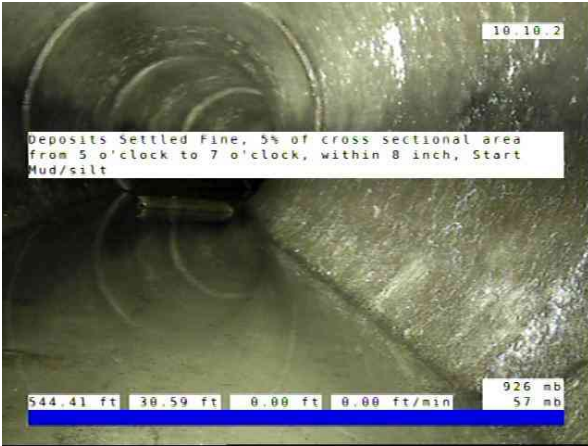
Inlet01-Inlet
02_78bf45a-64ba-49b3-9b29-682460321246_20251010_090502_970.jpg, 00:03:45, 30.59ft
Deposits Settled Fine, 5% of cross sectional area from 5 o'clock to 7 o'clock, within 8 inch, Start / Mud/silt

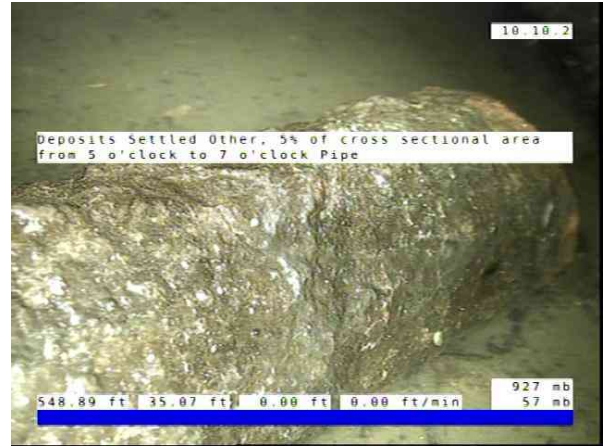
Inlet01-Inlet
02_8d54024a-3974-45b2-9eba-dbf4e934f909_20251010_090558_813.jpg, 00:04:15, 35.07ft
Deposits Settled Other, 5% of cross sectional area from 5 o'clock to 7 o'clock / Pipe

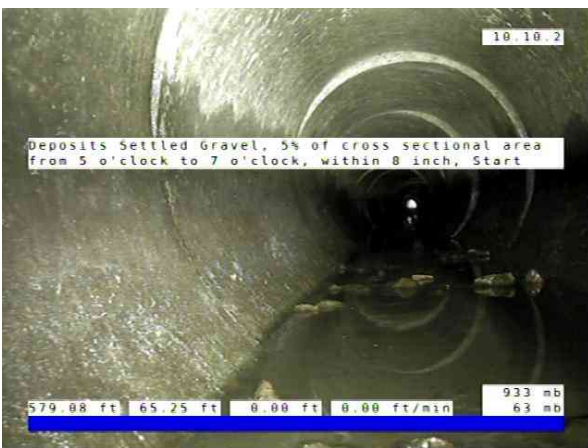
Inlet01-Inlet
02_2e7807ff-4cc5-4ebe-9fe1-969bbc6623a5_20251010_090826_600.jpg, 00:06:29, 65.25ft
Deposits Settled Gravel, 5% of cross sectional area from 5 o'clock to 7 o'clock, within 8 inch, Start

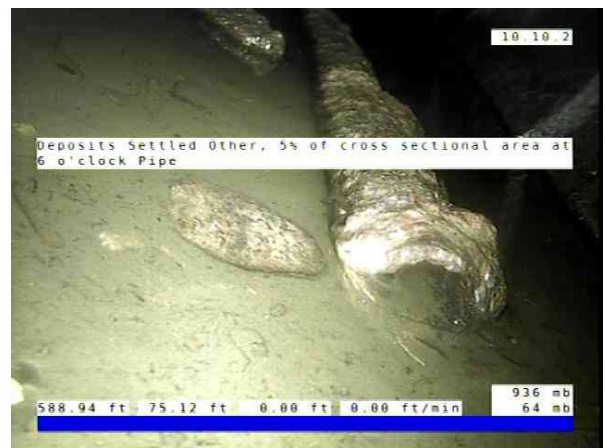
Inlet01-Inlet
02_d1fadcf8-0bdb-4cb0-9ea1-e30796fcc8aa_20251010_090945_947.jpg, 00:07:37, 75.10ft
Deposits Settled Other, 5% of cross sectional area at 6 o'clock / Pipe

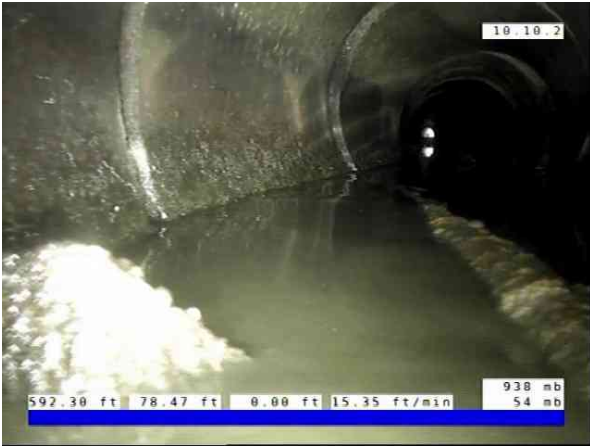
Inlet01-Inlet
02_ad0a5211-56df-4d64-bb13-9cbc7ff451ba_20251010_1419
01_282.jpg, 00:08:59, 78.46ft
Deposits Settled Gravel, 5% of cross sectional area from 5
o'clock to 7 o'clock, within 8 inch, Finish

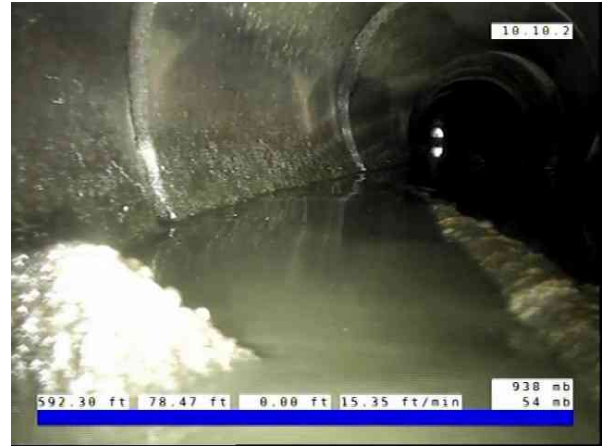
Inlet01-Inlet
02_d30c5ee5-1246-4ddc-a18a-74997edeaa6c_20251010_141
924_385.jpg, 00:08:59, 78.46ft
Miscellaneous Survey Abandoned / Debris in line preventing
further inspection

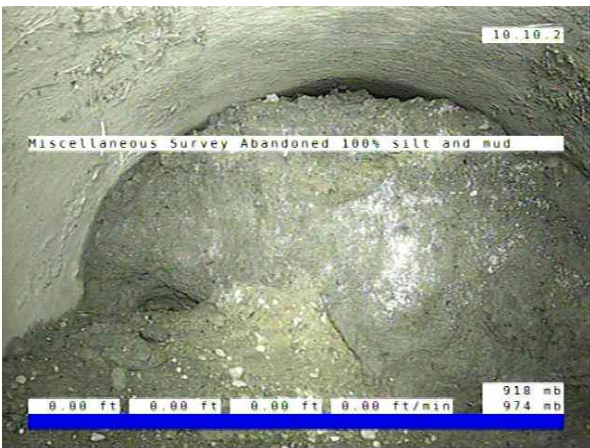
Inlet04-Inlet
05_0465d8d0-b35e-4f4c-983a-375dfc7bb184_20251010_1008
23_878.jpg, 00:00:44, 0.00ft
Miscellaneous Survey Abandoned / 100% silt and mud
