Yellow Creek State of the Watershed

Bob Hawley, Ph.D., P.E.

August 19, 2019

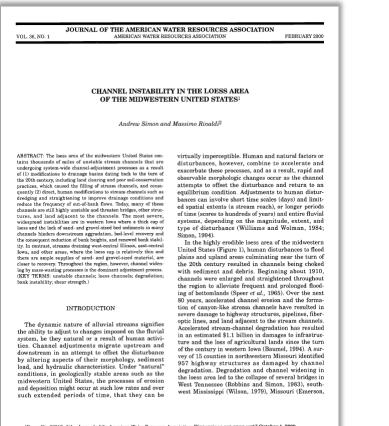
Channel Evolution Stages

Predictable trajectory of channel downcutting, widening, and enlargement in response to channelization and/or watershed urbanization

Channel Evolution Sequence in Response to Increased Flows from Urbanization, Adapted from Schumm et al. (1984) and Hawley et al. (2012)

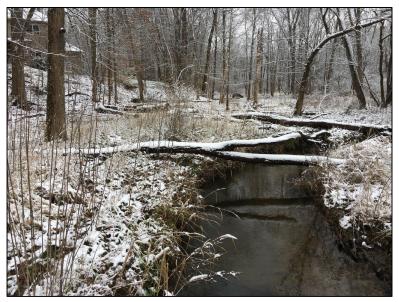
Example of a forested area with Type A soil

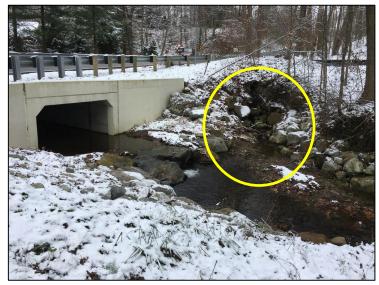
Outlet would benefit from additional armoring and stabilization

- Culvert maintenance
- Stabilization of outfalls
- Storm sewer repairs, etc.
