Aurora Shores Flooding Assessment Informational Meeting

August 18, 2025

HEC-RAS Modeling Assessment of Aurora Shores Flooding

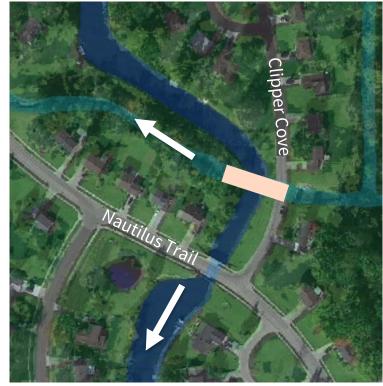
Hydrology Overview

Complex stream network

- 1. Pond Brook
- 2. Channel Brook

Cross each other at the Clipper Cove aqueduct.

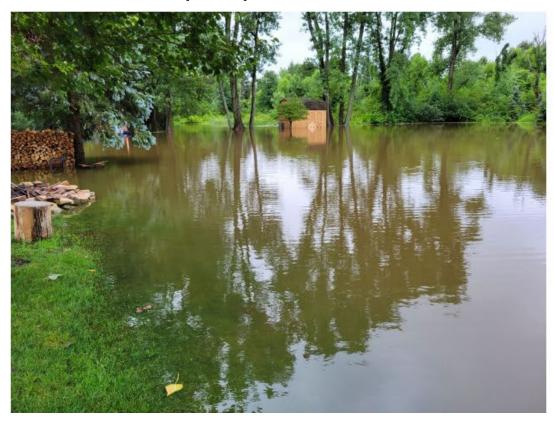
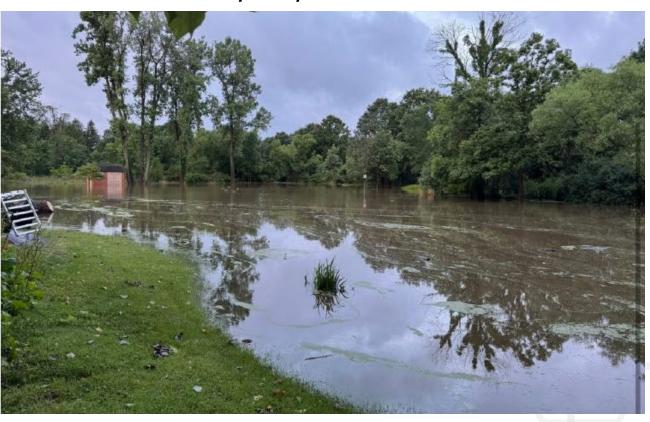
Windjammer Cove

7/17/2021

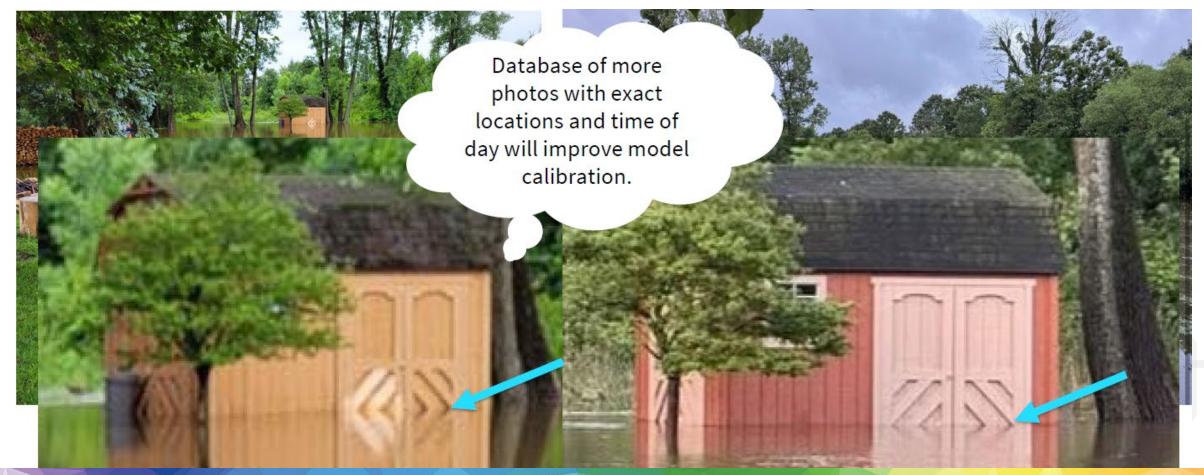
Windjammer Cove

7/17/2021

6/19/2025

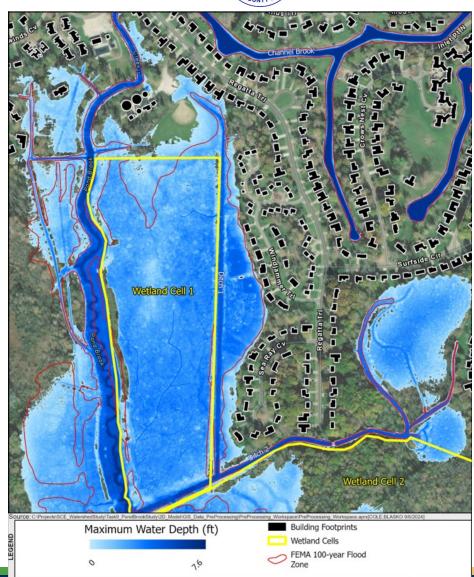
Scenario 3 – Aurora Lake Spillway Release

- Flood extent shown on map
- Volume released is 2.3 times greater than 100-year event entering Aurora Lake
 - Very rare event
- May occur if emergency spillway is overtopped or sudden lowering of spillway gate
 - Not expected under normal dam operations

- **Finding:** Large dam releases could cause temporary flooding similar to FEMA's flood zone—but this would only occur in rare, emergency situations.
- **Conclusion:** This is a low-probability contributor under normal operations.

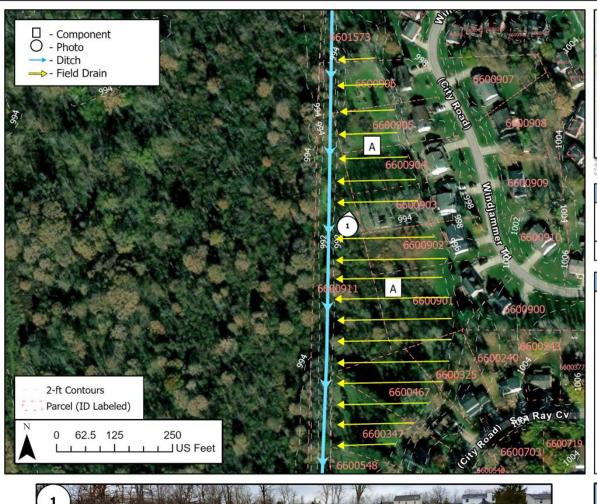
Flooding along backyards of Regatta Trail, Windjammer Trail, and Sea Ray Cove is longstanding and well documented. Historically a natural wetland / swamp, flooding occurs due to the pooling of direct precipitation and lack of adaquate grade to drain the area. The adjacent ditch has not been shown to overtop. Alternative 1 proposes maintaining the existing conditions and allow the area to flood within the FEMA 100-year floodplain which extends up to, but does not inundate, the homes.
