Technical Memo

Date	January 26, 2026
From	Patrick Blake, P.E., Ishwrya Geetha (w/ Verdantas)
To	Mr. Chuck Hauber, P.E., P.S. (w/ Summit County Engineer)
Subject	Springfield Lake Watershed Study No. 2 Task: H&H Modeling and Existing Conditions Level of Service Cornell Creek (Site #8)
Project Number	220741

Background

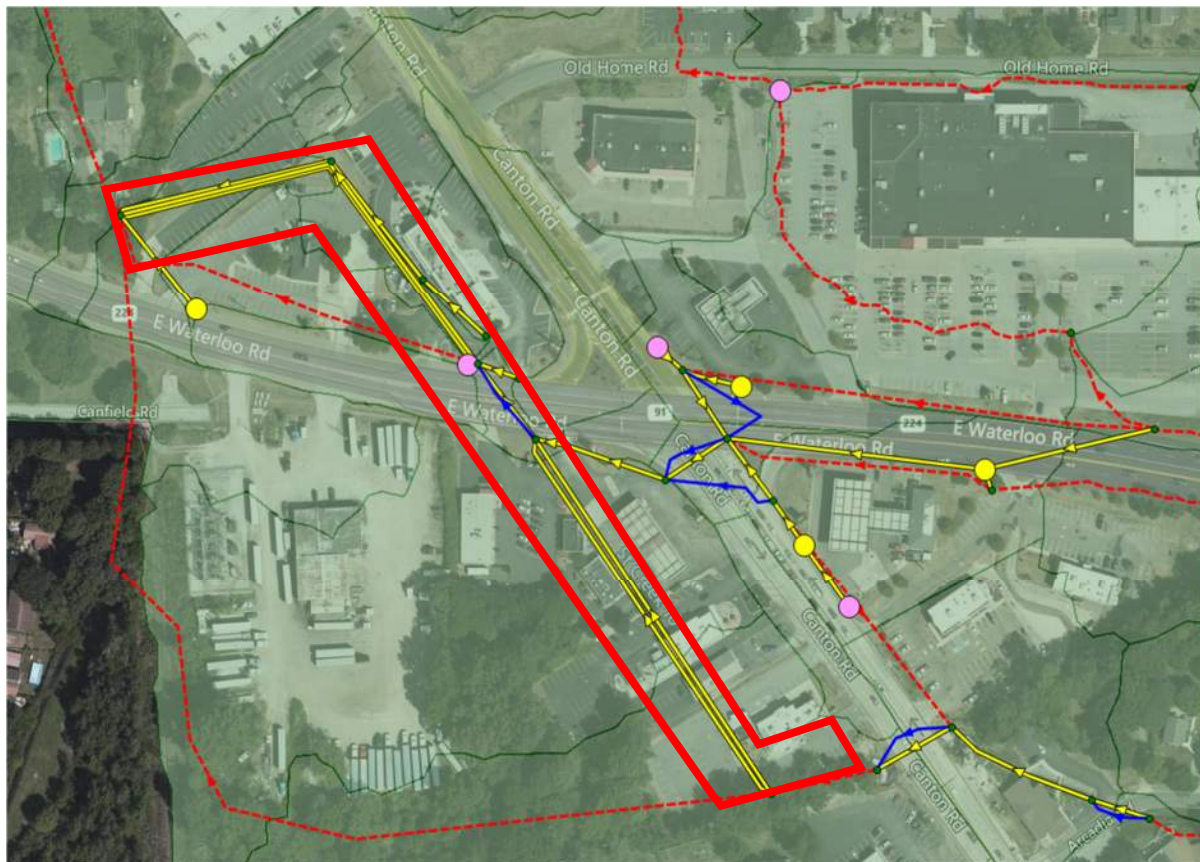
Figure 1: H&H Study Area (Courtesy of PCSWMM)

The model indicates that the study area pipes have a 25-year Level of Service and meets the Summit County Drainage Manual for the highlighted section (HGL of 25-year to not exceed rim, window or grate of any drainage structure). However, it is worth noting that although the immediate study section meets the County's level of service requirements, the modeling has identified flood in the peripheral vicinity. The model results indicated the US 224 and Canton Rd intersection has multiple ponded nodes and overland flow paths activated in the model that are indicative of flooding along the roadway and private properties near the Southeast quadrant of the intersection.

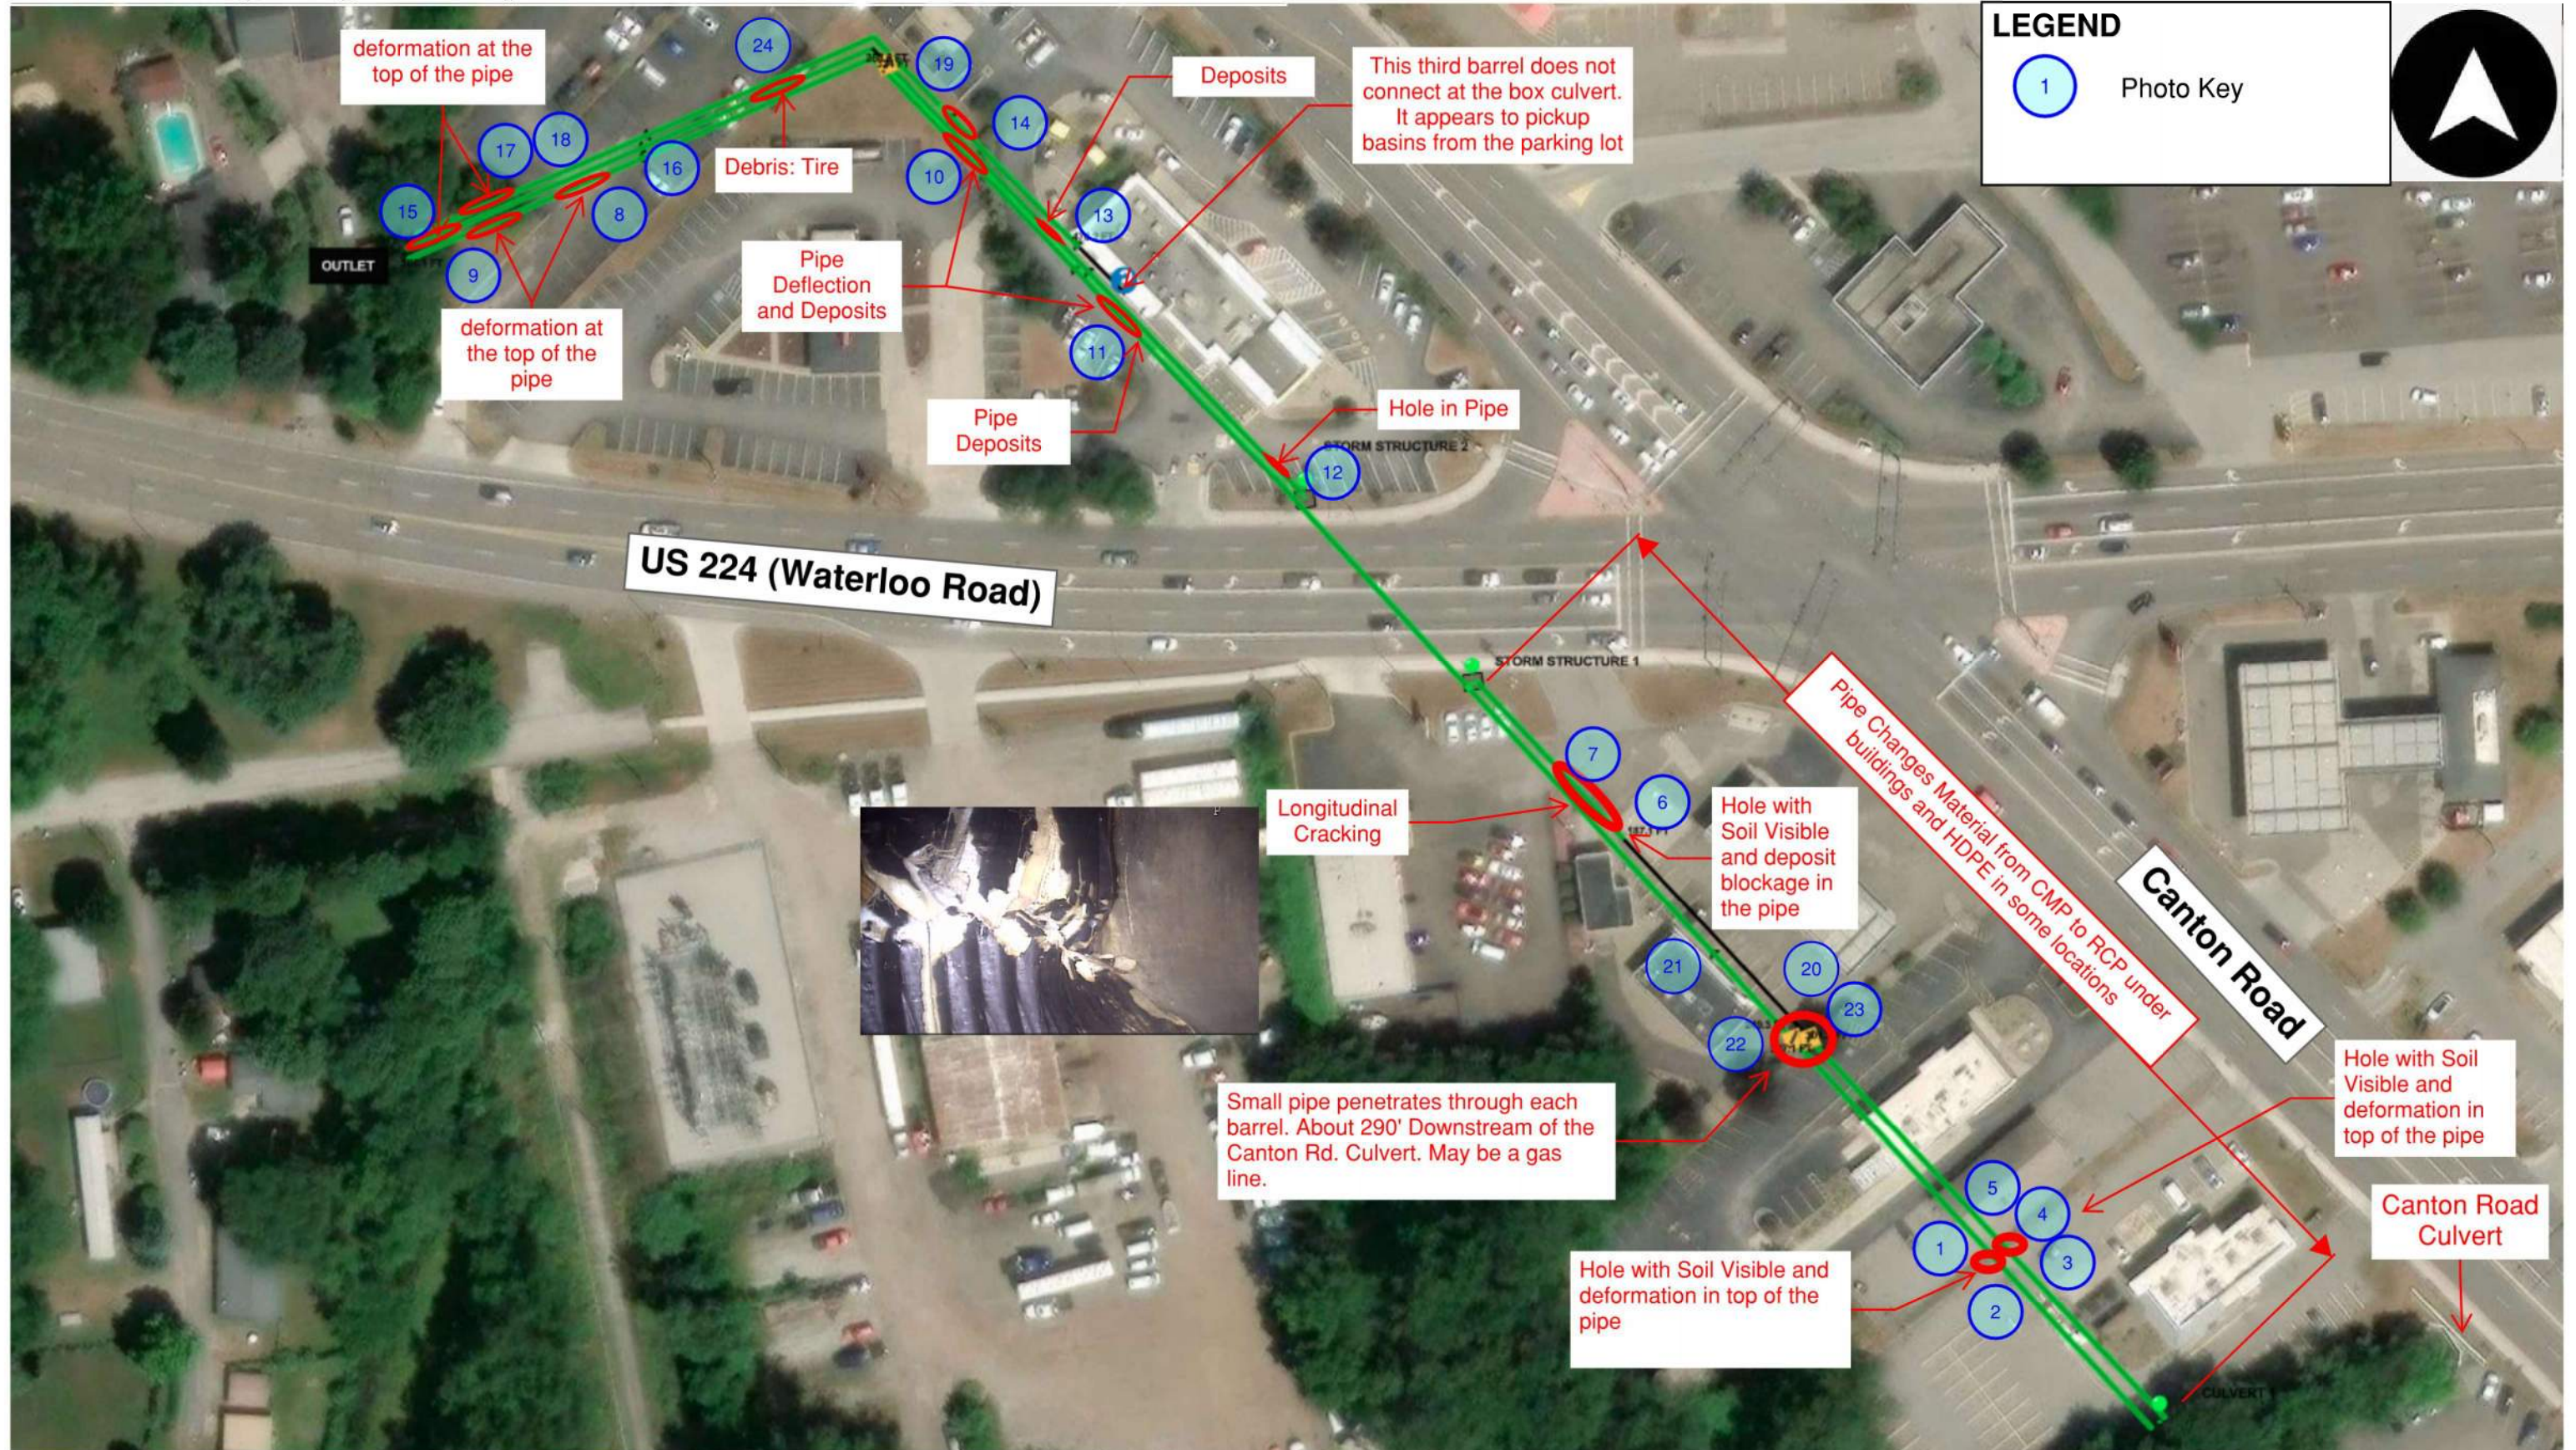
CCTV Highlight Map

Defects varied amongst the barrels, from debris deposition to occasional holes in the pipe wall, and deformation of the top of the pipes near the outlet. Highlights of the most notable CCTV findings were extracted from the full report and plotted on a figure along with corresponding photos (Exhibit B).

Note: Map is not to scale and is meant for general schematic locations of key defects. Line work shown in green is from C&K Industrial Services and represents storm sewer segments CCTV'd from exploration.

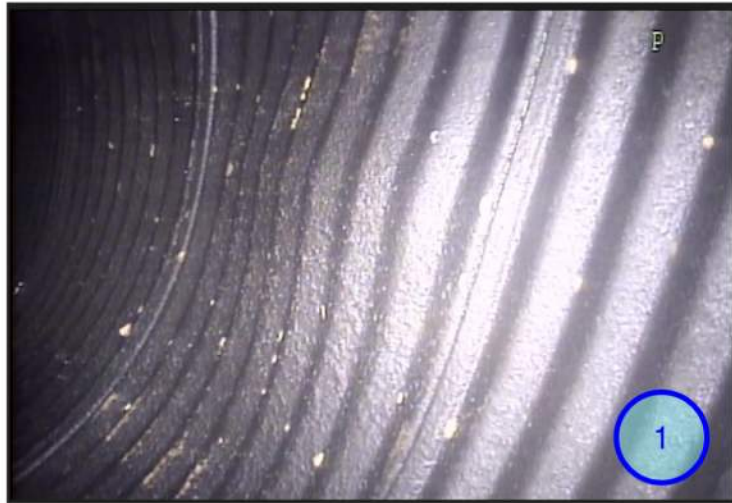
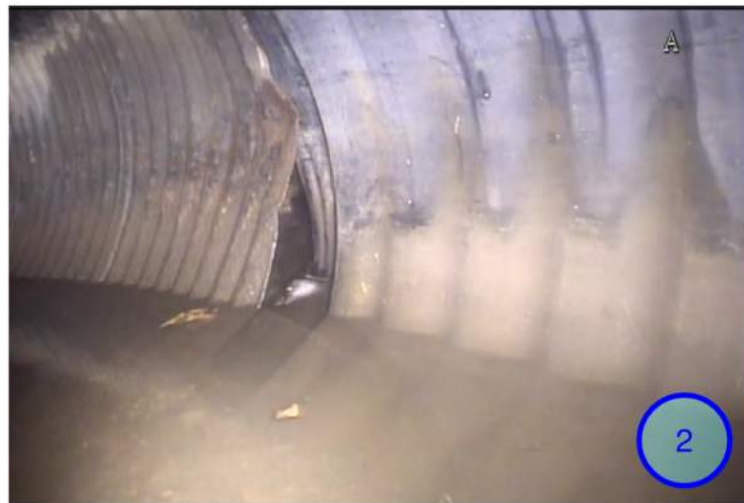
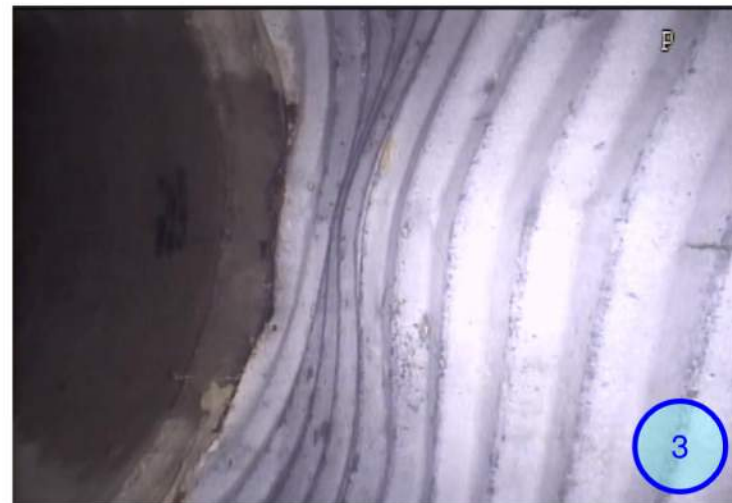
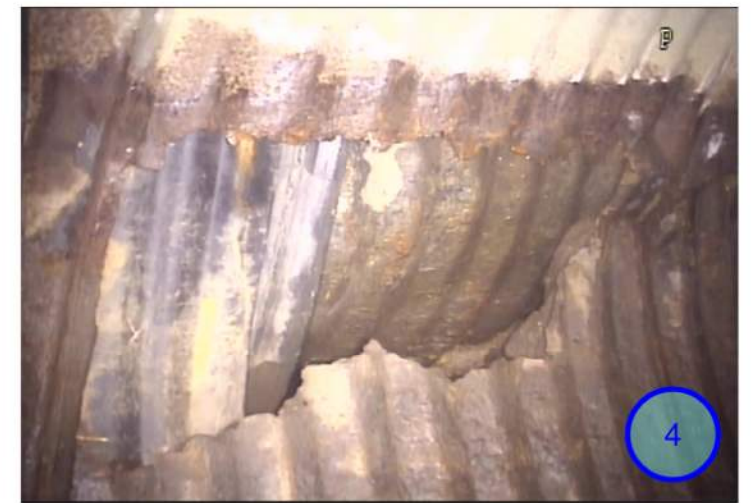
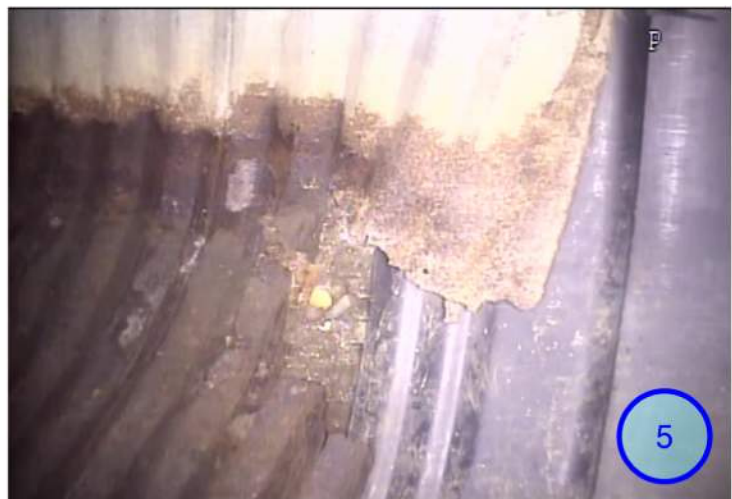
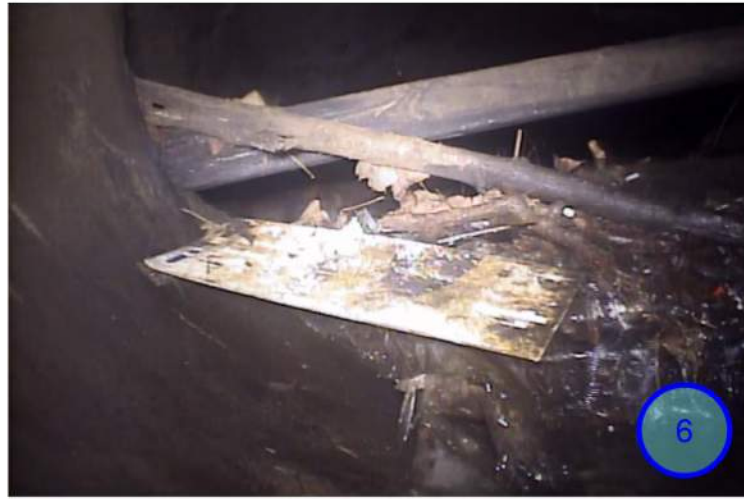
CCTV Photo Map (1 of 2)

In summary, sewers located south of US 224 appeared to change materials from CMP to RCP, and in some segments HDPE. RCP piping was most prominently located beneath the buildings. Piping through this area had noted structural defects including holes with visible soil, and most notably; penetration through both barrels approximately between the gas station and Wendy's was observed. In one photo the penetration appears to be a branch but in the other photo indicates it could be a small utility line. Review of the CCTV through the area supports SCEs desire to relocate this stretch of sewer from out underneath the buildings to mitigate risks associated with the sewers beneath the infrastructure with their given structural defects.

The box culvert beneath US 224 appears to be in good shape, with minor sediment deposits. The storm sewer from the box culvert towards the lake outlet had variable defects ranging from sediment deposits, holes with soil visible and consistent deformation in the top of the barrels near the lake outlet. CCTV showed that an access point at the bend of the sewer does not exist, and instead there are buried 45-degree bends in the sewer at that location. The CCTV shows deposits and debris near and around these bends. A third storm sewer barrel was verified to not be connected to the box culvert north of US 224. This sewer barrel instead picks up drainage in and around McDonalds and conveys flow to the lake outlet.

It is recommended the sewer north of the US 224 box culvert undergoes heavy cleaning to remove the large debris from the sewer to work towards improving the capacity and conveyance potential.

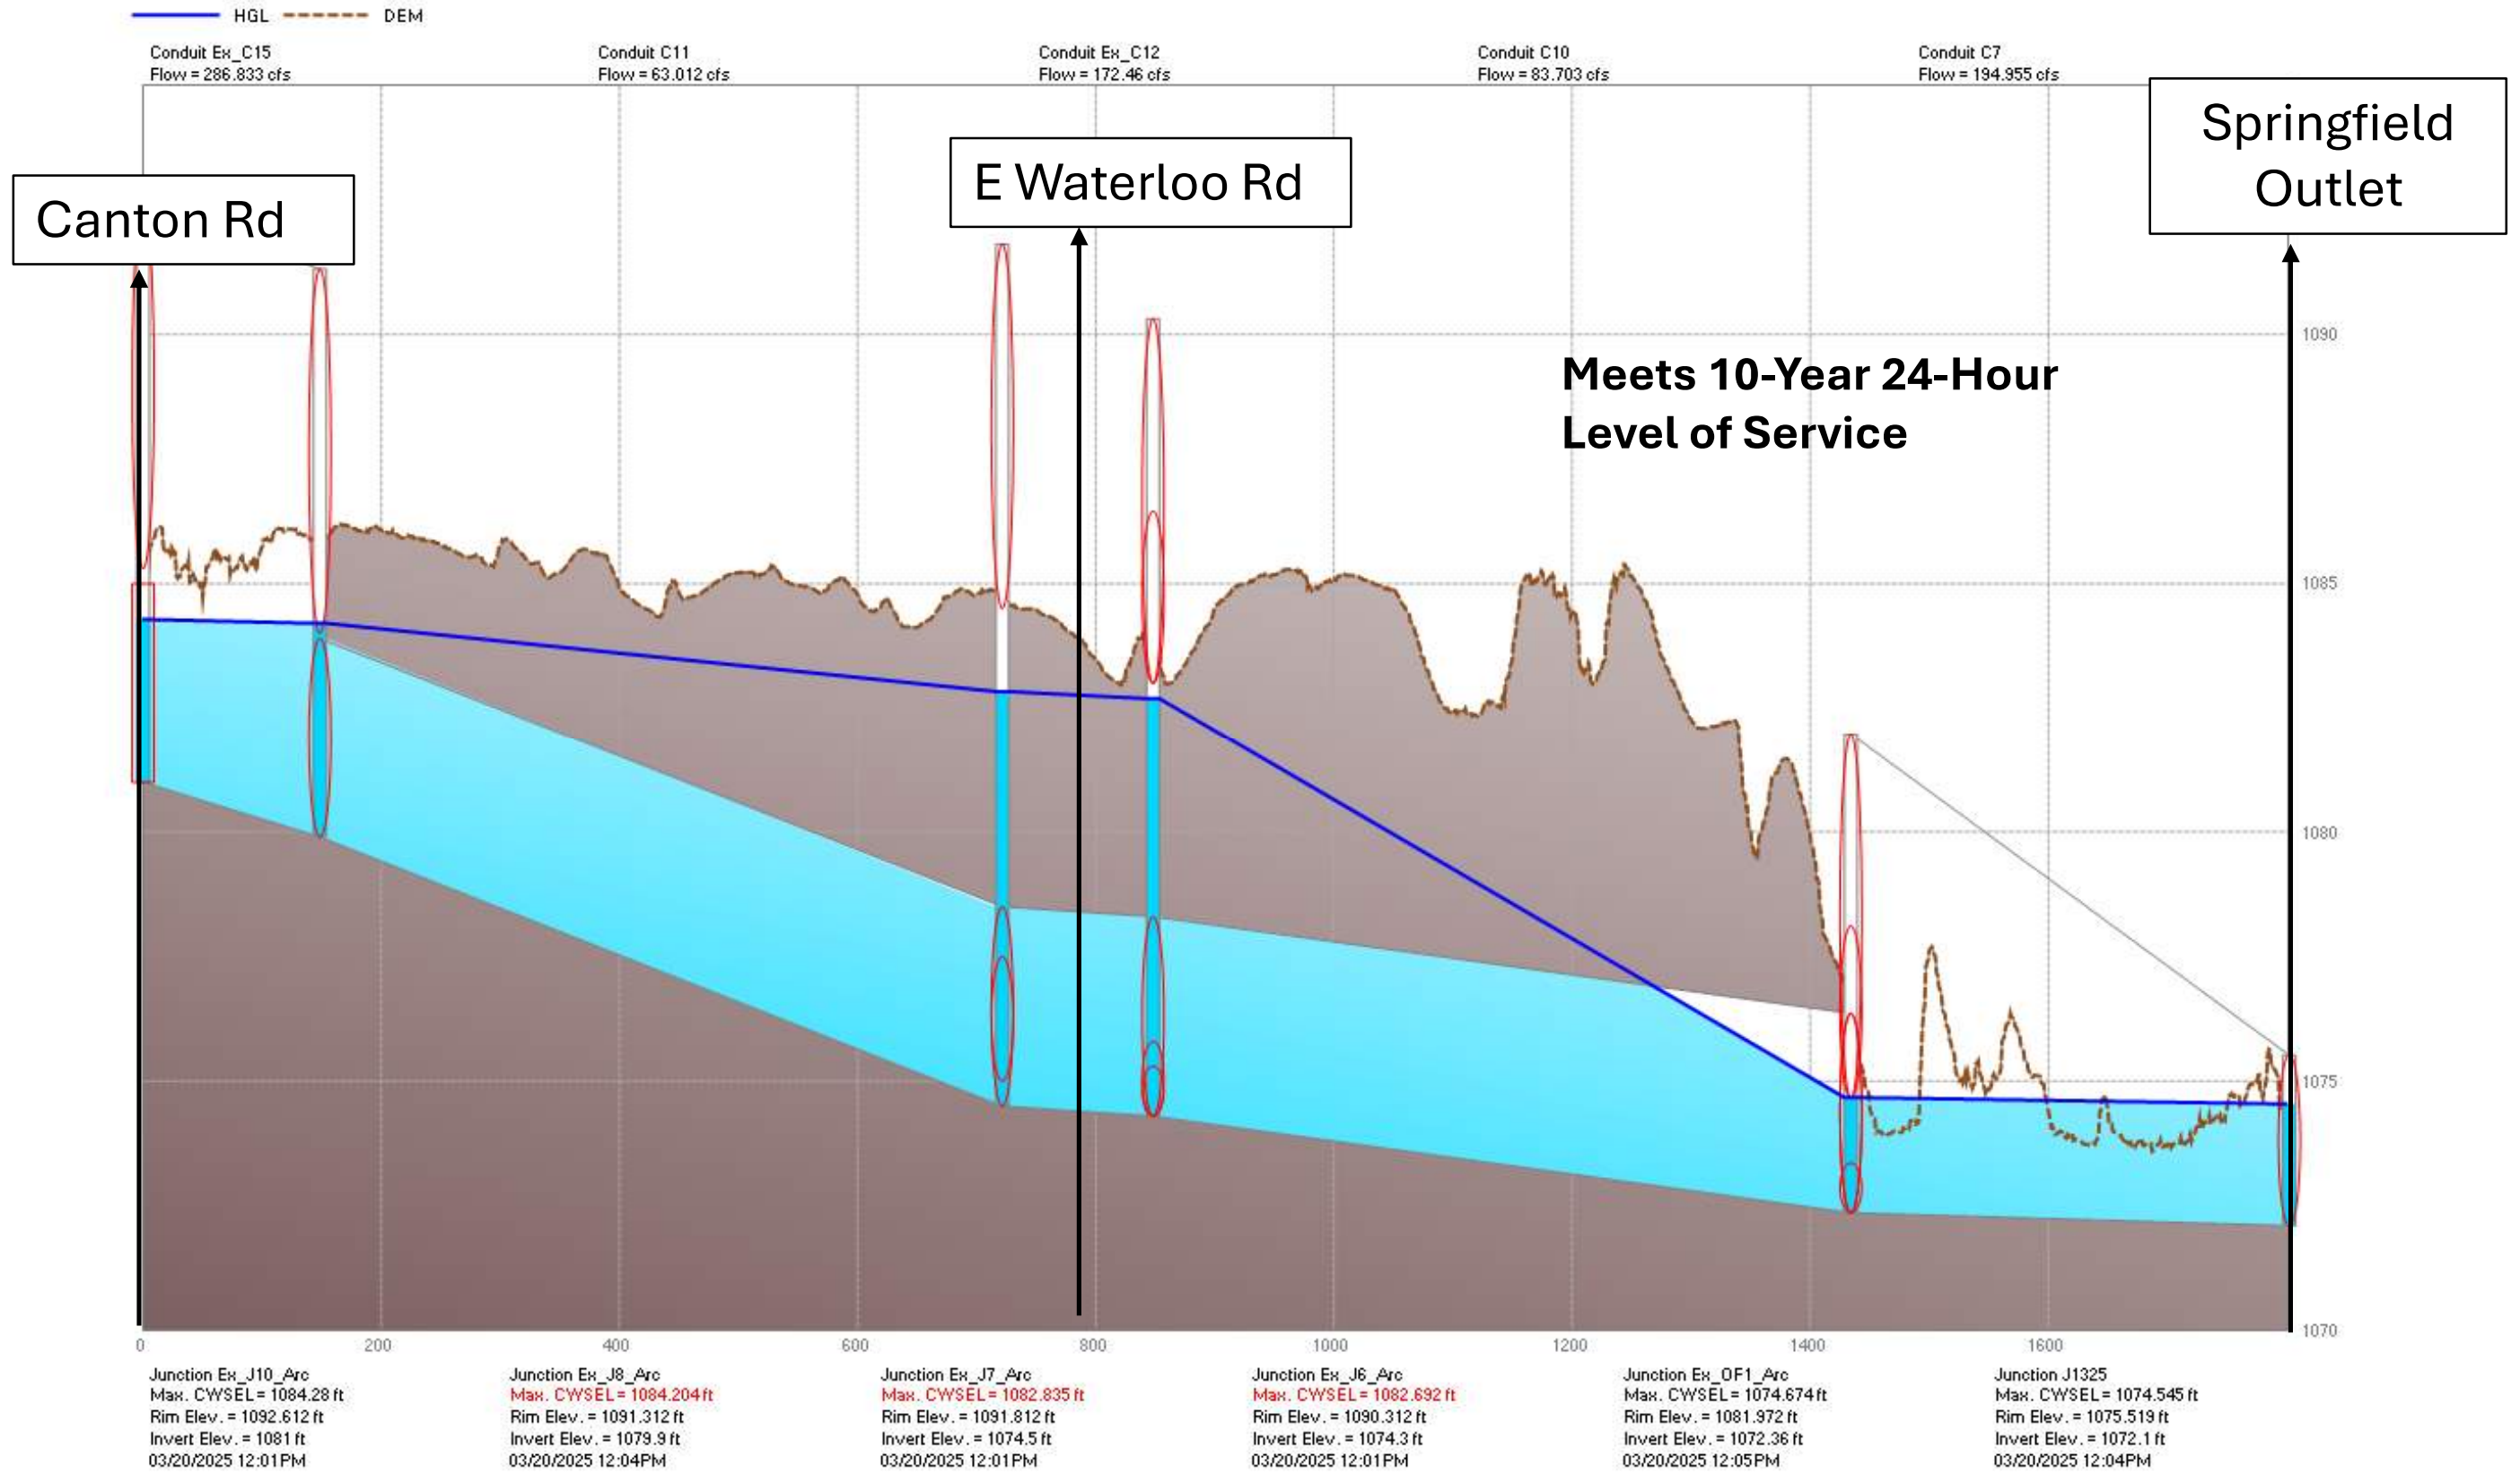
10Yr 24Hr Storm

H&H model was analyzed for both 10-year 24-hour and 25-year 24-hour storms, and results have been summarized and attached to the report (Exhibit C). The results contain: profiles of the highlighted stretch, capacities of the roadway crossings, flooding volumes and peak flows of overland flow paths.

Peak values

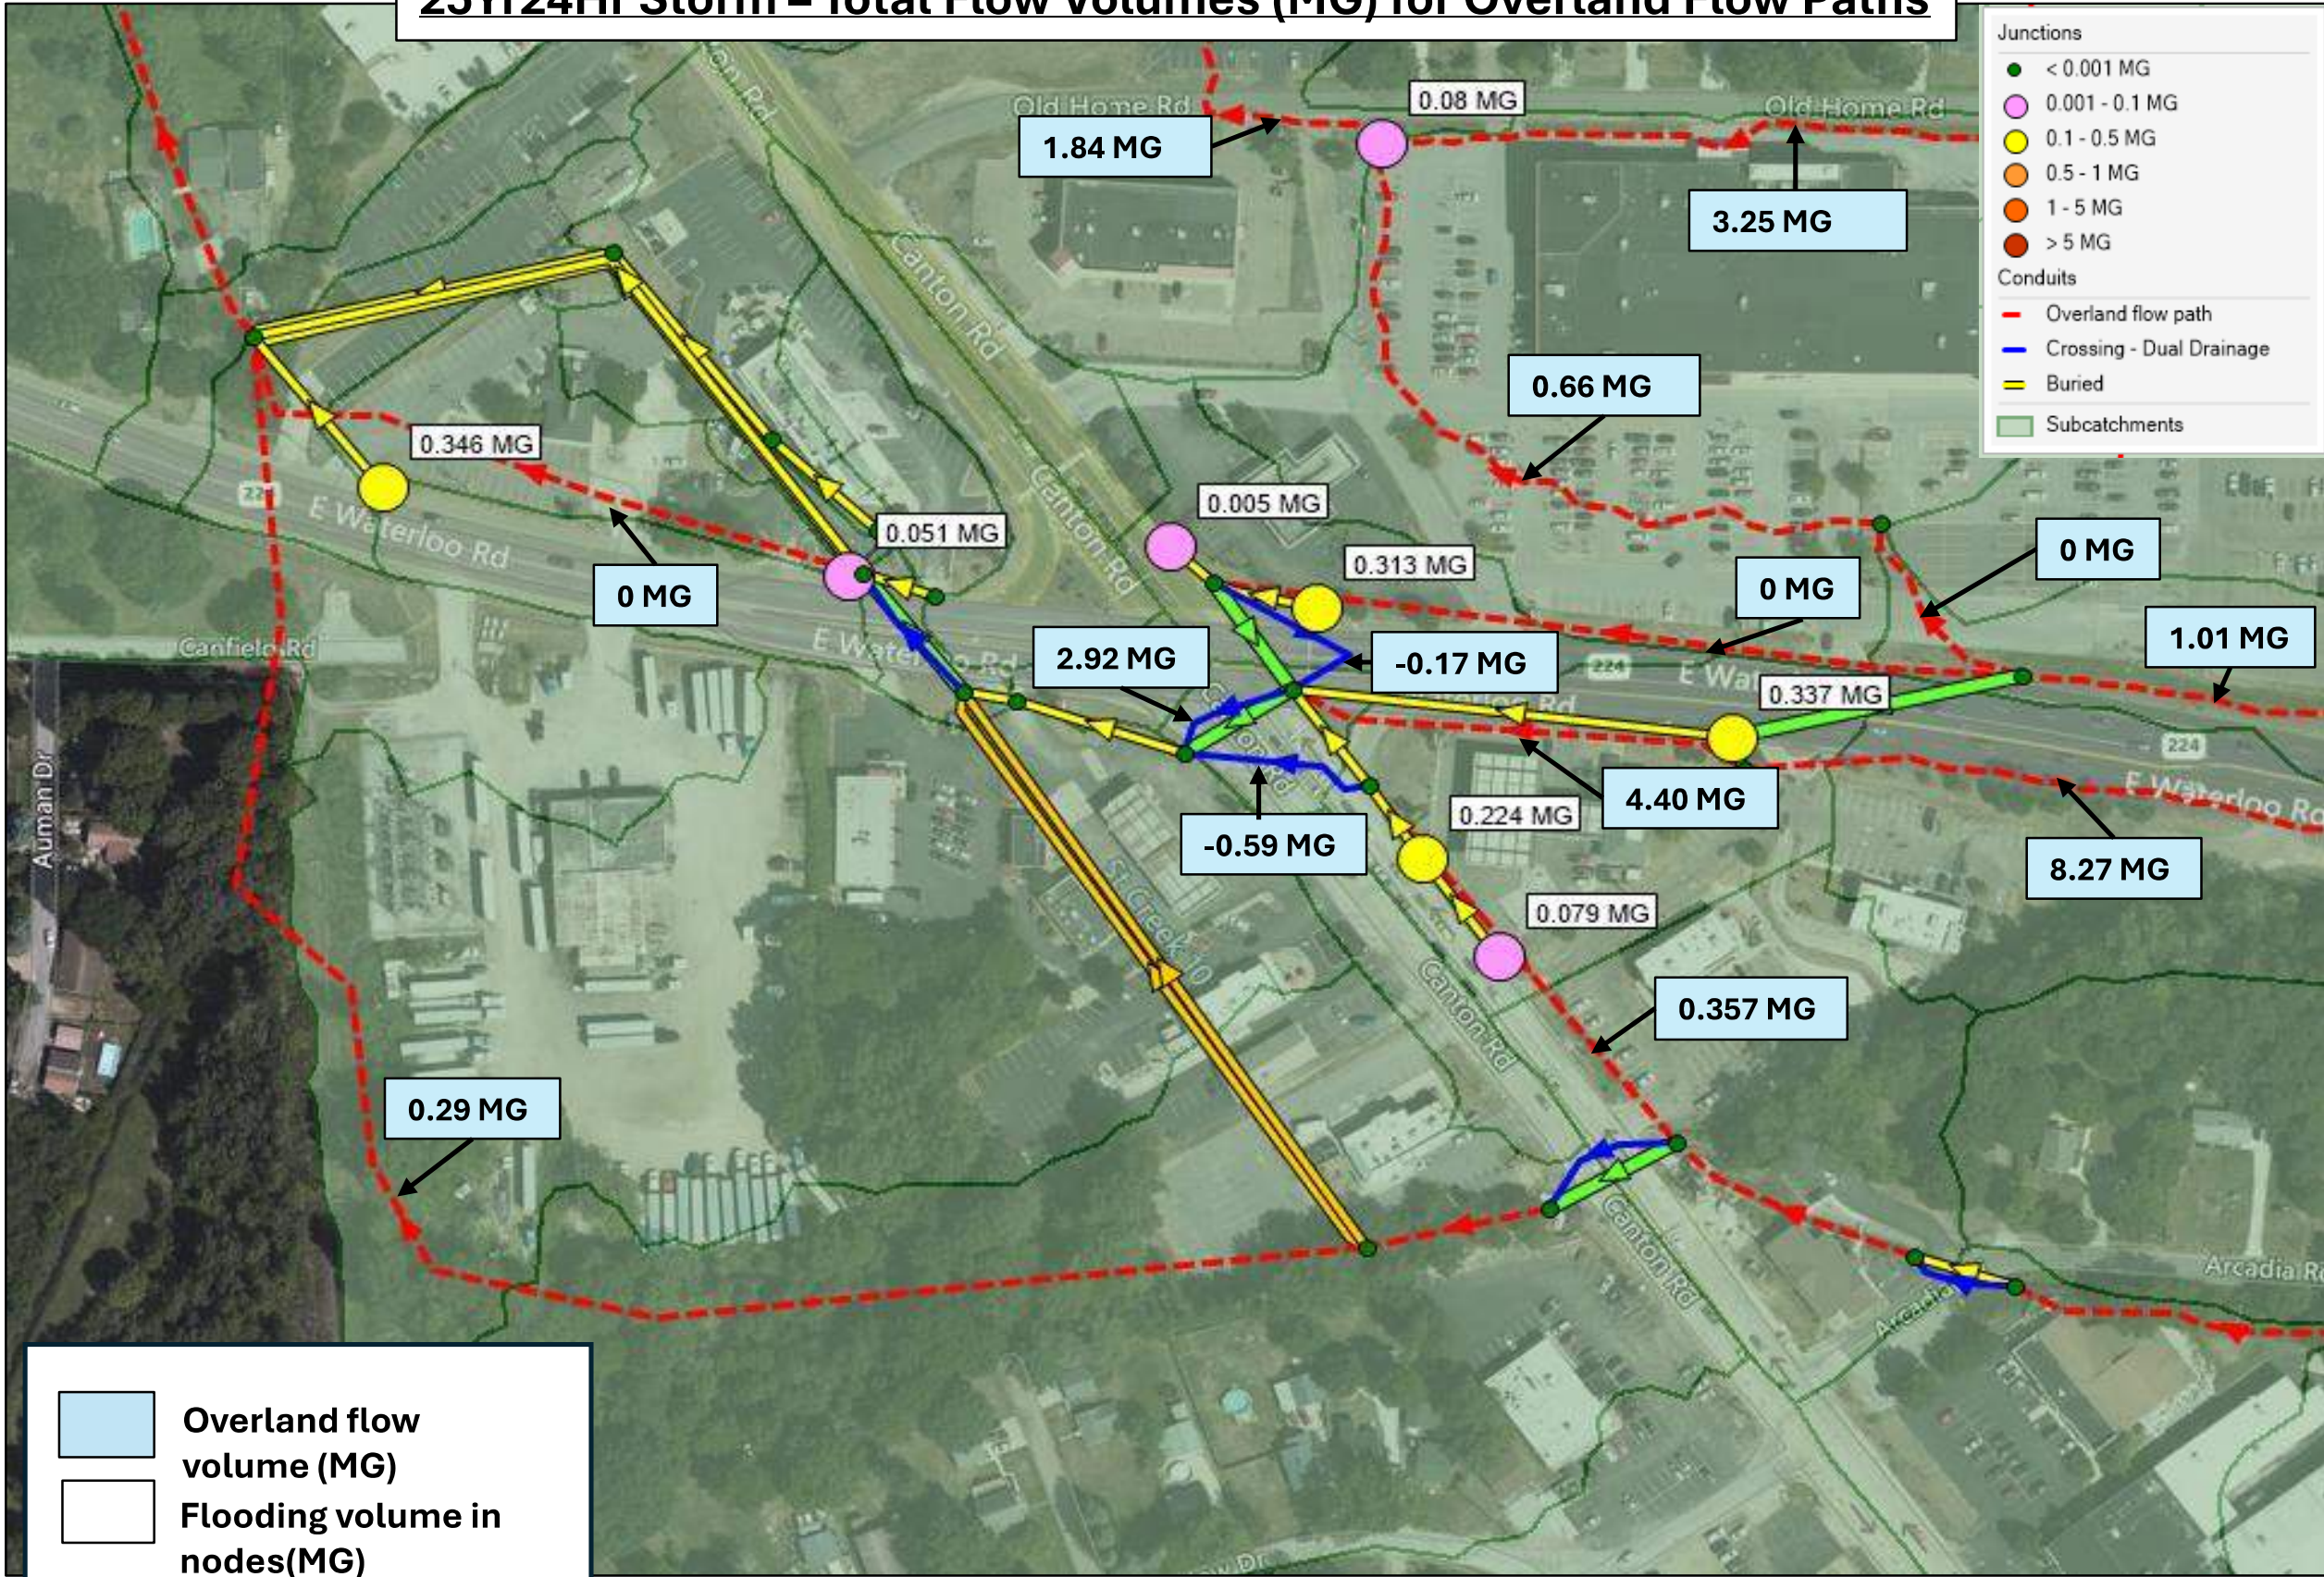
25Yr24Hr Storm – Total Flow Volumes (MG) for Overland Flow Paths

Overland flow volume (MG)
 Flooding volume in nodes(MG)
