## **Yellow Creek Watershed Technical Memorandum**

Prepared for  
**Summit County Engineer's Office**  
**September 2019**

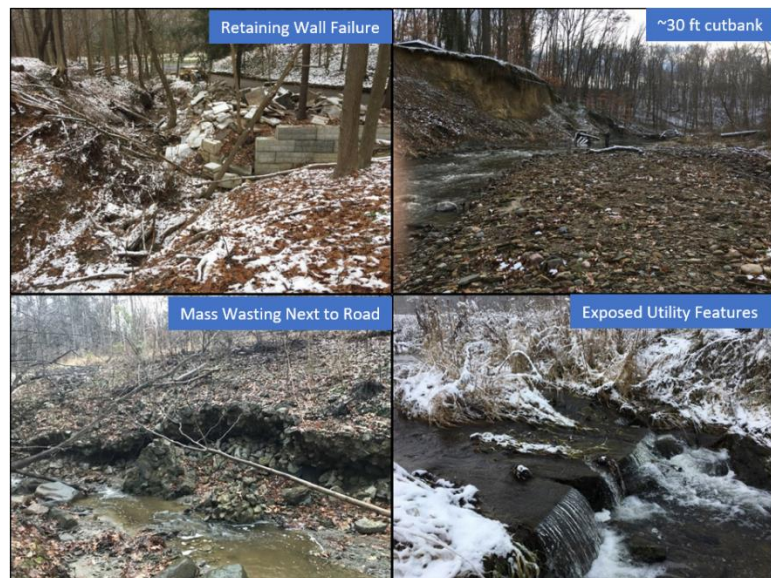
Although beneficial in their own right, these efforts were not expansive enough to offset the degradational stream trajectory that was observed throughout much of the stream network (Figure 2). The degradation is at least partially attributable to both extreme weather in recent years and inadequately managed stormwater runoff from impervious surfaces such as roofs, roads, and parking lots. In Summit County and across Ohio, flooding has increased in frequency and intensity since 2003 (Delaney, 2016; Liberatore, 2013; USEPA, 2016). This increase in flood frequency, coupled with consistently increasing urbanization in the Yellow Creek Watershed, has resulted in significant hydromodification over the years (Delaney, 2016). A notable example of the increased flooding in Yellow Creek is the occurrence of a storm on May 12, 2014, which dropped approximately five inches of rain in about two hours (estimated to be around a 500-year event for those in the hardest hit areas) (National Weather Service, 2014). Per resident claims, this storm washed out culverts, eroded roadways, and caused major debris jams in addition to flooding.

*Figure 2: Hydromodification and its effects along Yellow Creek and its tributaries*

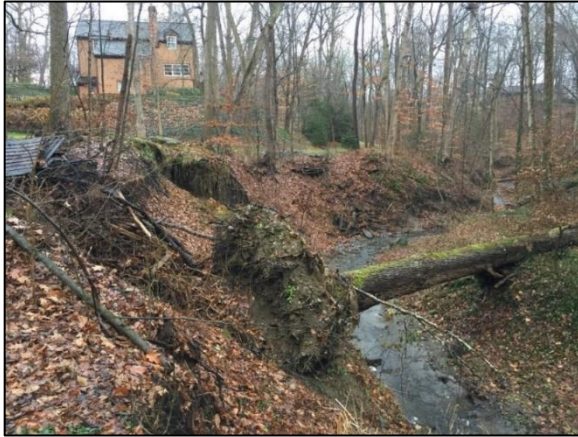
In the fall of 2018 the Friends of Yellow Creek, a local environmental non-profit, circulated a stormwater-related survey in their quarterly area newsletter. The survey asked residents to describe the frequency and severity of flooding, erosion, runoff, and loss of trees on their properties since 2000. Of the 50 survey responses within the watershed, 36 residents (72%) listed erosion as a problem, 24 (48%) listed runoff as an issue, and 21 residents (42%) listed incidents of flooding or yard ponding in their survey responses (Figure 9; Appendix A, page A17). Only four residents stated they had no issues. Issues ranged from stormwater problems (Appendix A, page A18) to major mass wasting of ravines. Appendix B includes a

Figure 9: Example of issue observed based on resident survey responses

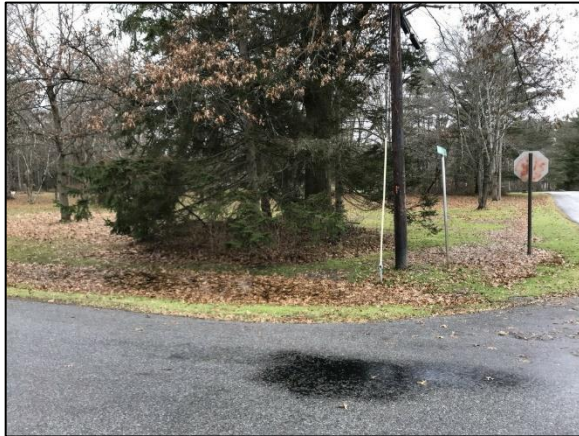
*Figure 15: Culvert across Partridge Lane with landscaping rocks and driveway on left*

At the intersection of Harmony Road and Acacia Drive in Bath Township, several unmapped culverts are apparently causing ponding issues for local residents (Figure 15). Upon visual inspection, an excessive amount of leaf litter was clogging the infrastructure, which may be part of the problem. At a starting point, it is recommended that the connectivity of all inlets, culverts, and storm pipes at this intersection is confirmed/mapped. The clogged inlet could be replaced with a more conventional structure that may be less likely to clog, and additional benefits may be seen from upsizing and/or relaying the culverts at steeper slopes. Refer to Appendix D, page D13 for this concept.

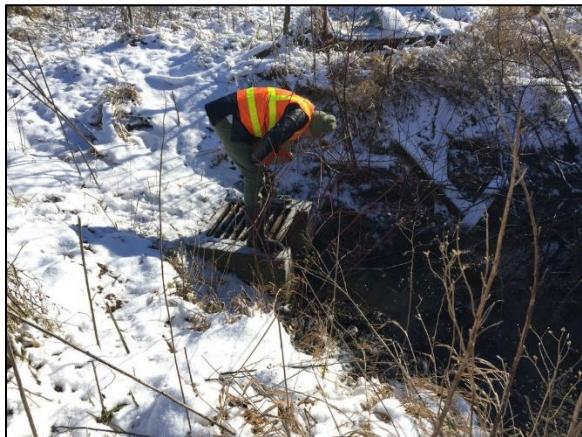
*Figure 21: Outlet control structure at Arbour Green North basin*

During field efforts, outlet structure data (Figure 21) was collected on this basin, located northeast of the intersection of Mallard Pond Drive and Arbour Green Drive in Bath Township. This data, paired with storm sewer infrastructure data, provided enough information to complete hydrologic and hydraulic modeling of this basin. Modeling results, included in Table 3, indicate that there is essentially no freeboard in the basin during the 100-year storm, and that both the 1-year and 2-year storms are released above the pre-developed flow. With a simple retrofit that would reduce the existing water surface elevation by one foot via an extended v-notch weir, approximately

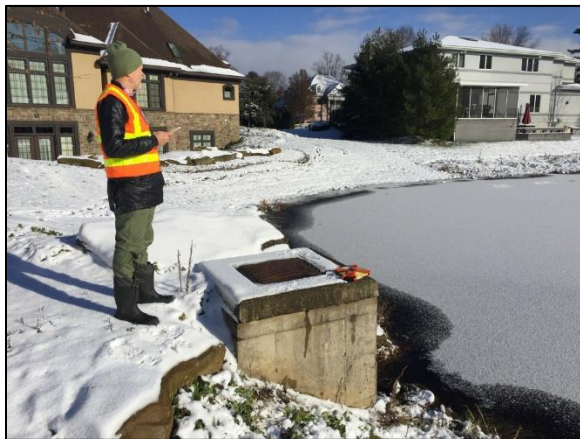
*Figure 22: Outlet control structure at Arbour Green South basin*

During field efforts, outlet structure data (Figure 22) was collected on this basin, located southeast of the intersection of Mallard Pond Drive and Arbour Green Drive in Bath Township. This data, paired with storm sewer infrastructure data, provided enough information to complete hydrologic and hydraulic modeling of this basin. Upon review of the contours, it appears the overflow route for this basin follows the outlet pipe. Prior to implementation of any retrofit, this should be further studied to better understand if this flow path is ever used and if it is, it is strongly recommended to lower the water surface elevation to limit overland flows in such close proximity to residences.

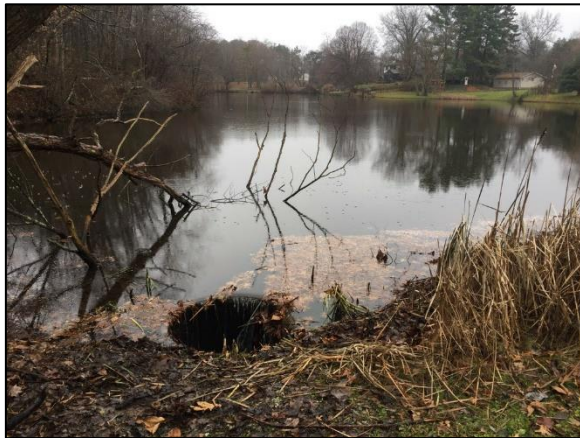
Figure 23: Outlet control structure at Goodrich Lake Dam

The existing basin in this location is a Class III privately owned dam (Goodrich Lake Dam, file number 1114-023, Figure 23) located on Revere Run in Bath Township. The owners of the dam, located at 3320 W. Bath Road shared that the dam has overtopped, which causes extensive yard flooding and occasional basement flooding. Additionally, Revere Run downstream of the dam and Bonnebrook Drive have widespread instability with up to ~65-foot-tall banks. A proposed stream stabilization concept, Revere Run Select Stream Stabilization, has been proposed to provide some stabilization in the reach. However, reducing flows, especially to a  $Q_{critical}$  threshold if

possible, would be a sustainable way to continue to protect the channel downstream. The proposed concept would completely drain the dam and restore the stream to a more natural alignment in the bed of the basin. During storm events, the remaining basin area, converted to floodplain, would function as a detention area with the ability to throttle back wet weather flows without flooding concerns. It is anticipated that the existing outlet from the pond would be modified but would continue to be used. Being a private dam, coordination with private property owner(s) and possibly an easement would be required. Refer to Appendix D, page D22 for this concept.

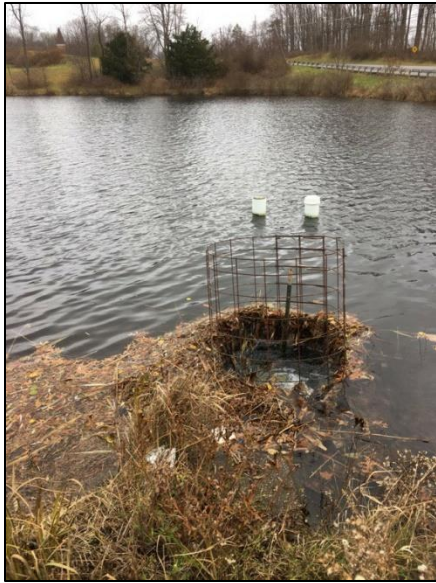
*Figure 24: Outlet control structure at Ghent Road basin*

This large, inline basin along Ghent Road in Fairlawn and Akron (Figure 24) has a surface area of over eight acres and may be an ideal opportunity to throttle back erosive flows in the downstream channel. A lack of information on upstream, inline basins and stormwater infrastructure provided several unknowns, however preliminary modeling showed an overtopping risk in this basin. The apparently unarmored spillway may be used in events as small as the 2-year storm. This concept recommends an evaluation of the upstream basins' outlet structures and drainage areas for more accurate modeling of the Ghent Road basin. Upon review of the results, spillway armoring is recommended if the spillway is modeled to be used in any storm up to the 100-year event. Furthermore, with more detailed information, additional consideration should be given for reducing the existing water surface elevation in the basin. If the basin is found to overtop, this would provide additional storage, and if the basin does not overtop, there may be freeboard available to retrofit the basin to

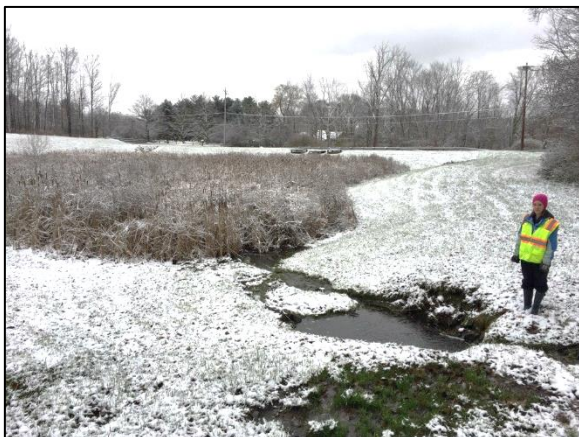
*Figure 25: Tippy Run inlet and cattails covering bottom of Solar Cir basin*

This existing basin in Bath Township (Figure 25) receives neighborhood stormwater runoff and flows from Tippy Run. Upon evaluation, both the inflow from Tippy Run and the low-flow outlet show signs of instability that would benefit from some rock placement. Additionally, outlet control structure information was not gathered on this basin, but it can be said that removal of the cattails would provide additional storage within the basin. Should detailed information on the outlet structures become available, a retrofit of the structure should be considered that would reduce flows in the 2-year and smaller storm events (while maintaining the current level of service in larger events) to the  $Q_{critical}$  threshold to reduce

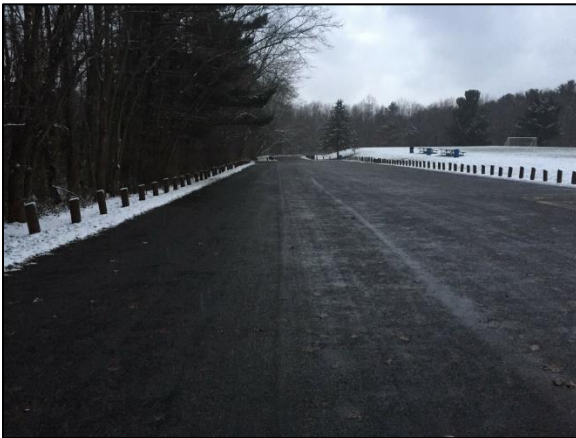
Evaluation of stormwater at Bath Community Park in Bath Township was a result of several downstream residents' complaints related to erosion and flooding after the soccer fields were installed. Based on a site visit, it appears the water is allowed to sheet flow off the parking areas without detention (Figure 28). Amended swales have been proposed to slow the runoff from these areas in a linear configuration. Based on property boundaries, it appears any detention may require an easement on private property.

*Figure 28: Undetained parking areas adjacent to soccer fields*

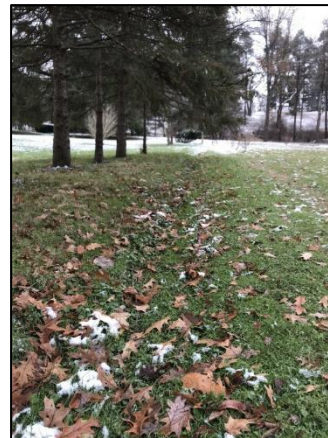
*Figure 31: Existing swale/flow path from Ghent Hill Road*

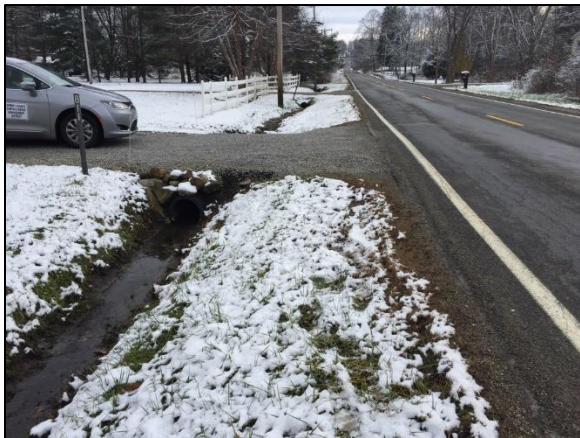
*Figure 32: Driveway and existing swales on Medina Line Road (looking south)*

Drainage issues along Medina Line Road were reported by a resident on the Bath Township side of the road, including large pools of water at the street and an impassable driveway with erosion (approximate location shown in Figure 32). The immediate cause of these issues was not identified during a field visit, and the resident was not home to collect more information. It is possible that the issue is a result of stormwater coming from the north along Medina Line Road or from the channel that runs through their property. It is recommended that an additional study of the area and problem is conducted prior to identifying solution(s). However, potential

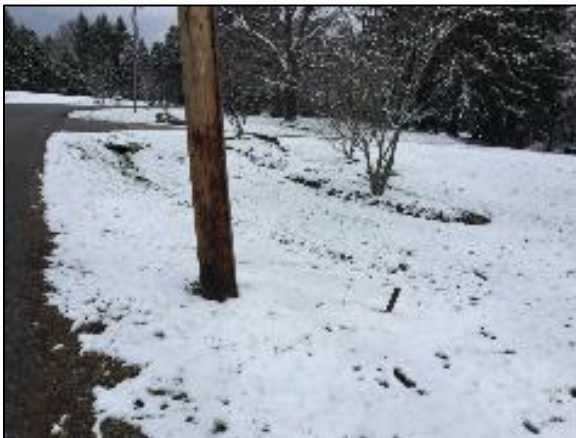
Drainage issues at two properties along Ranchwood Road in Bath Township indicated that the volume of stormwater may be overwhelming the existing system. A resident on the north side of Ranchwood Road stated that basement flooding was a result of runoff from Pin Oak, and a resident on the south side of Ranchwood Road has reported flooding through their yard due to upstream, overwhelmed inlets and swales (Figures 33 and 34). This flooding, which reportedly occurs about three times per year, has resulted in a partially exposed septic system and a flooded driveway during events.

*Figure 33: Culvert along Ranchwood that directs flows onto driveway at 4826 Ranchwood*

To help to reduce the severity of the reported issues, new detention and new stormwater routing is proposed. Two vacant lots on the north side of Ranchwood Road, which currently appear to allow flow through of water from Pin Oak Road, are proposed for conceptual detention basins. Based on drainage area delineations and available contours, these basins may or may not be able to substantially reduce the flows from Pin Oak Road but would at a minimum consolidate the flows. From these basins, the flows could enter storm sewers (including existing and new) that could direct the flows to the natural flow paths south of Ranchwood Road, which may need armoring to resist erosion. To redirect additional flows from Pin Oak Road, armored stormwater routing is proposed along several backyards on the north side of Ranchwood Road that would be directed to the more western proposed basin. Refer to Appendix D, page D38 for this concept.

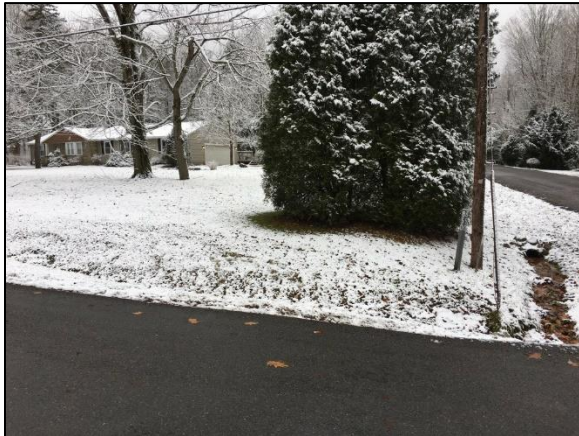
*Figure 35: Open yard area for proposed basin with existing culverts shown in bottom right*

Flows from Timberline Drive and Westridge Road in Bath Township enter a culvert that directs the flows under Timberline Drive toward 901 Timberline Drive. Due to the stormwater issues at 901 Timberline Drive, discussed later in this section under the stream stabilization category (i.e. Timberline Part B: Swale Stabilization), upstream detention was evaluated. It appears there is enough area in the front yard of 850 Timberline Drive (Figure 35) to install a detention basin that could substantially reduce the flows from the drainage area, ultimately reducing the erosive flows in the receiving channel and on 901 Timberline Drive. Refer to Appendix D, page D39 for this concept.

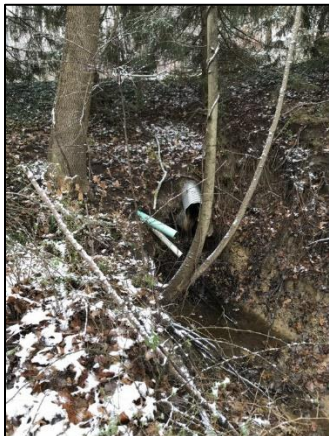
*Figure 36: Undercut stormwater pipes document erosion in ravine*

Erosion/instability and tree loss concerns at Top of the Hill Road in Bath Township suggest a potential lack of adequate stormwater controls for the neighborhood. Stormwater runoff is currently directed to swales along the road, which discharge to the tributaries surrounding 1135 Top of the Hill Road (Figure 36). With the existing swales already in place, conversion to amended swales should be a fairly simple process that will slow runoff and provide some detention in an area that currently has none. At the end of the court, there appears to be an existing depression that receives flows from the north side of Top of the Hill Road. Enhancement of this area is proposed to further reduce peak flows to the receiving channel. Modeling efforts would be necessary to ensure flooding of the roadway and/or nearby residences would not occur as a result of the enhanced detention. Potentially in combination with or, as an alternative to this project, the receiving ravines could be investigated for potential armoring needs. Refer

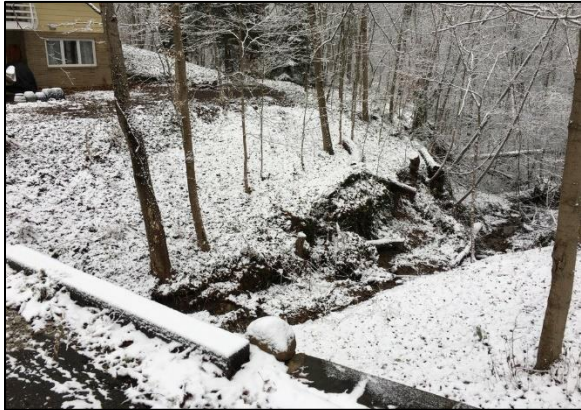
*Figure 37: Eroded ravine downstream of driveway*

The system of ravines and culverts on 901 Timberline Drive in Bath Township receive runoff from Timberline and Westridge drives (see Timberline Part A: Detention concept for partial drainage area.) When it rains, the stormwater runoff appears to potentially contribute to erosion in the ravines and a loss of trees. Additionally, the resident reports various debris from the runoff, ranging from bottles to construction debris and a car battery and also flooding of an outbuilding. Major erosion on the property is threatening the private driveway and culverts (Figure 37). The proposed concept on this property creates a new

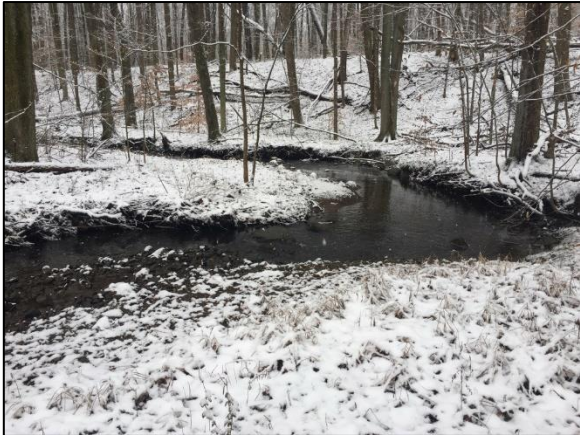
*Figure 44: Some bank erosion and lateral migration in this reach*

In this upper reach of North Fork in the Village of Richfield, intermittent bank erosion and lateral migration are apparent (Figure 44), although the streambed appears stable, with good riffle-pool sequences. Although not a large contributor of sediment to the system, stabilizing these banks with a low-cost method could be an excellent training activity that would benefit the system. In addition to reduced sediment entering North Fork, hand-placed log structures can improve habitat and can be installed with no disturbance to the existing riparian vegetation onsite. Refer to Appendix D, page D50 for this concept.

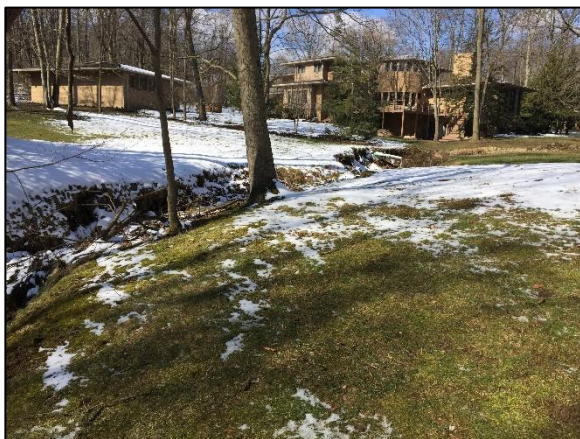
*Figure 45: Pre-project photo courtesy of Summit County*

In 2016, an affected owner approached Summit County about severe erosion in her backyard (Figure 45), downstream of the public storm drainage system. Because it was beyond the storm drainage easement included on the subdivision plat, the County could not repair it. The owner, subsequently joined by a neighbor, proceeded with a ditch petition. The County calculated preliminary assessments; however, due to overwhelming negative response from many of the 42 upstream landowners to be assessed, County Council did not authorize proceeding with the design. In 2017, the two owners hired an engineer to prepare an improvement plan and subdivision replat in

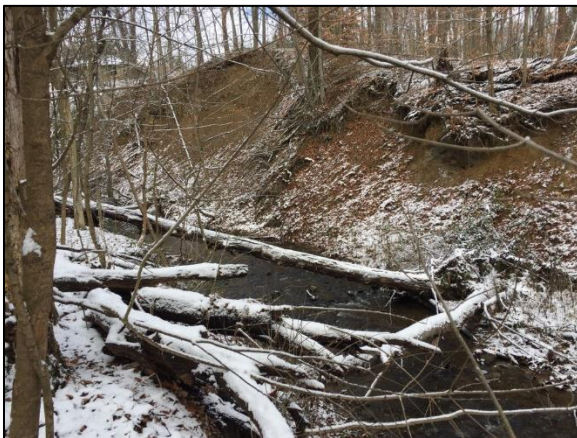
Bath Creek, downstream of Nina Lane to its confluence with North Fork (in Bath Township), showed extensive instability, with tall, vertical banks, mass wasting and slumped hillslopes, and large tree loss (Figures 50 and 51). One area armored with rock exhibited continued instability. This concept addresses the worst banks along this reach in Bath Township and proposes to protect select sections of streambed and toes of the bank for improved stability. Where residents along this reach are concerned about stability, separate action(s) would need to be taken by them for full protection of the entire hillslope (via retaining walls or other methods). Refer to Appendix D, page D58 for this concept.

*Figure 50: ~40-ft tall near vertical bank with mass wasting and tree loss*

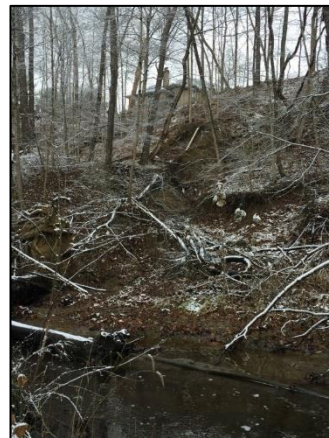
*Figure 51: Major erosion and mass wasting at pipe outfall*

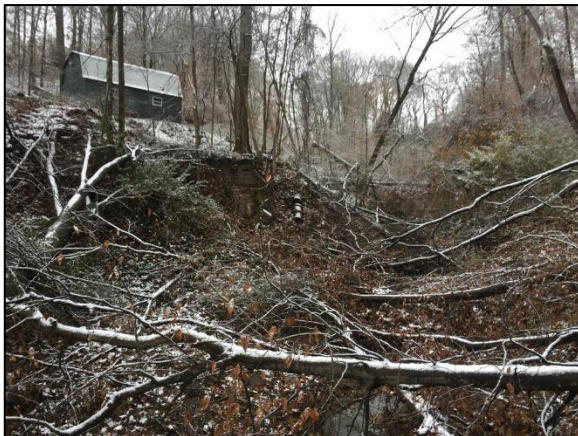
Merrill’s Run, located in Bath Township, is an extremely unstable, entrenched stream. Some residents have dumped rock to an effort to provide some protection, although tree loss is extensive and private bridges and sheds have been lost to erosion (Figures 53 and 54). The extreme cost to address the instability in this reach is estimated to be too costly to implement. Refer to Appendix D, page D60 for this concept.

*Figure 53: Extensive tree loss along Merrill’s Run with shed at top of bank*

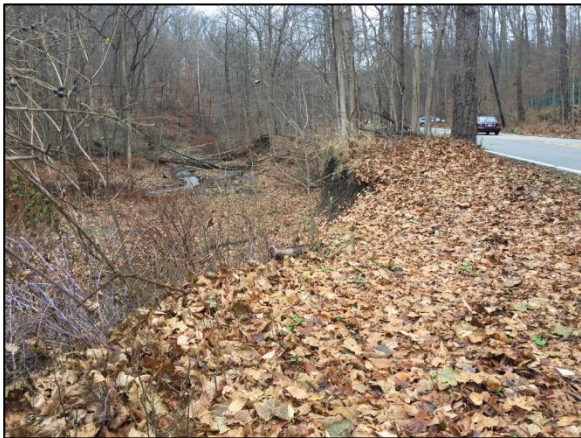
*Figure 56: Revere Run valley in close proximity to Revere Road*

This section of Revere Run, located along Revere Road in Bath Township, exhibits signs of instability that is threatening Revere Road (Figure 56) and some residences. Along the roadway, bank erosion is apparent at the edge of the floodplain, although the low flow channel is farther away from the road. The opposite bank has tall, steep banks that appear to be slumping below the houses at the top. This concept proposes to protect the streambed and toes of the bank for improved stability. Where residents along this reach are concerned about stability, separate action(s) would need to be taken by them for full protection of the entire hillslope (via retaining walls or

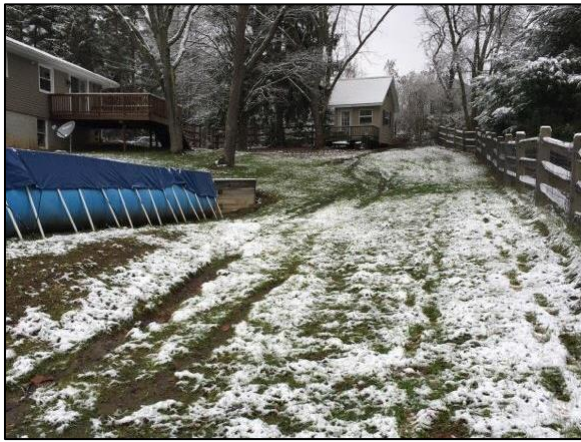
*Figure 59: Yard within the watershed where septic has been smelled*

A common theme from talking to local residents was septic smells in yards (e.g. Figure 59). Proper septic maintenance can not only protect property value and the environment, it will save money long term. The Summit County Public Health Department has several informational presentations to help spread best practices on septic system management and help residents understand how their systems work. This item assumes one homeowner education event per year for three years could be held, in conjunction with the health department, to inform citizens of appropriate maintenance activities, phone numbers and other resources for help, and available grant

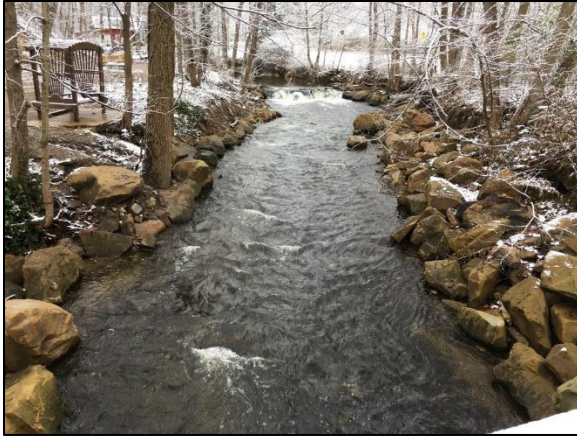
During the visual assessment, it was obvious that many homeowners have taken their own actions to protect their properties from the erosive nature of the streams in this watershed (Figure 60). Providing residents with do-it-yourself knowhow via a workshop and/or pilot project would likely provide real benefit to the system. The workshop should highlight the use of loose material over hardscape products, which are more forgiving in a natural setting. It would also be prudent to touch on the importance of riparian buffers in stream stability (Figure 61), from no-mow native seed buffers to live stakes and trees. From a budget standpoint, one workshop per year for three years has been assumed. An example workshop handout and workshop flyer have been included in Appendix E.

*Figure 60: Loose rock bank protection on a private property*

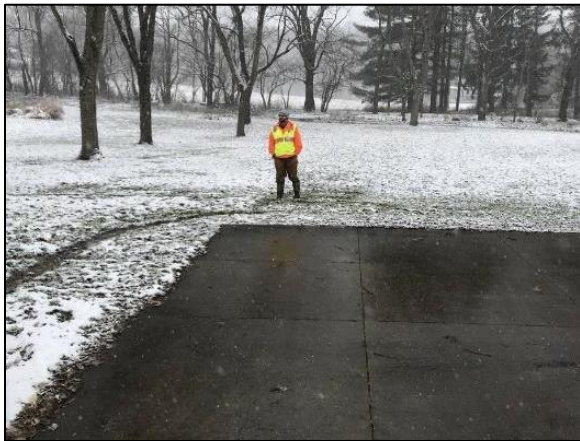
*Figure 62: Resident complaint of wet spots that are slow to drain in yard.*

Based on feedback in the resident surveys, local drainage issues (e.g. Figure 62) seem to be prevalent in the watershed. For those residents with soggy yards and/or poor drainage, an educational workshop on practices that could improve conditions could be valuable. The workshop could cover simple modifications, such as splash blocks on downspouts, but could also include pocket rain gardens and other green infrastructure that homeowners can do themselves. Materials could be developed that list local regulations and resources pertaining to stormwater drainage can empower open dialogue between neighbors and personal actions to remediate

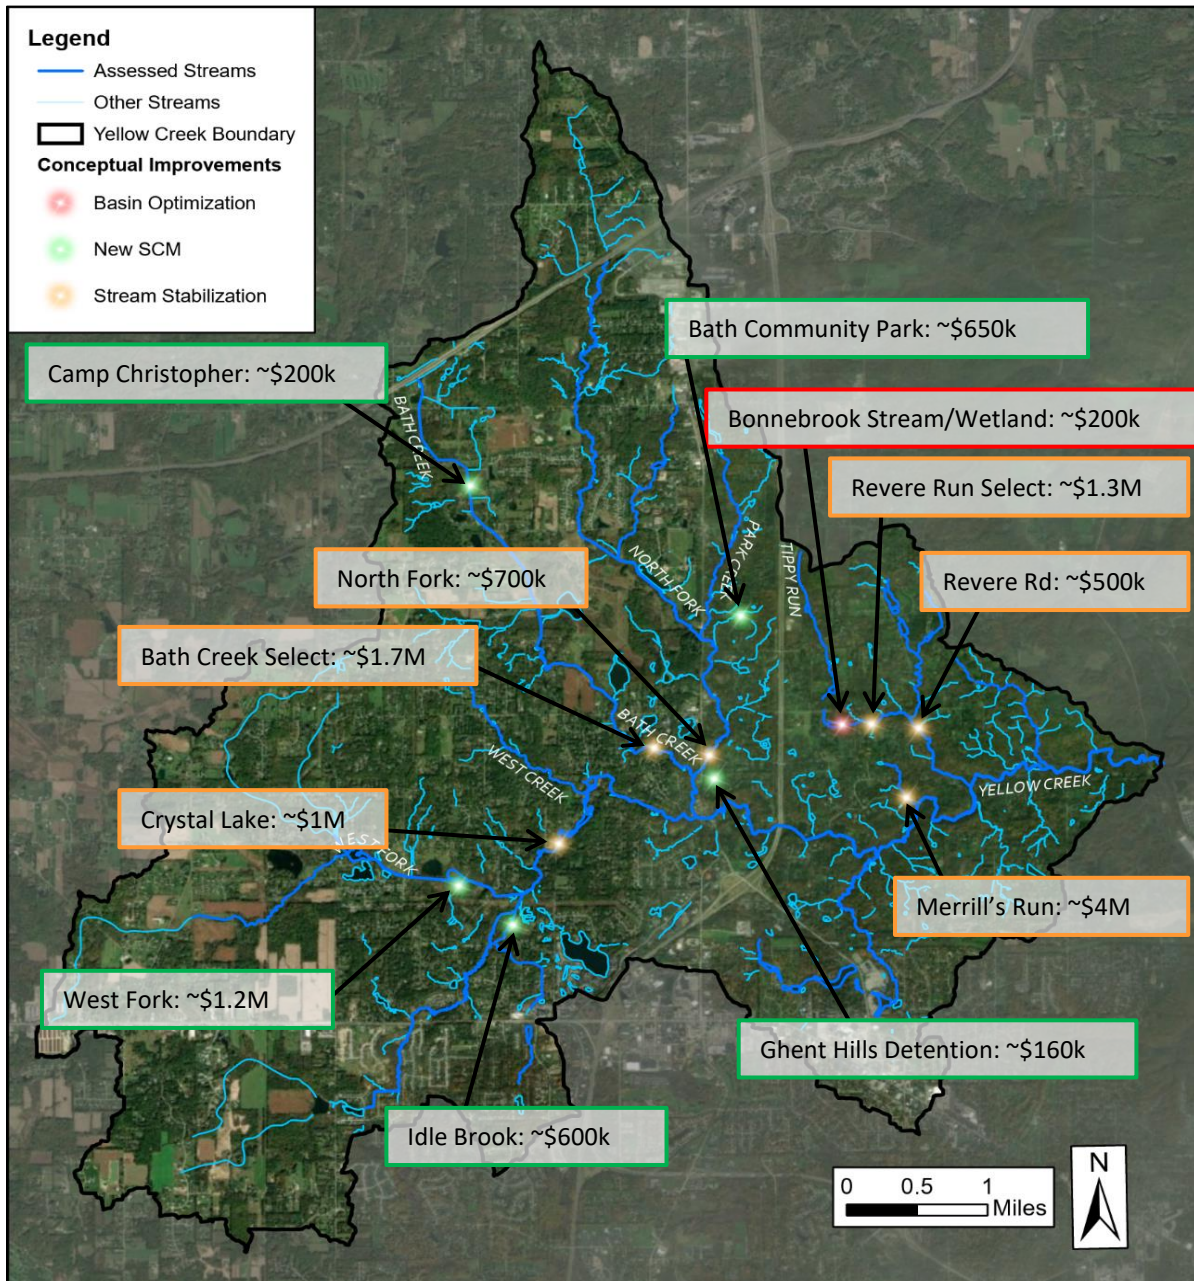
Figure 80: Potentially high-impact projects in the Yellow Creek Watershed

There are many aspects of the projects listed in this report that should be considered when determining the best projects for the community, including costs, access, cost-effectiveness, infrastructure protection, public safety, etc. The list below, shown in Figure 80, focuses on arguably the greatest opportunities for reducing stream erosion. They include two distinct strategies: 1) stormwater management interventions to intercept large volumes of potentially erosive flow upstream of actively eroding stream reaches, and 2) stream restoration projects to rehabilitate large sections of unstable channel.
