# APPENDIX A

## Yellow Creek Watershed Maps

**HIGH INFILTRATION AREA PROTECTION**  
**BATH CENTER CEMETERY FOREST PRESERVATION**  
 BATH TOWNSHIP DRAINAGE BASIN IMPROVEMENT  
 SUMMIT COUNTY SURFACE WATER MANAGEMENT DISTRICT

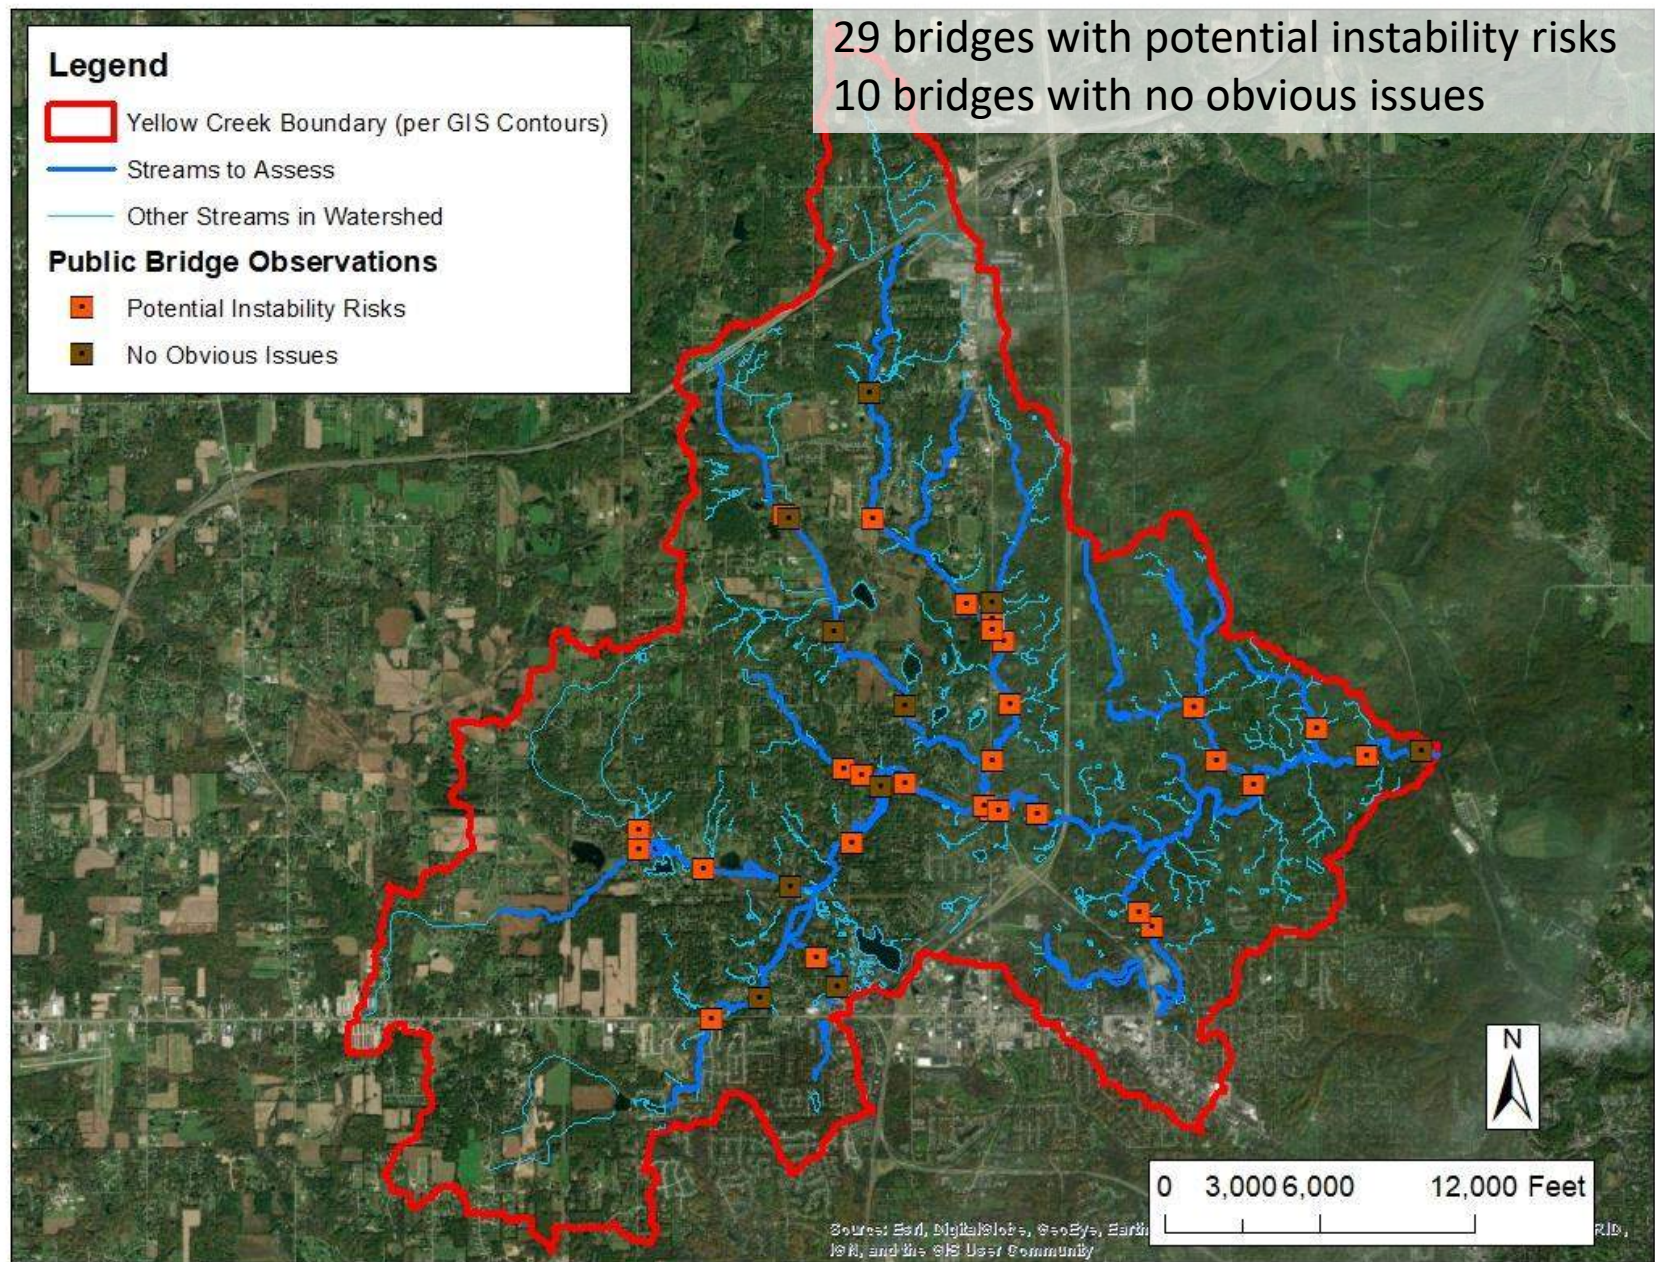
Figure A12. Public bridge observations

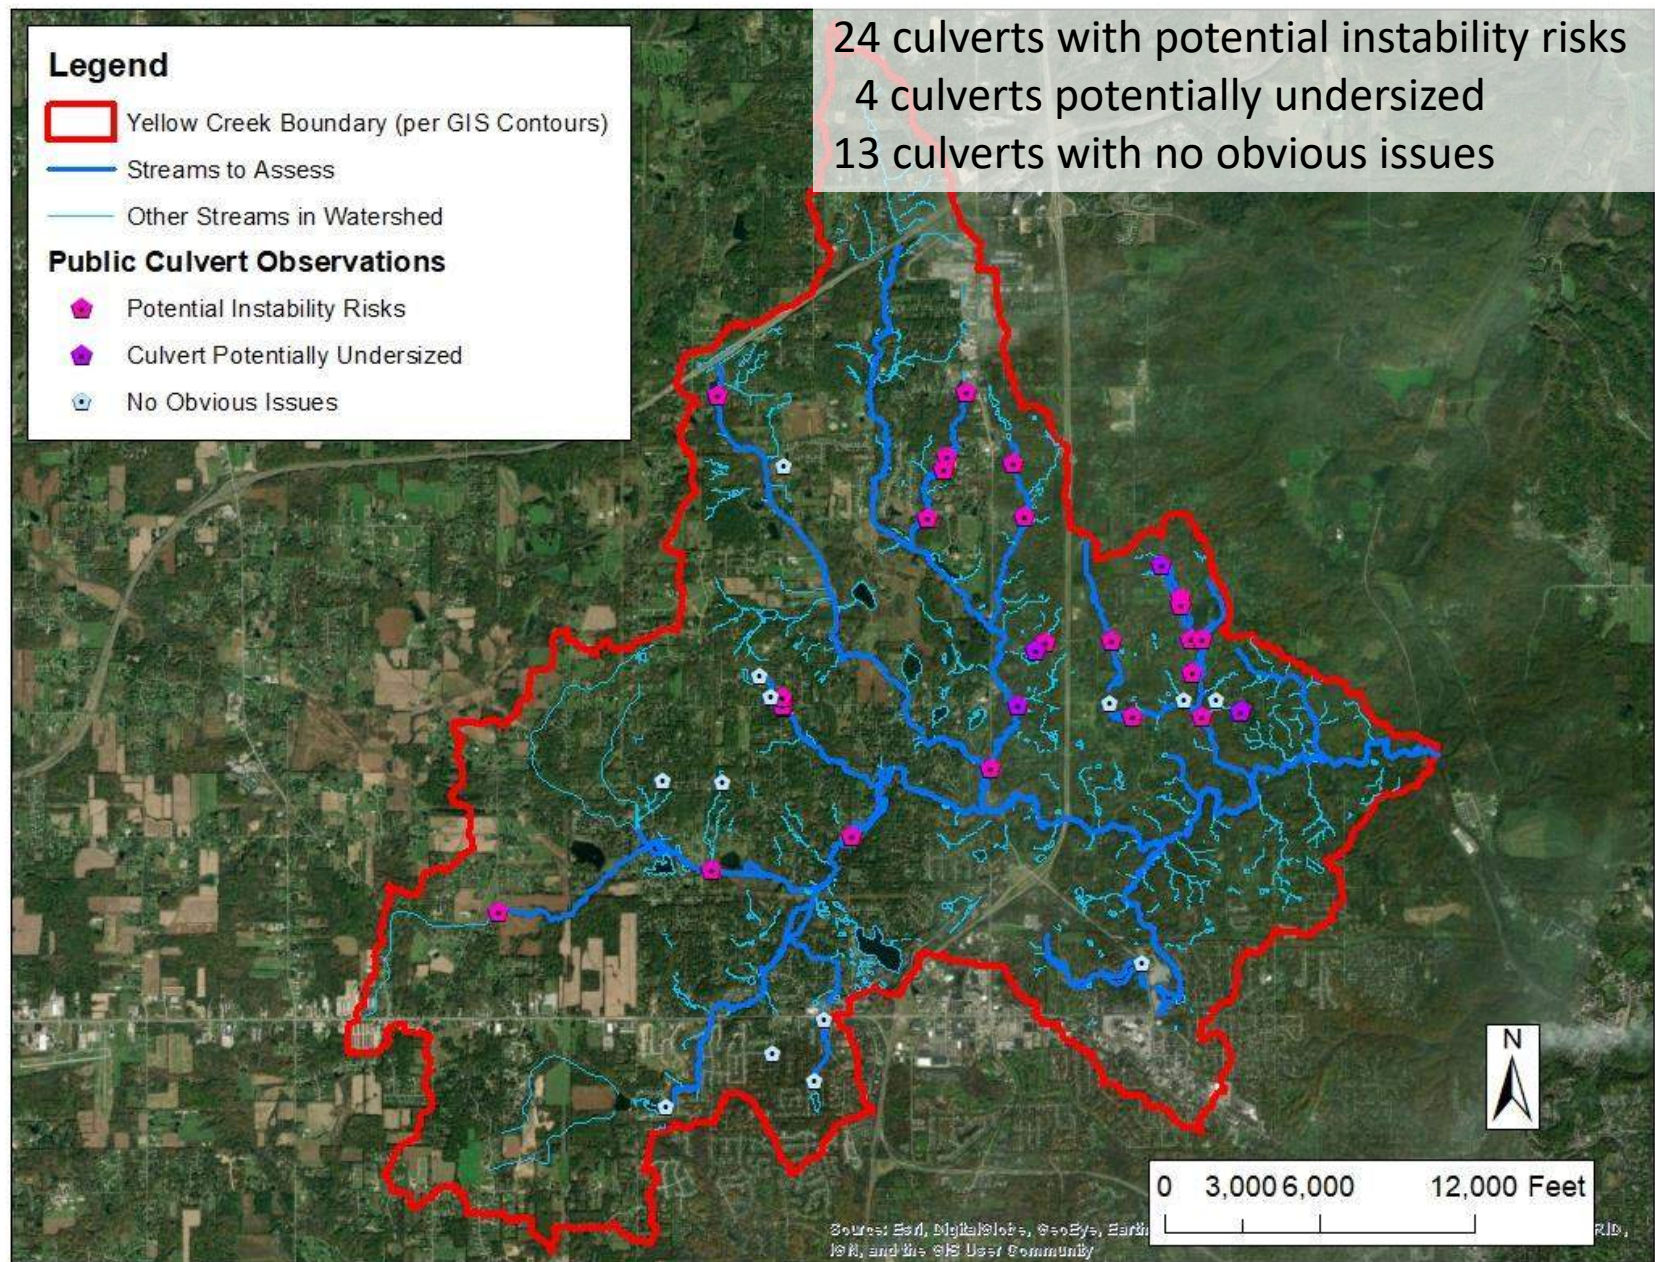
Figure A13. Public culvert observations

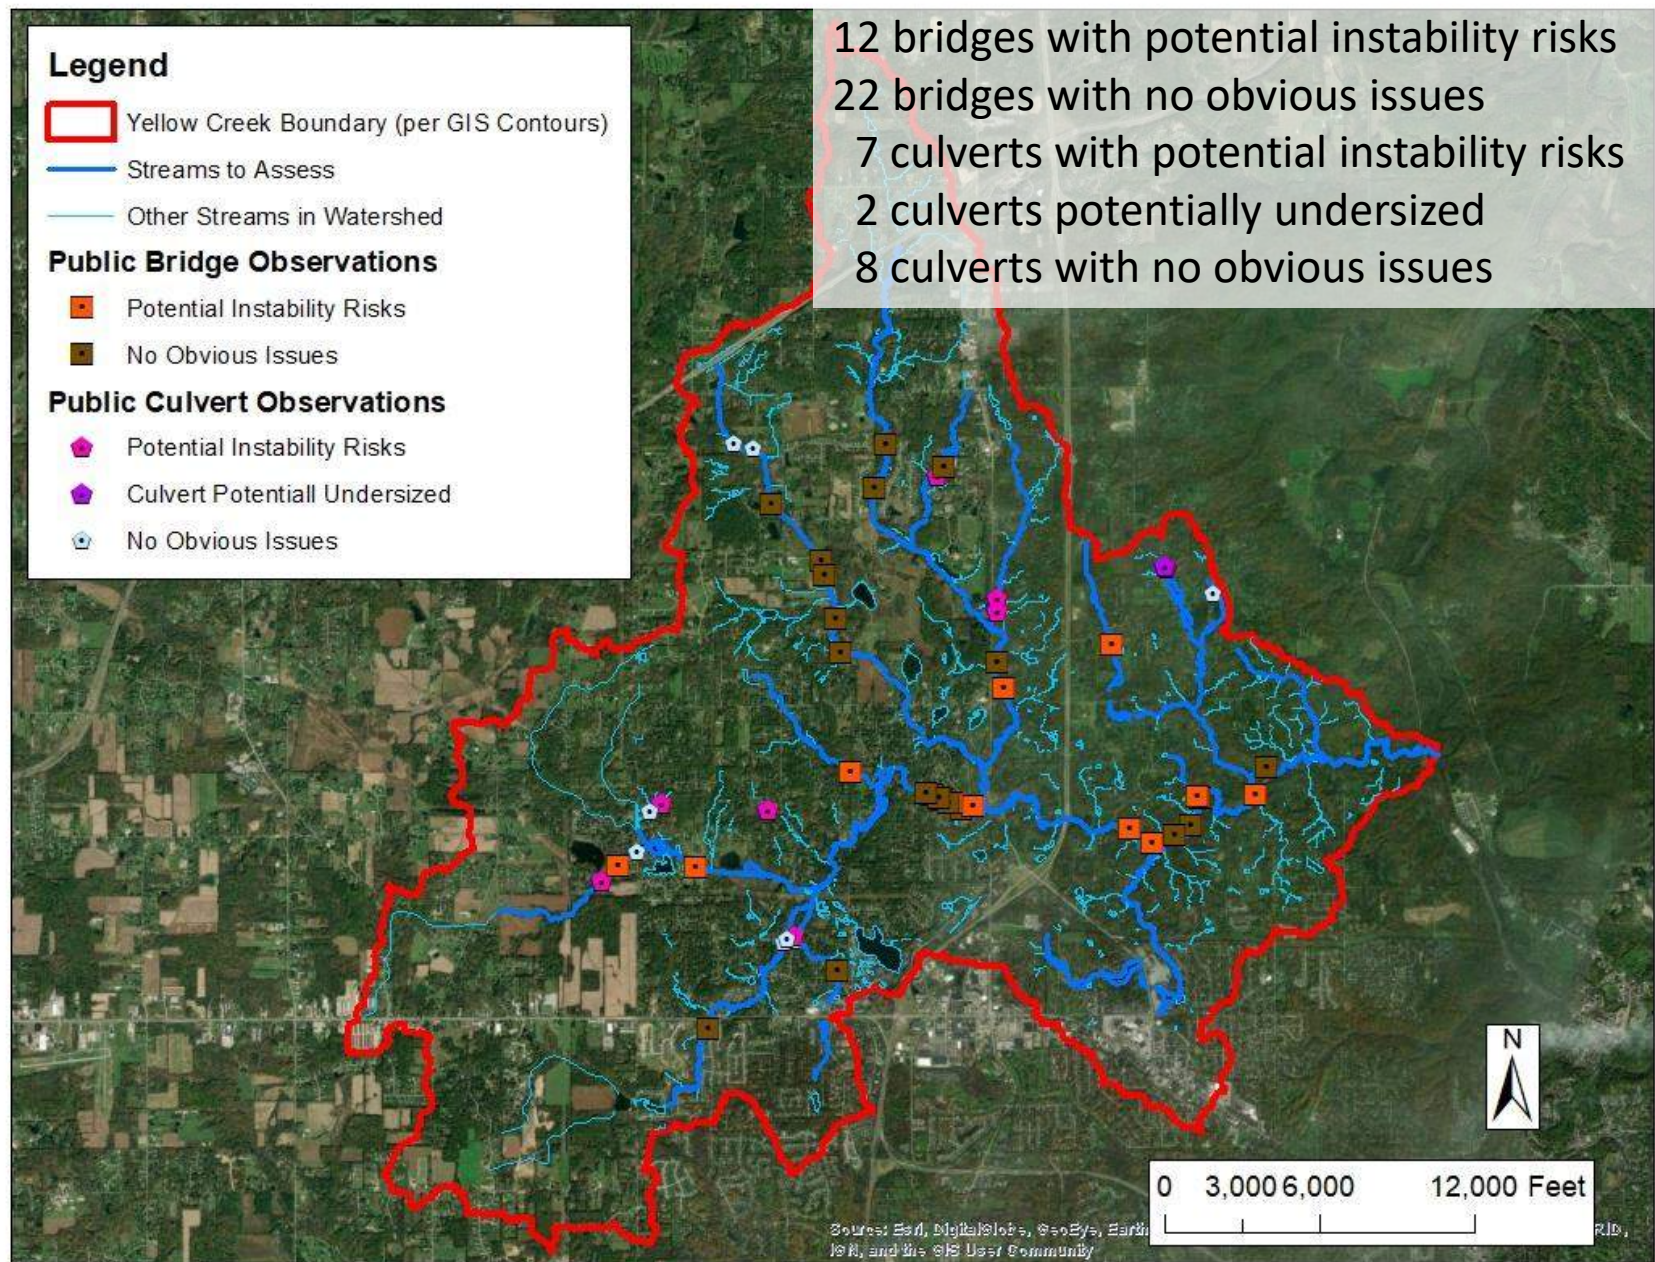
Figure A14. Private bridge and culvert observations

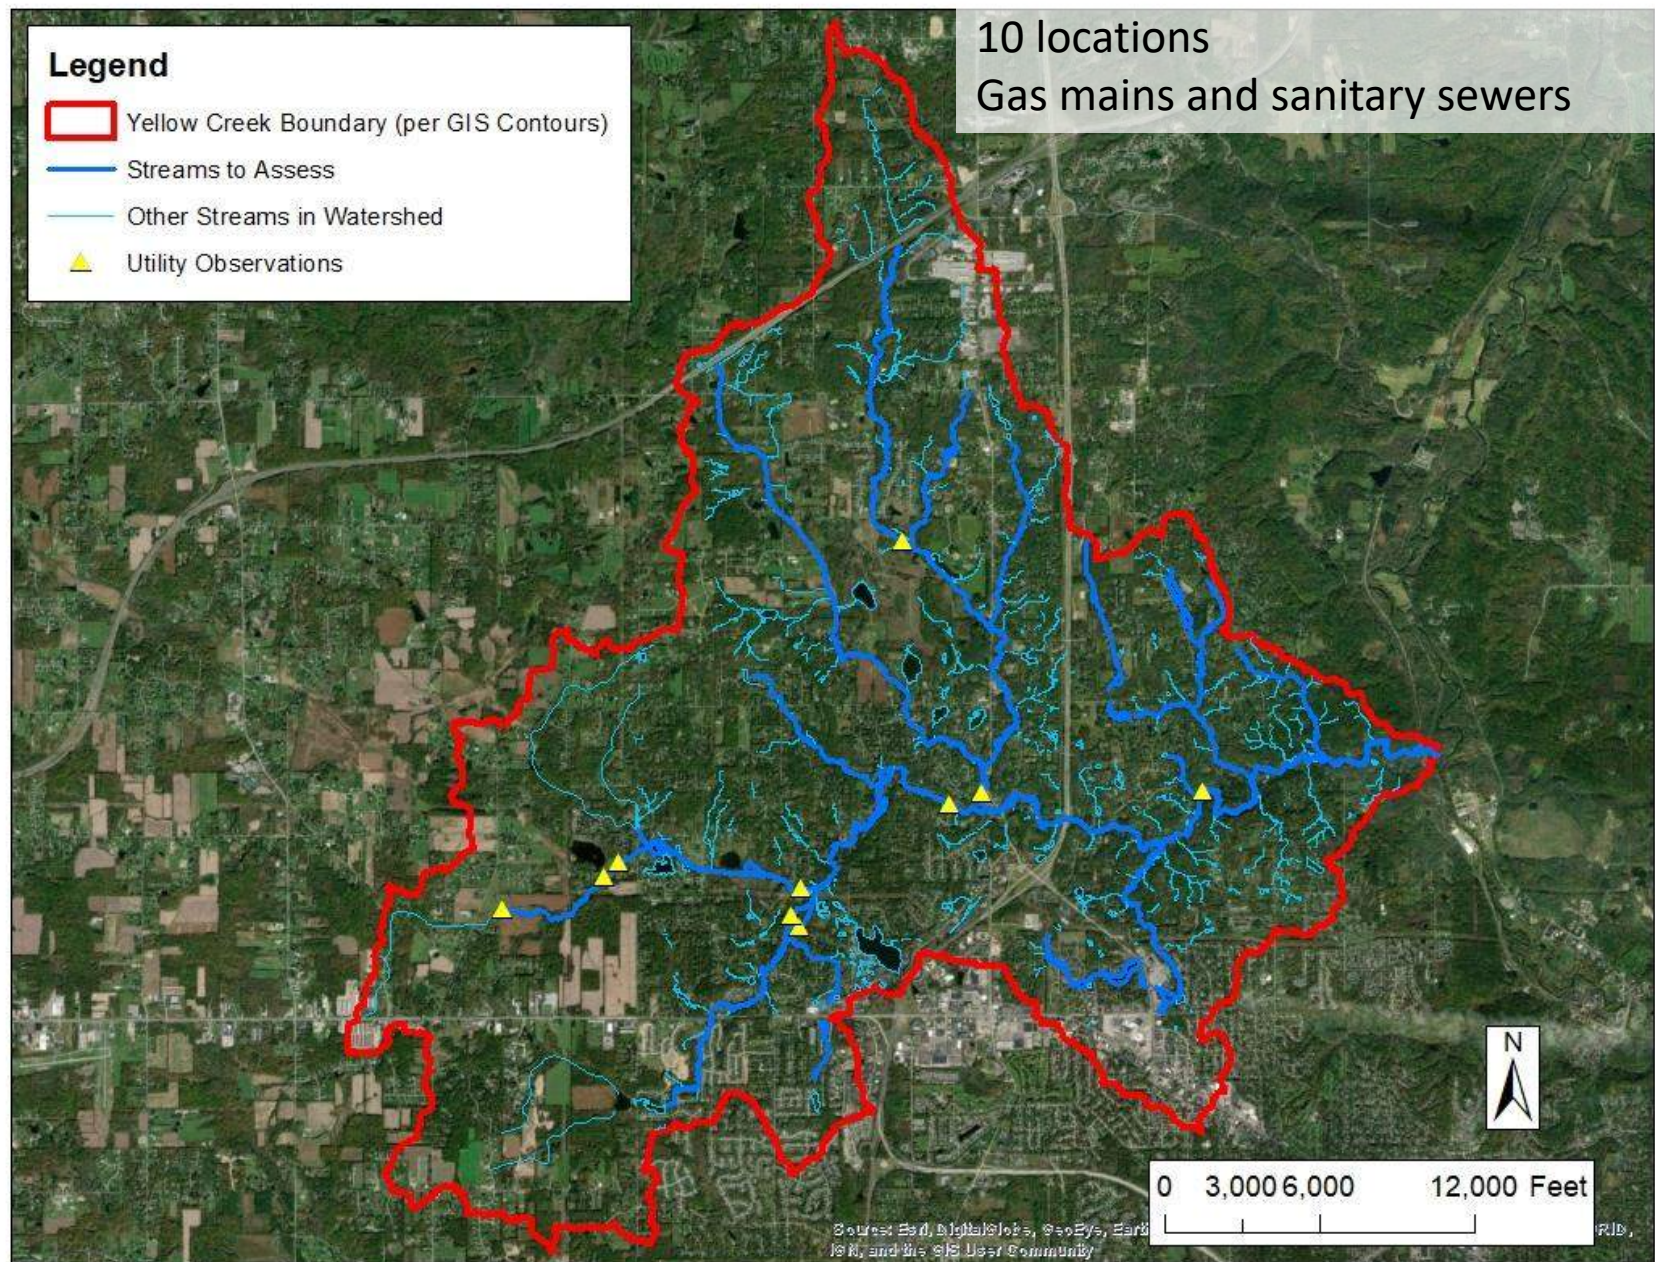
Figure A15. Utility observations  
Note: This is not an exhaustive list of utilities in the vicinity of streams in the watershed.

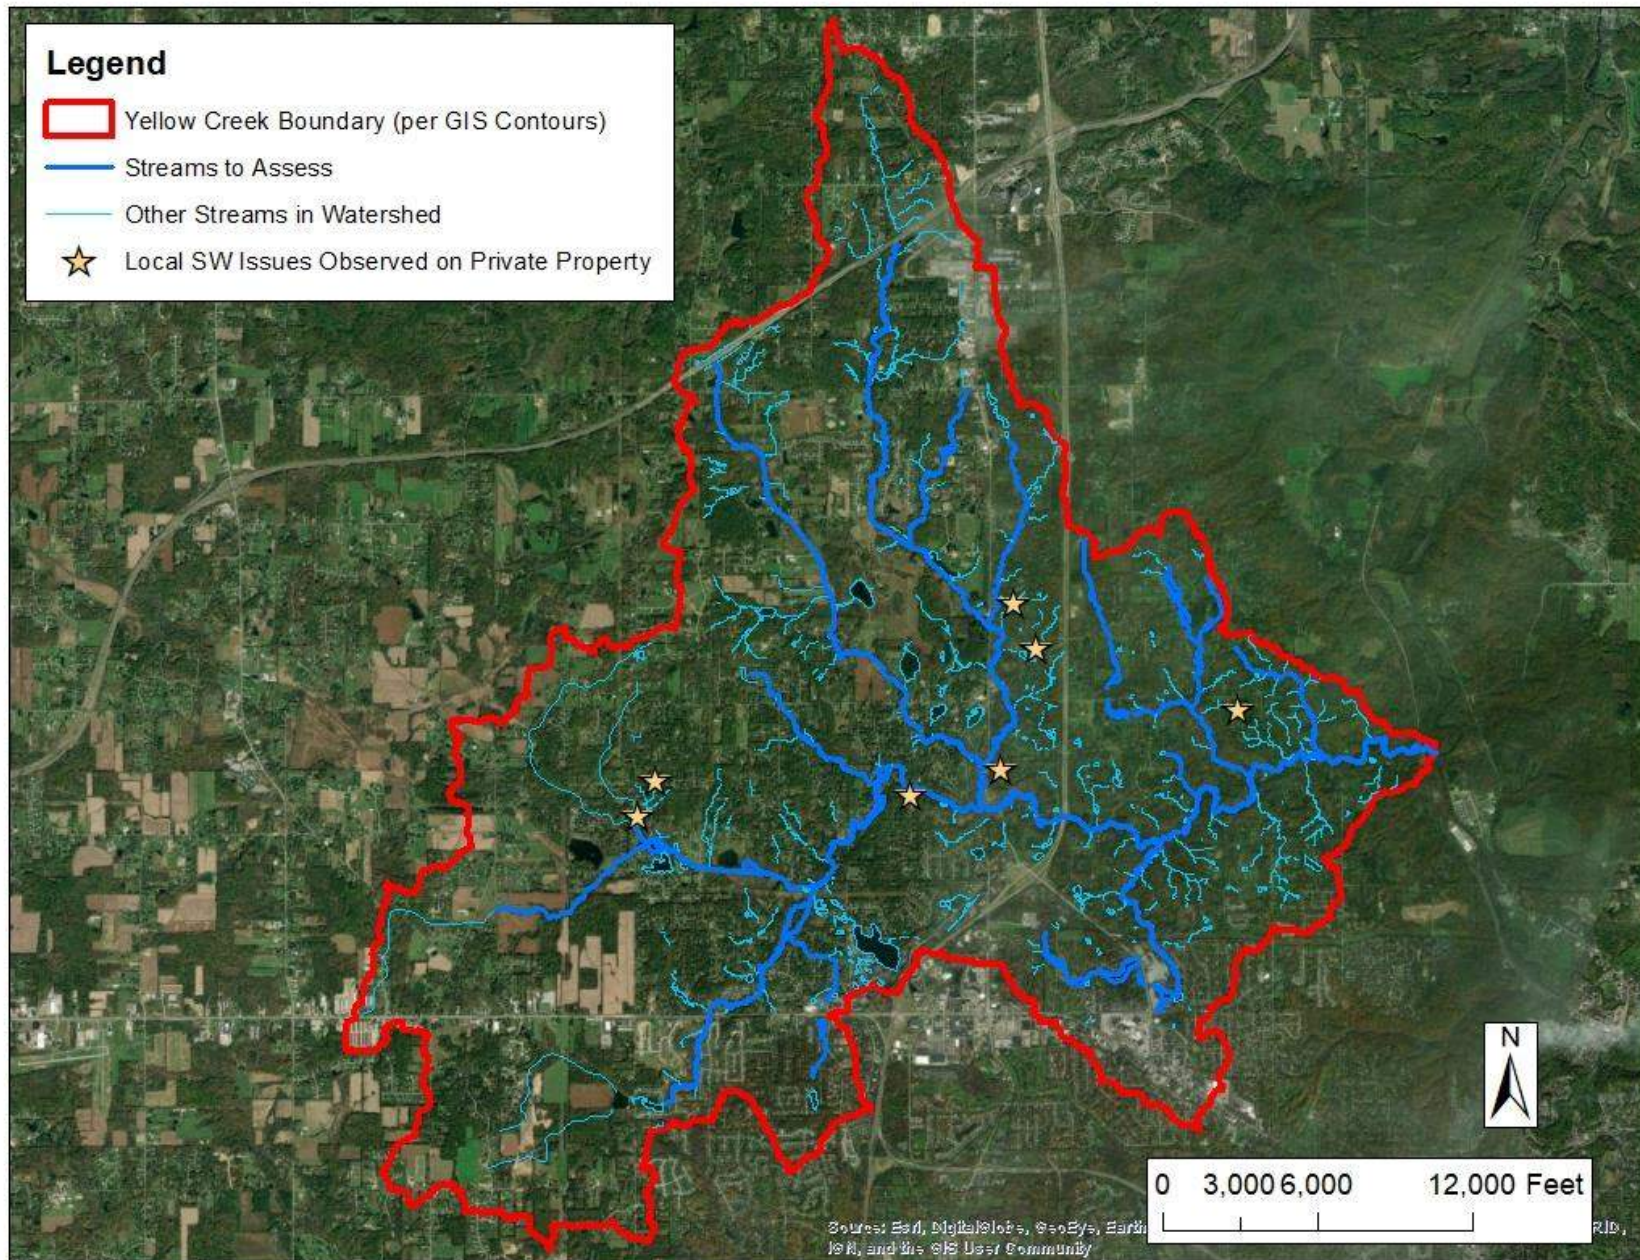
Figure A18. Local stormwater issues observed on private property in the watershed  
Note: This is not an exhaustive list of all stormwater issues in the watershed.

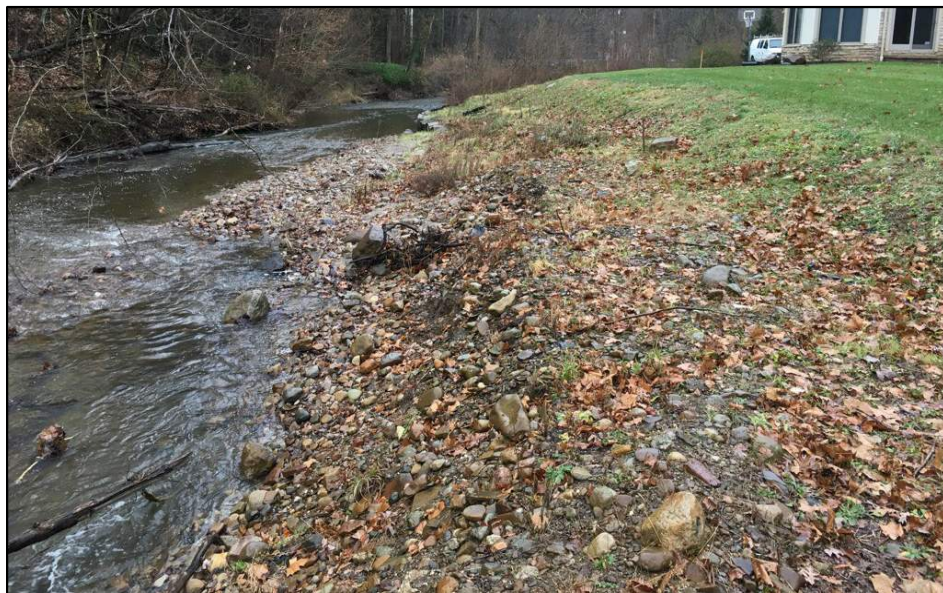
Notes: Slope is flatter (<1%) with large bars of rounded material. The fact that the pebble count riffle was submerged and had macroinvertebrates on 32s (d50) suggests hiding (less frequent mobility than the Qc estimate associated with this riffle slope (9%) would suggest). This warranted using the downstream riffle slope, which was associated with a Qc estimate (39% of Q2) that was more consistent with the regional Qc estimate (~40% of Q2).

Figure C5: Looking downstream near cross section location

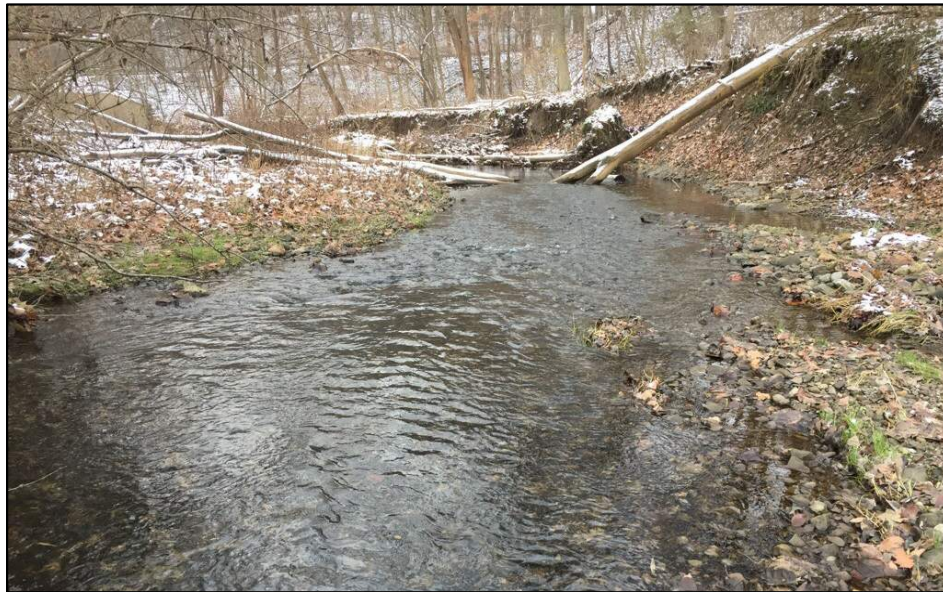
Notes: Slope is flatter (<1%). Macroinvertebrates on d20 suggests hiding behind d50s. Qc associated with d50 seems appropriate.

Figure C9: Looking downstream from cross section location

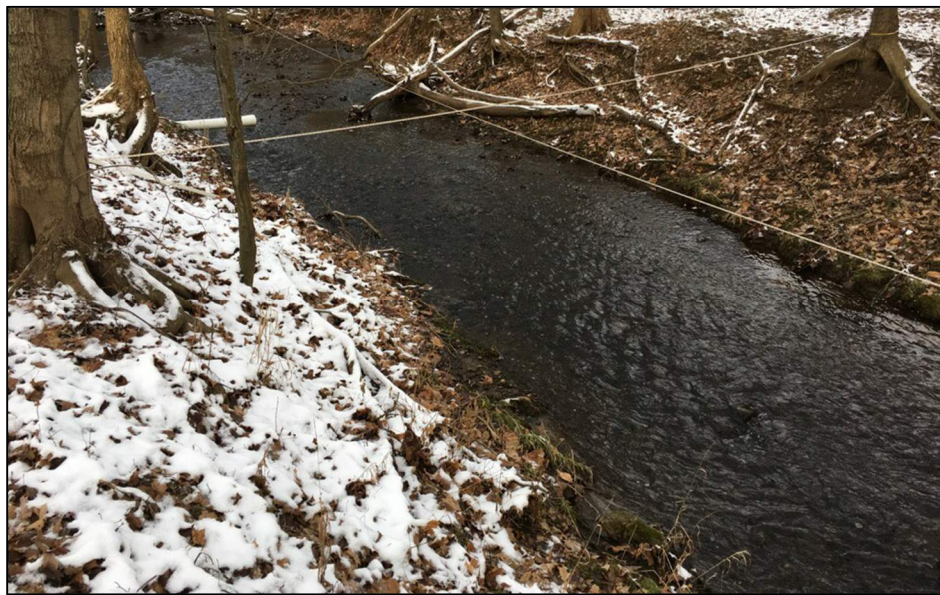
Notes: Slope is flatter (<1%). Macroinvertebrates only on 64s, which corresponds to d95. Site could be entering a depositional valley, making its pebble count skewed to the finer end (i.e. perhaps it's downstream of a steeper knickpoint zone). Qc associated with d84 (38% of Q2) is more appropriate than Qc associated with d50 (9% of Q2).

Figure C13: Looking upstream. Cross section tape visible.

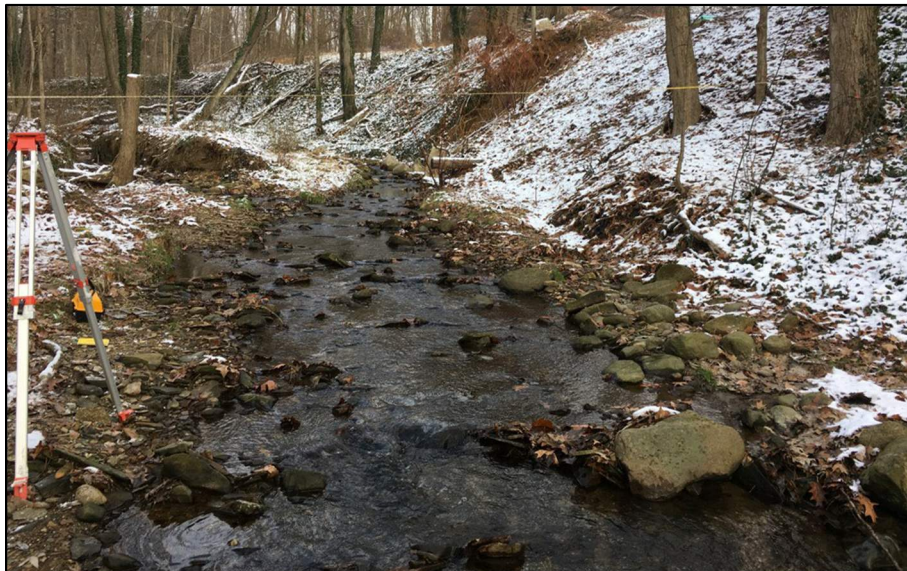
Notes: Slope is moderate (2%), with lots of incision evident in upstream reaches. No macroinvertebrates reported, but this reach could dry out (small watershed). Qc values are probably representative of how infrequent d84 moves and how frequent particles that aren't hiding move, but true Qc is probably more associated with d65 on a transitional reach like this (between a pool-riffle (relatively flat) and step-pool (steeper) profile form).

Figure C21: Looking upstream. Cross section tape visible.

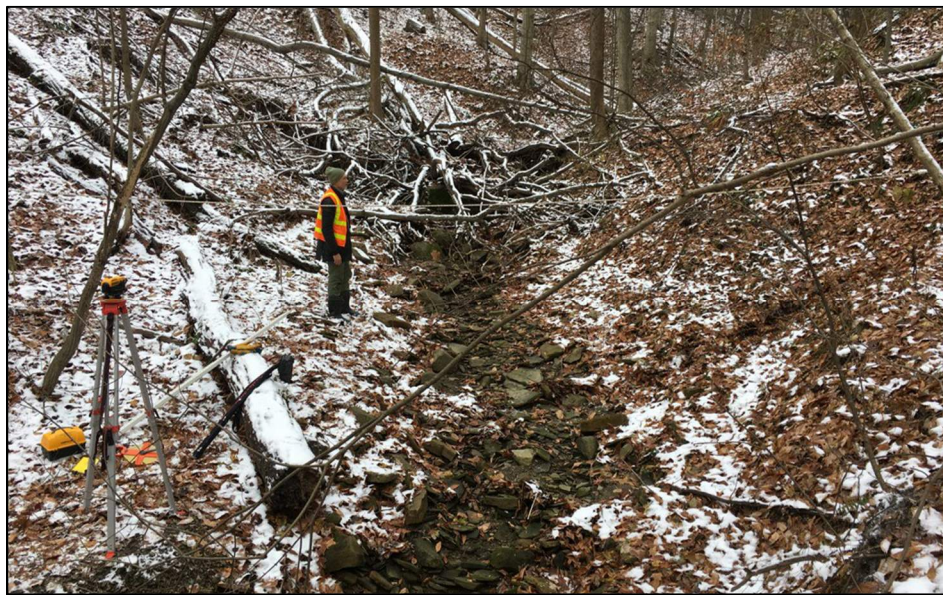
Figure C25: Looking upstream. Cross section tape visible.

Notes: Slope is steep (~6%). Site is in a confined valley with coarse bed and a decent bench. Bed material sample associated with more of a riffle than a step, which was also somewhat protected by the downstream grade control provided by the culvert, so the Qc associated with d50 is appropriate.

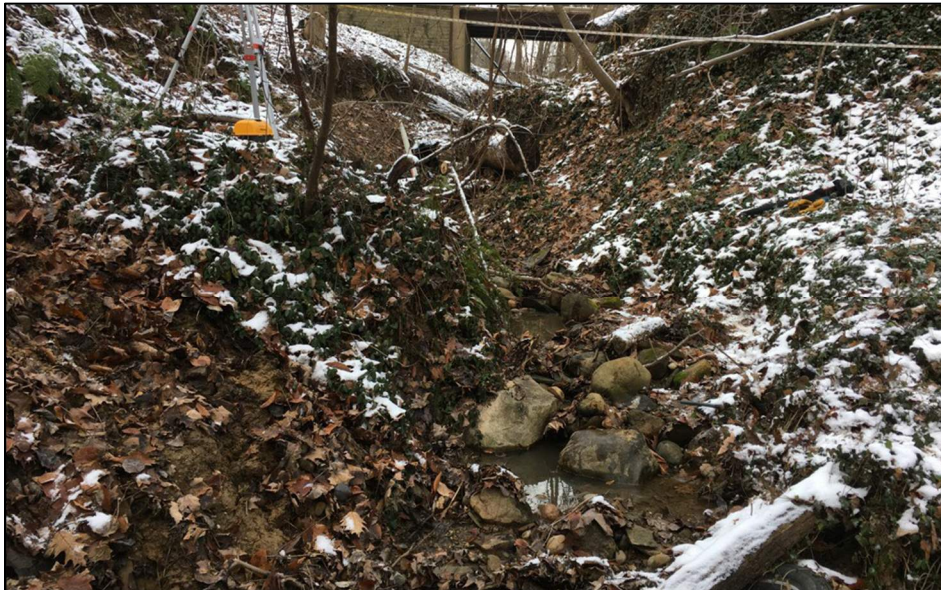
Figure C30: Looking upstream. Cross section tape visible.

Notes: Slope is very steep (10-15%) and highly unstable. There was not much of a representative bed material to count, but this riffle was somewhat protected by a downstream step, so d50 may be somewhat representative.
