# APPENDIX A

## Yellow Creek Watershed Maps

**HIGH INFILTRATION AREA PROTECTION**  
**BATH CENTER CEMETERY FOREST PRESERVATION**  
 BATH TOWNSHIP DRAINAGE BASIN IMPROVEMENT  
 SUMMIT COUNTY SURFACE WATER MANAGEMENT DISTRICT

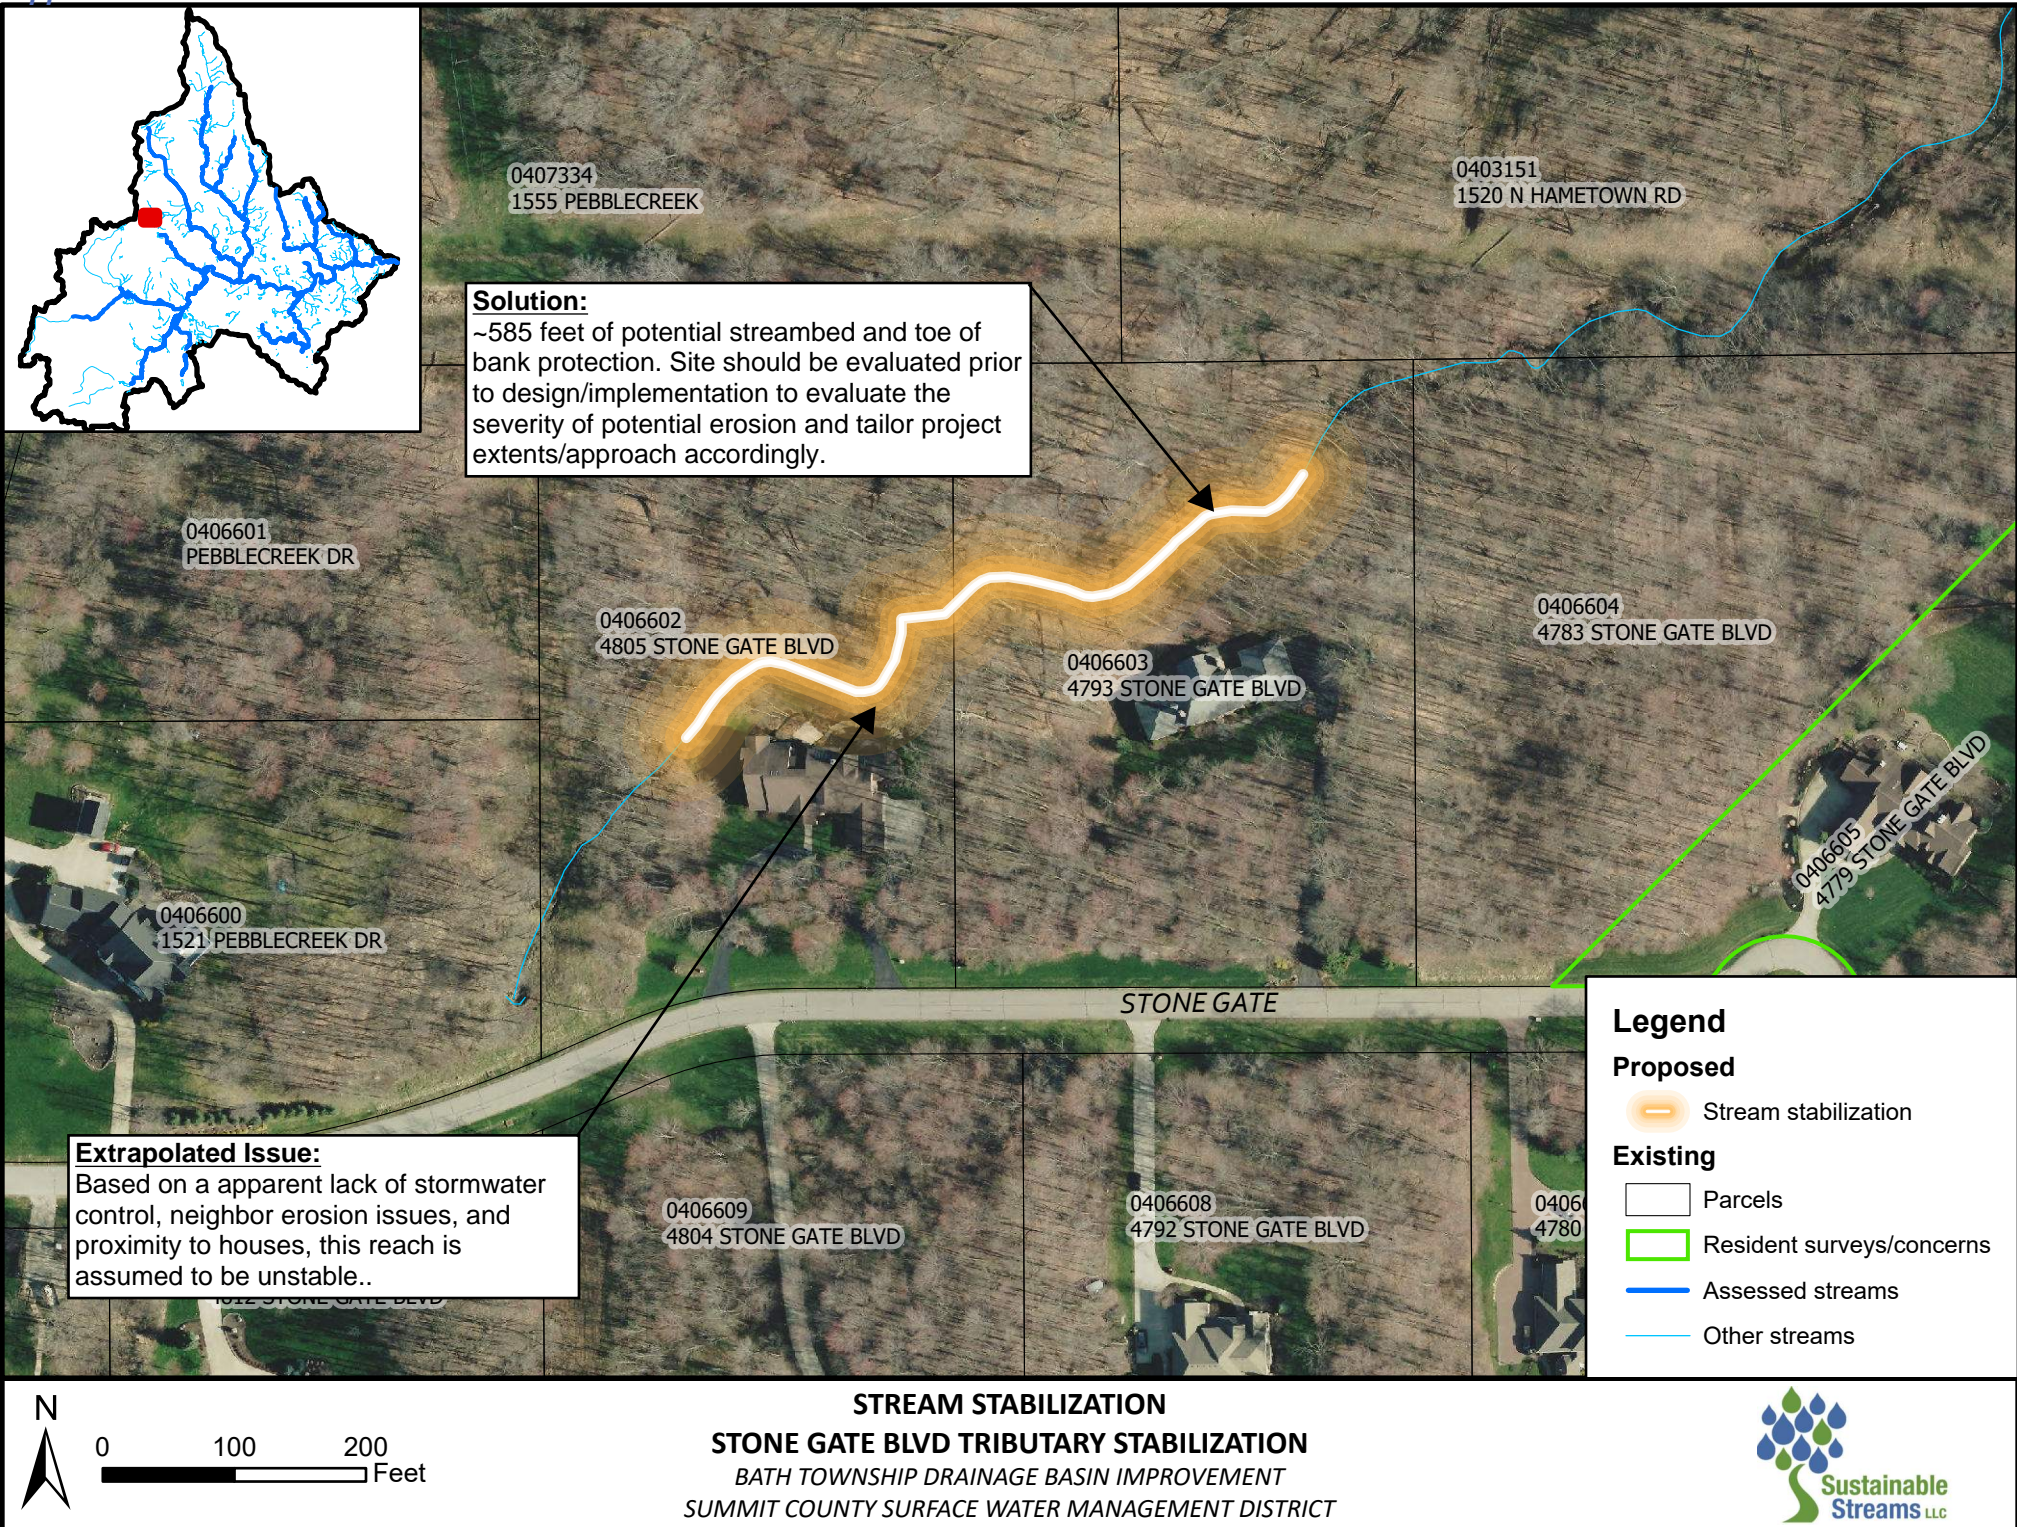
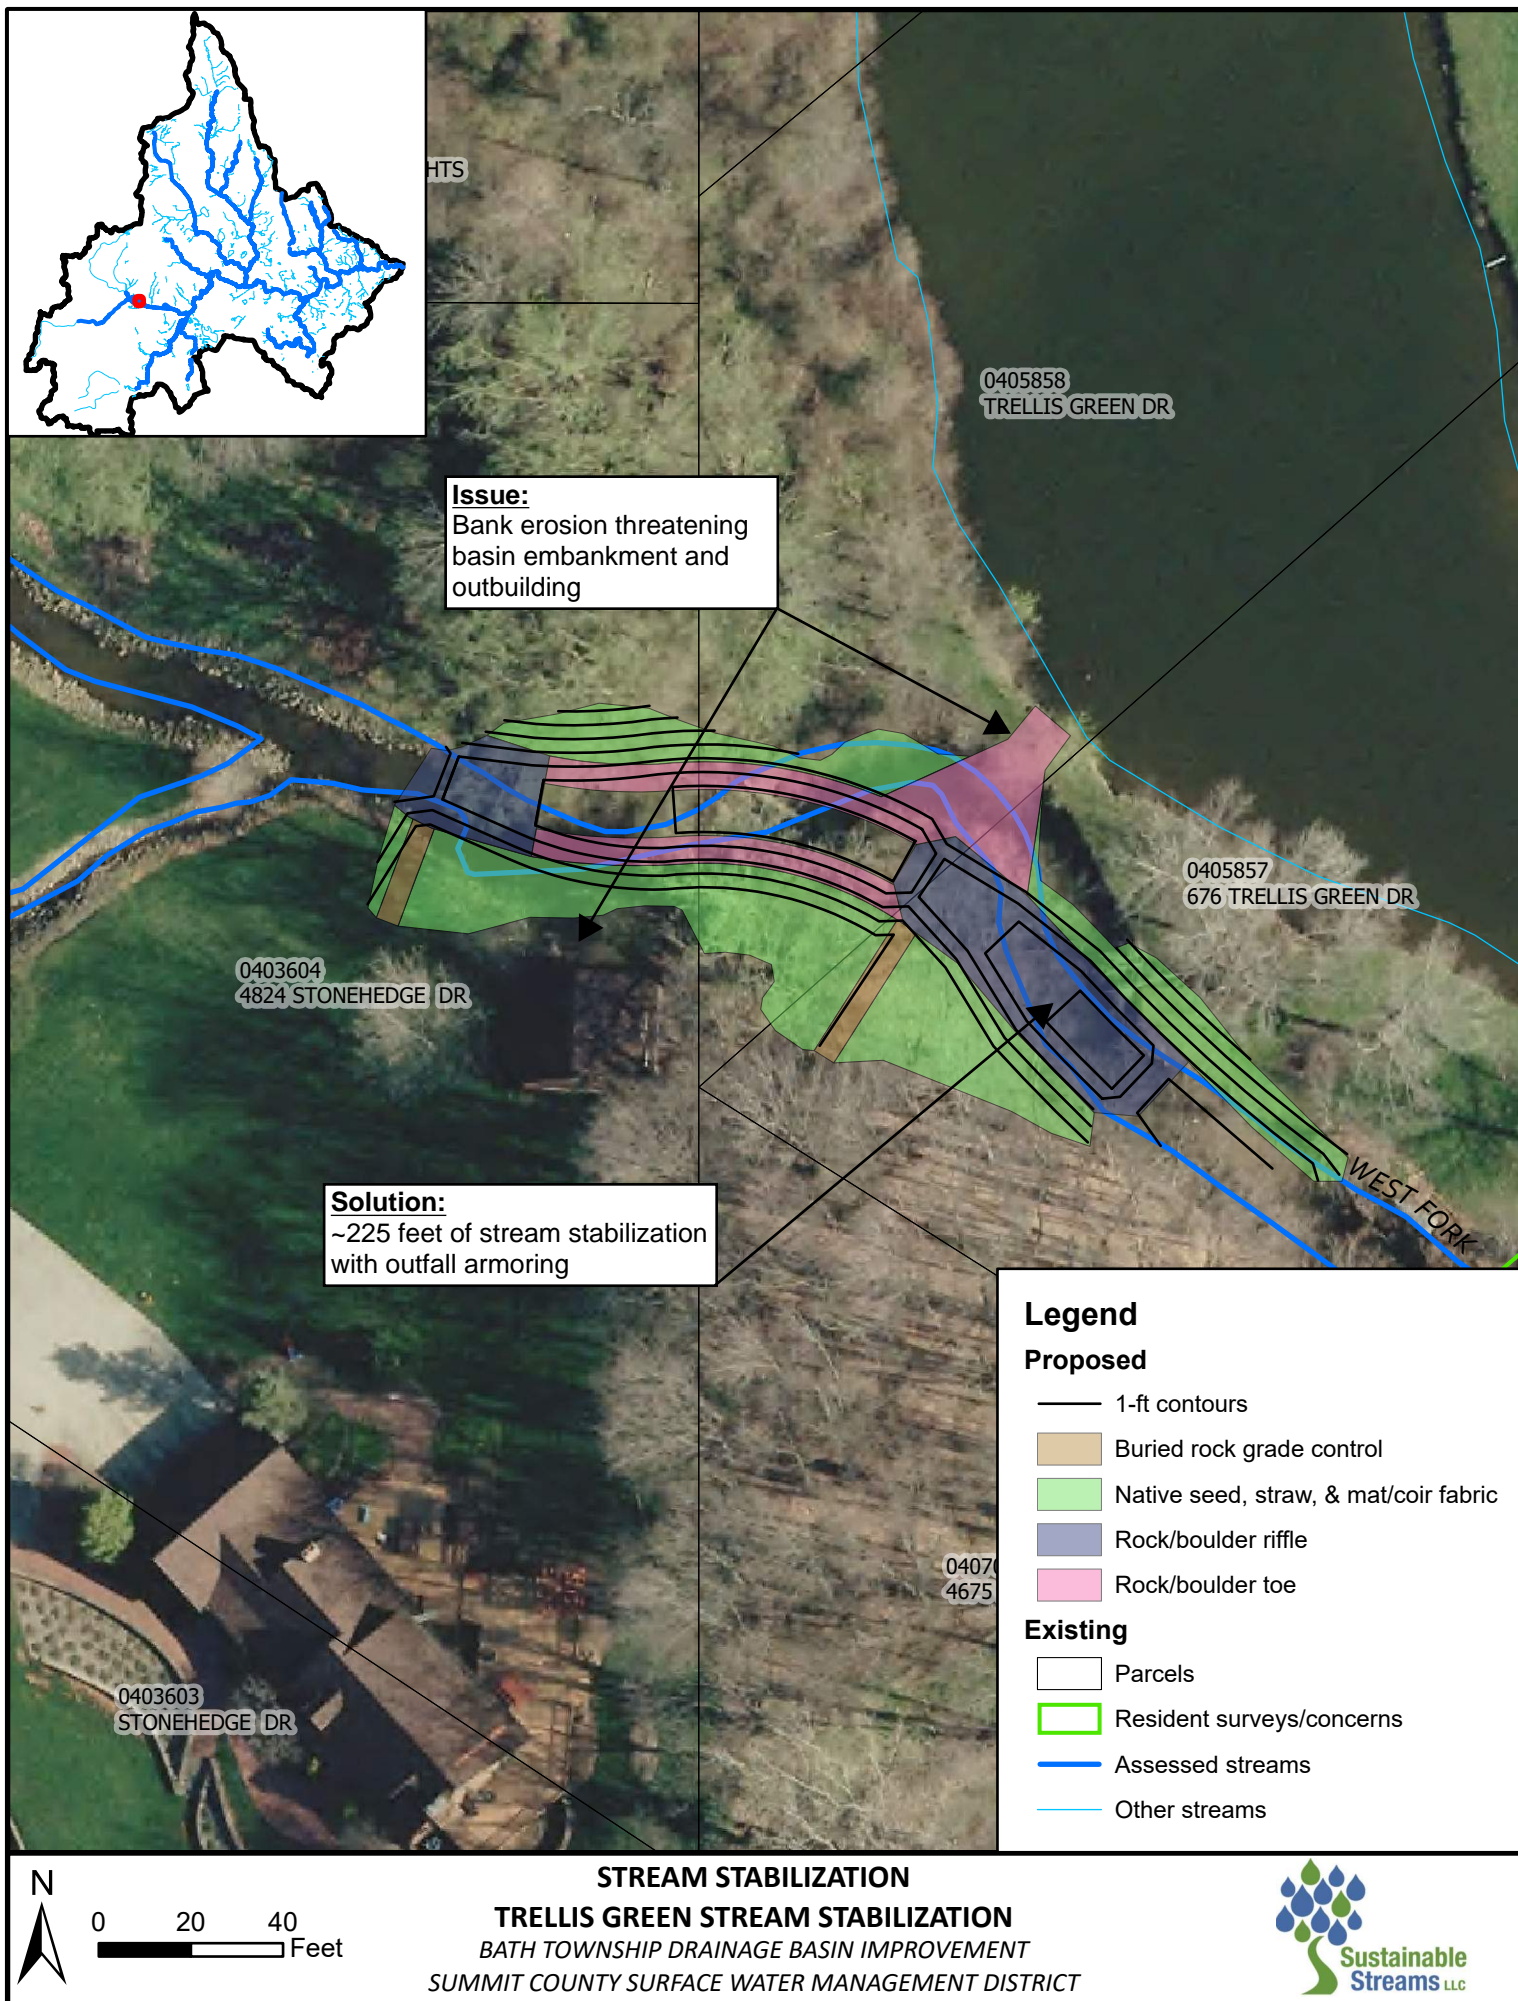
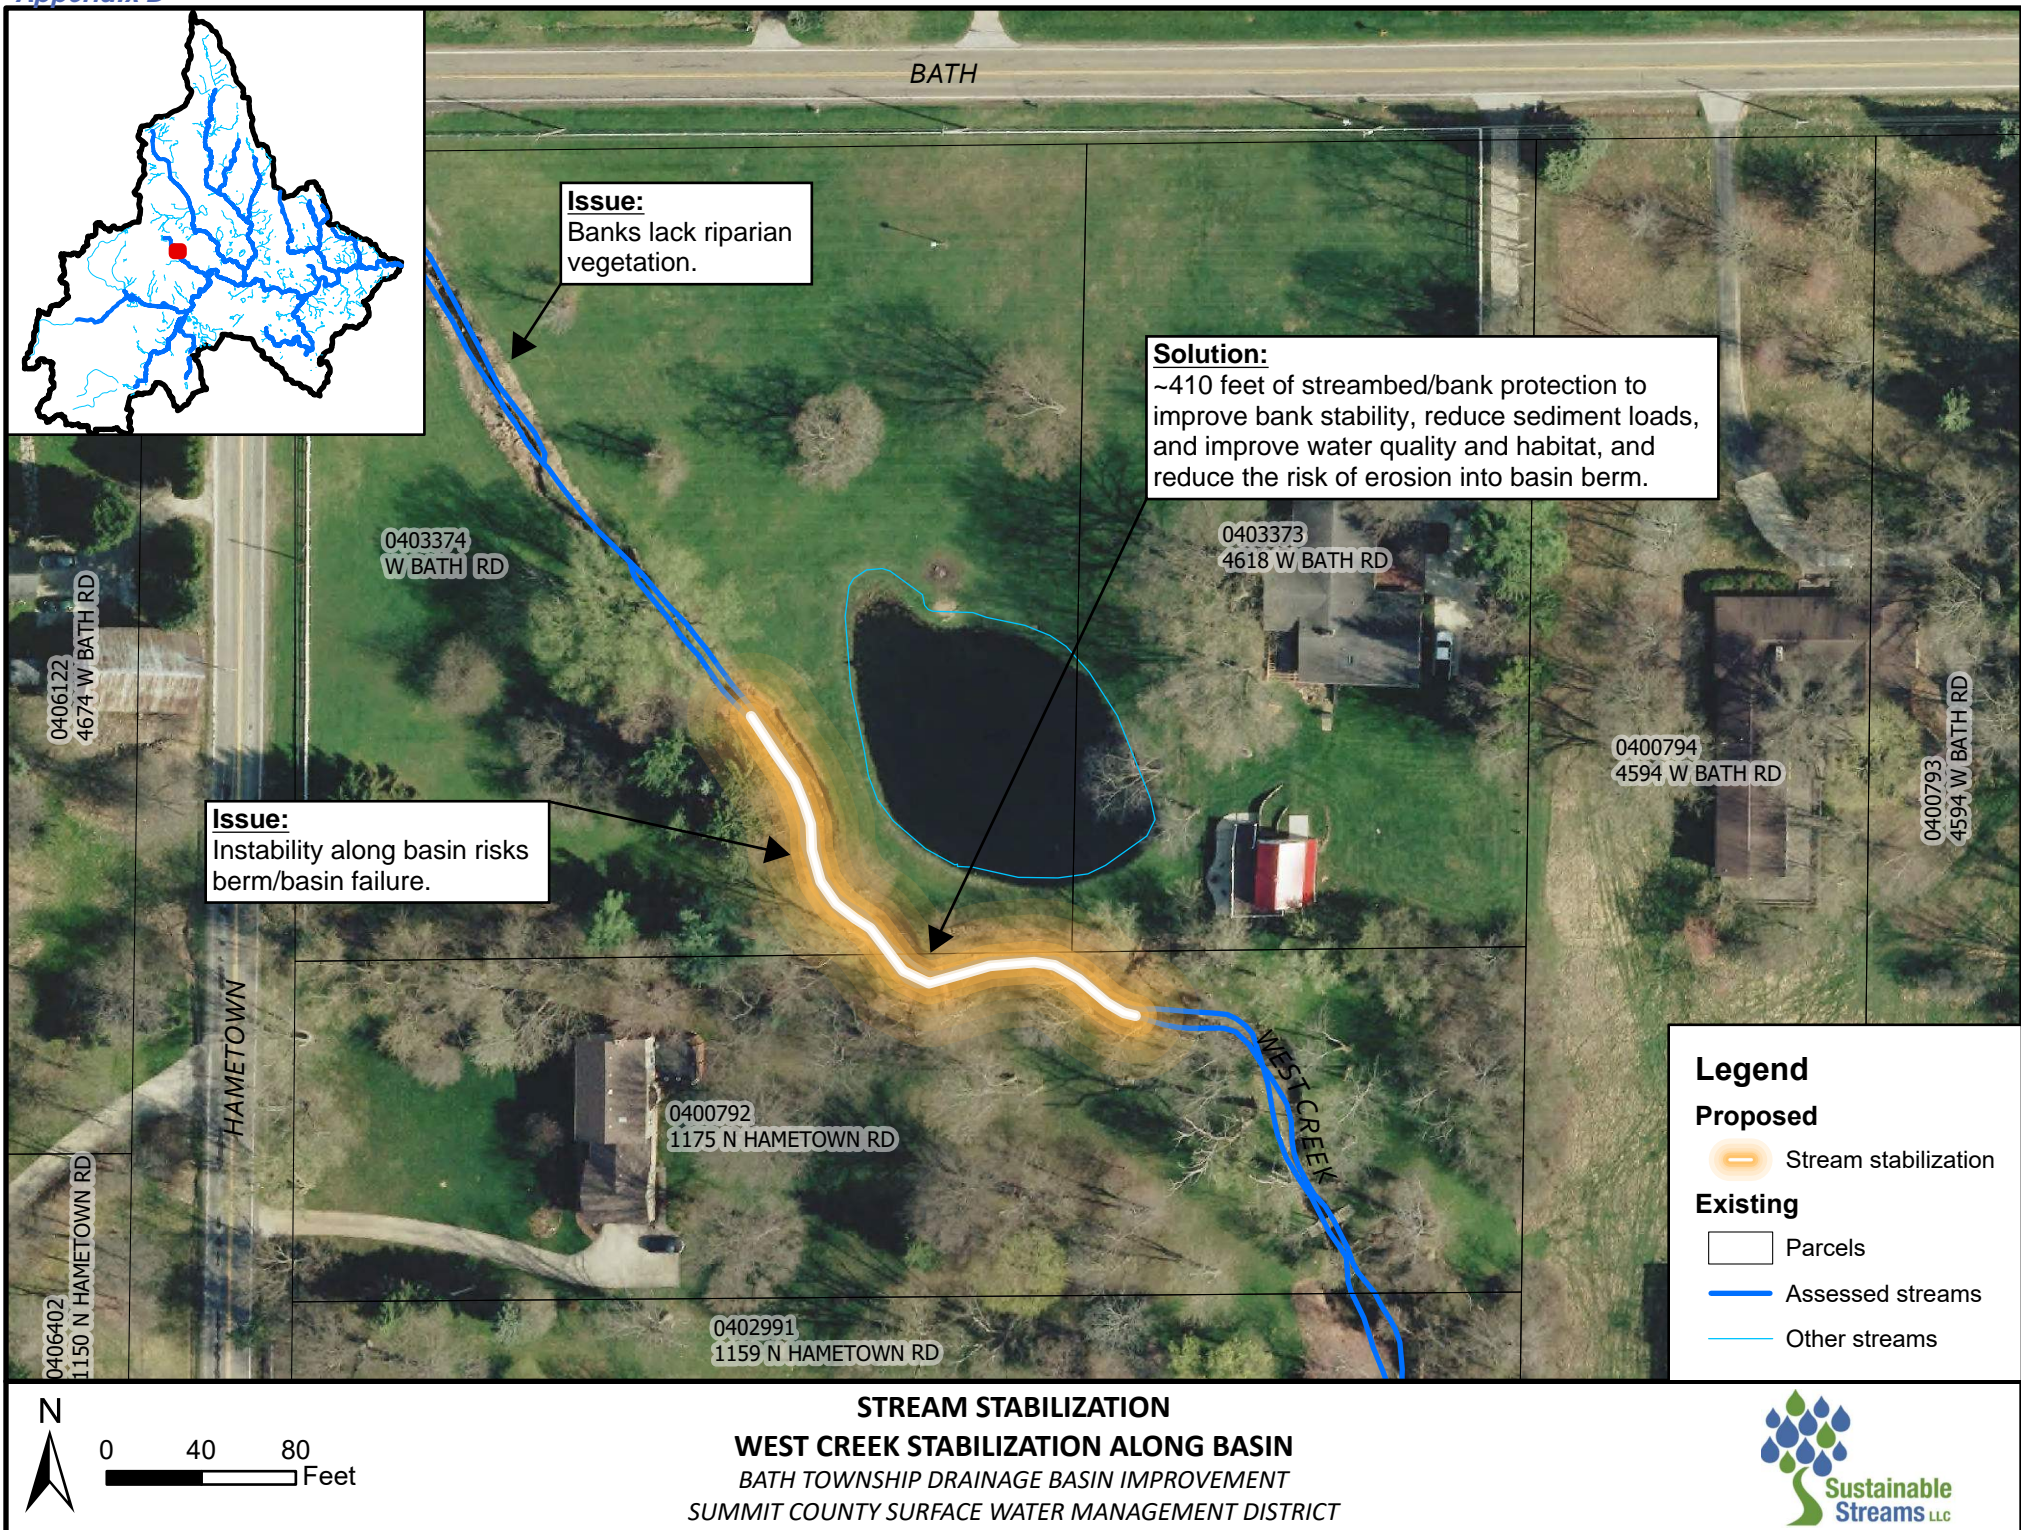
**STREAM STABILIZATION  
STABILIZATION NEAR WWTP**  
BATH TOWNSHIP DRAINAGE BASIN IMPROVEMENT  
SUMMIT COUNTY SURFACE WATER MANAGEMENT DISTRICT

**Issue:**

Numerous properties appear to be built on fill with steep embankments immediately adjacent to a stream. The instability may have been prevented with alternative subdivision planning that, for example, included wider stream buffers and avoided fills in floodplains.

**Solution:**

~1,000 feet of stream restoration to improve habitat and stream stability and reduce the risk of future erosion along the toe of slope adjacent to houses and sheds.

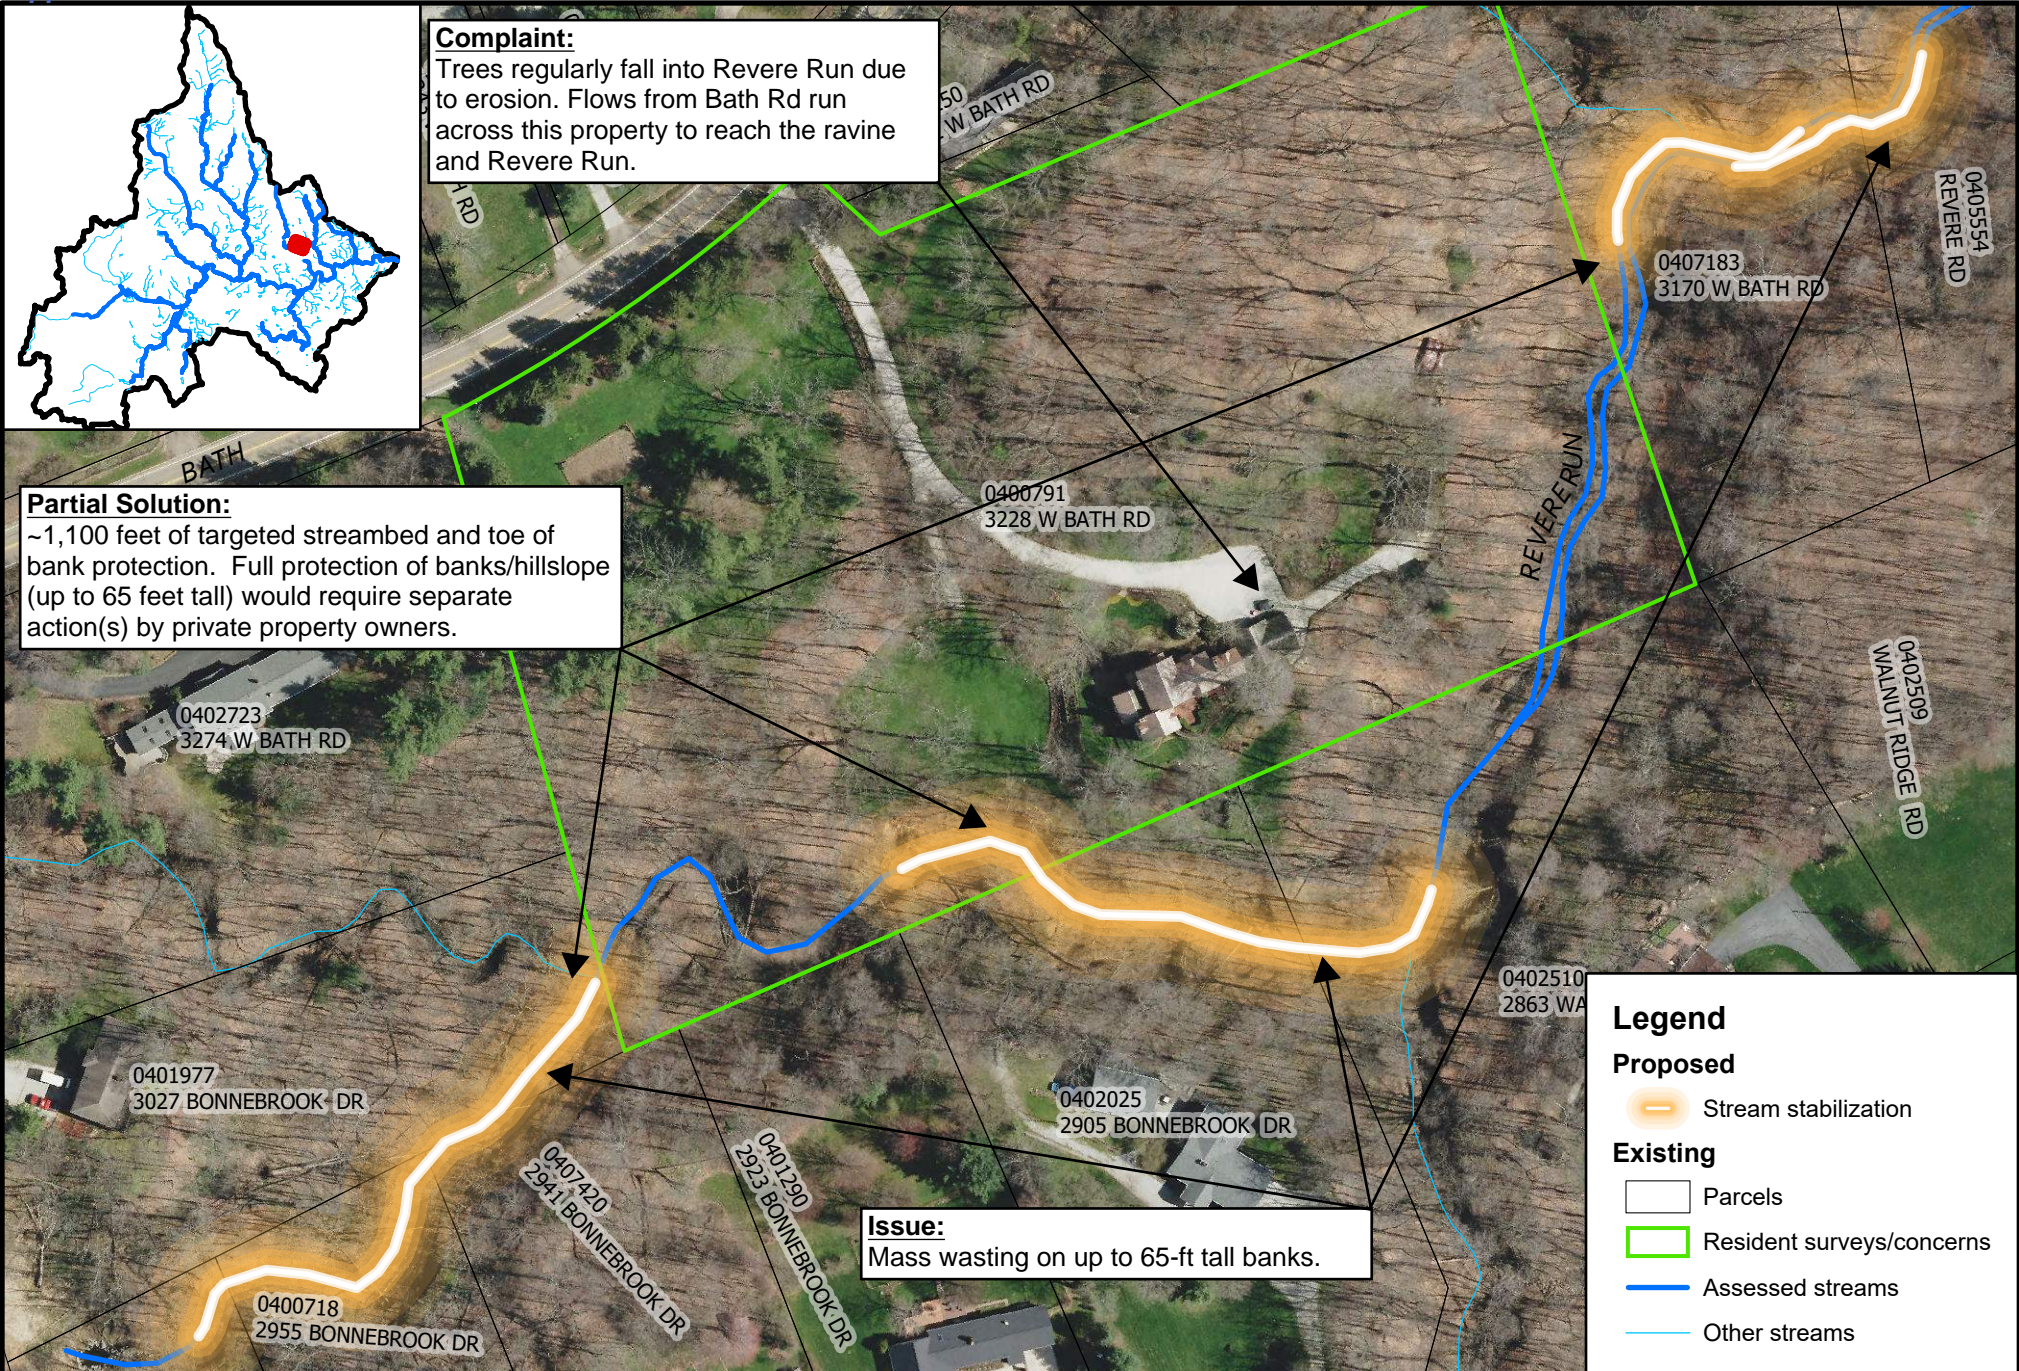
**STREAM STABILIZATION**  
**REVERE RUN SELECT STREAM STABILIZATION**  
 BATH TOWNSHIP DRAINAGE BASIN IMPROVEMENT  
 SUMMIT COUNTY SURFACE WATER MANAGEMENT DISTRICT

**Complaint:**

Trees regularly fall into Revere Run due to erosion. Flows from Bath Rd run across this property to reach the ravine and Revere Run.

**Partial Solution:**

~1,100 feet of targeted streambed and toe of bank protection. Full protection of banks/hillslope (up to 65 feet tall) would require separate action(s) by private property owners.

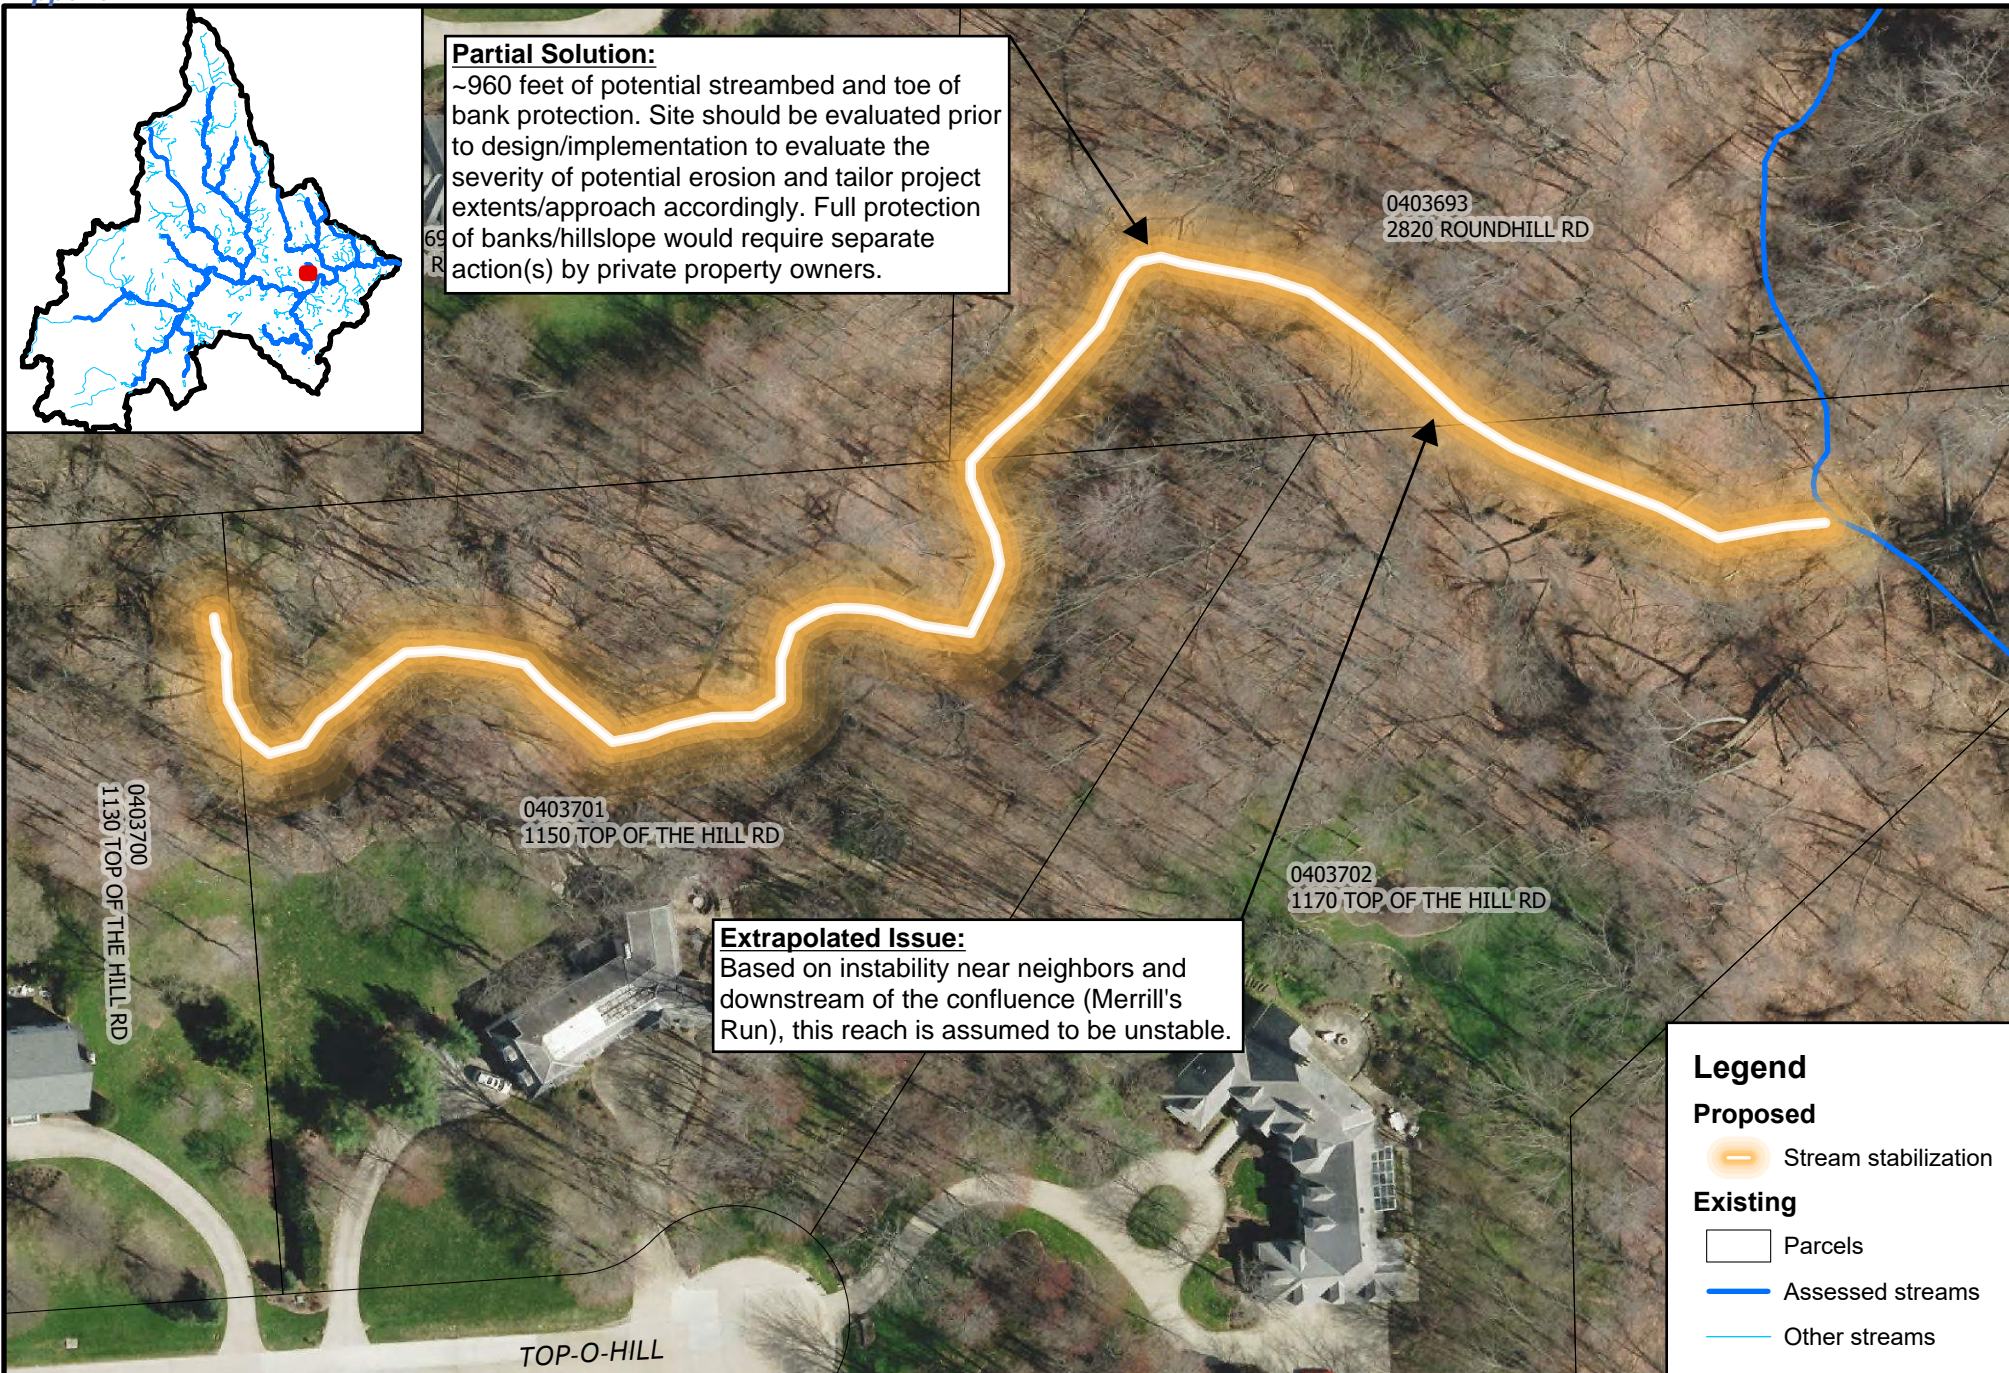
**STREAM STABILIZATION**  
**TOP OF THE HILL NORTH TRIBUTARY STABILIZATION**  
 BATH TOWNSHIP DRAINAGE BASIN IMPROVEMENT  
 SUMMIT COUNTY SURFACE WATER MANAGEMENT DISTRICT

**Extrapolated Issue:**

Based on instability near neighbors and downstream of the confluence (Merrill's Run), this reach is assumed to be unstable.

**Partial Solution:**

~960 feet of potential streambed and toe of bank protection. Site should be evaluated prior to design/implementation to evaluate the severity of potential erosion and tailor project extents/approach accordingly. Full protection of banks/hillslope would require separate action(s) by private property owners.

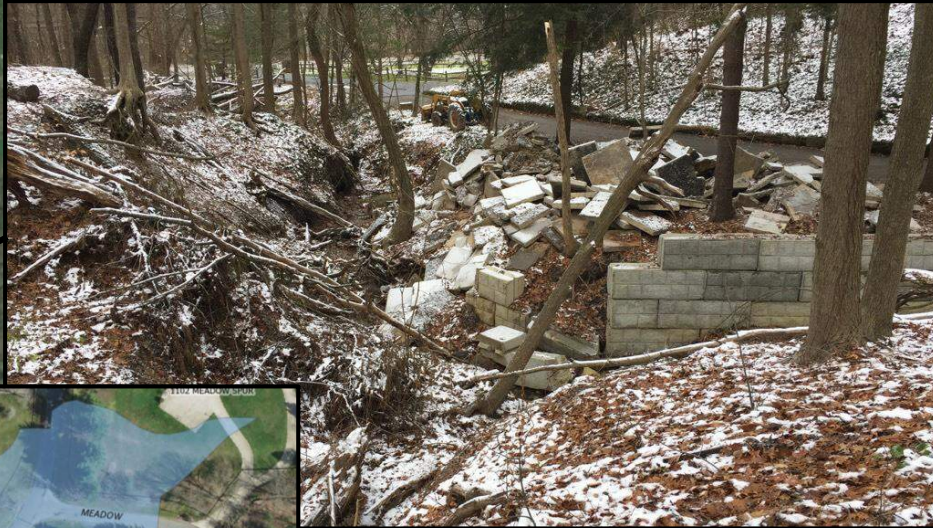
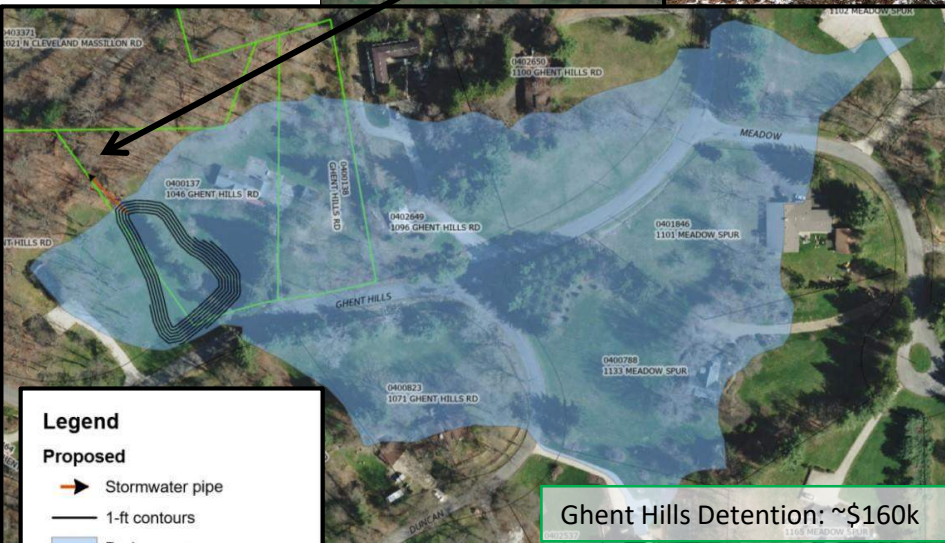
Eroding ravine next to driveway of ~1019/1021 N. Cleveland Massillon Rd.
