2023 Routine Bridge Inspection Report

North Main Street High Level Bridge

SUM-M008-00908
SFN: 7730306

October 19, 2023

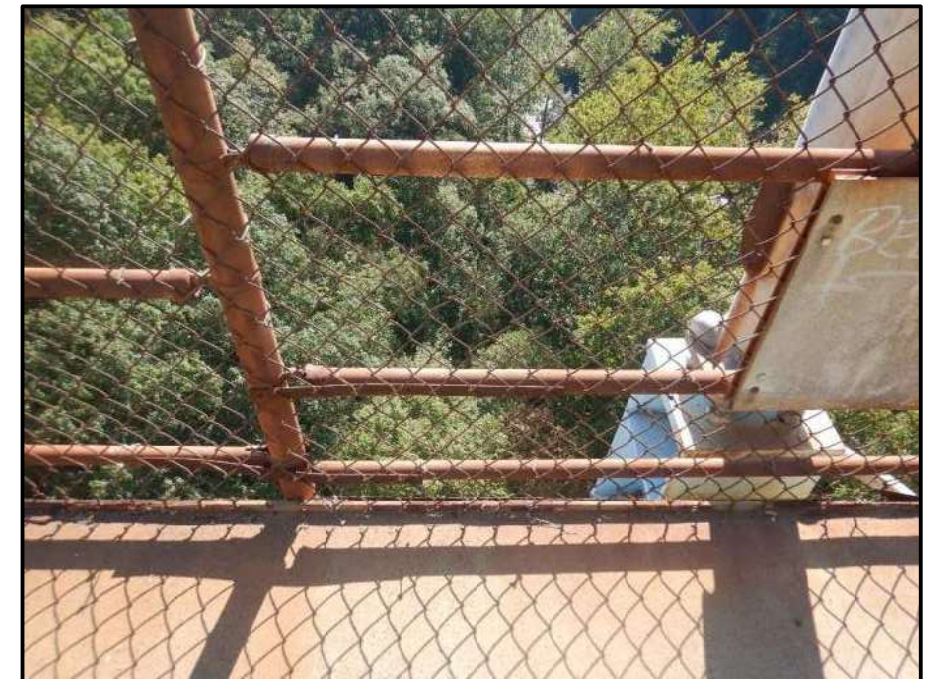
- The bridge railing exhibits light surface corrosion along the full length of both railings **(photo 3)**. No change from previous inspection.
- Very minor, isolated collision damage exists along the bridge railing and is heaviest on the east railing of span 2. No change from previous inspection.
- The east pedestrian fence posts exhibit heavy corrosion with multiple locations of 100% section loss **(photo 4)**. At some locations where heavy corrosion exists in the pedestrian fencing, steel plates were recently fastened to the horizontal pipes by county maintenance to stiffen the loose components. Most of the repairs were functioning at the time of inspection **(photo 5)**. Loose areas of the chain-link fence should be checked for during future inspections for safety.

Photo 4 – Looking east at east pedestrian fence in span 3. Note: typical through holes in ends of horizontal pipes for fence.

- Continue to repair the east pedestrian fence. **(Page 6)**
- Continue to repair the security fences at both abutments and on the south side of pier 2. **(Page 6)**
- Trim or remove the trees encroaching on the bridge at the northwest corner of the roadway and growing near the piers. **(Pages 6 and 15)**
- Seal the joints between the deck and sidewalk to prevent further deterioration. **(Page 7)**
- Continue to patch areas of spalling or delaminated concrete in the approach slabs and bridge deck. **(Pages 7 and 16)**
- Clean/remove debris from the strip seal expansion joints **(Page 8)** and from inside the bearings at piers 1 and 2 to promote proper drainage through the drilled holes. **(Page 14)**
- Remove inactive bird nest at the east end of the catwalk at panel point 17. **(Page 6)**

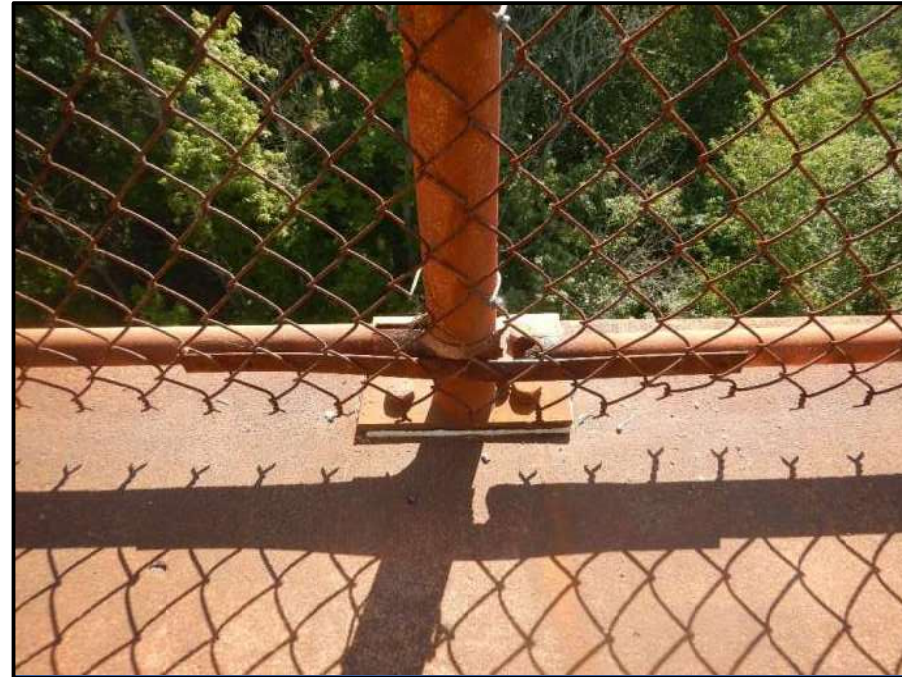
Photo 5 – Looking east at east pedestrian fence base connection in span 3. Note: steel longitudinal retainer plate repair due to previous heavy corrosion.

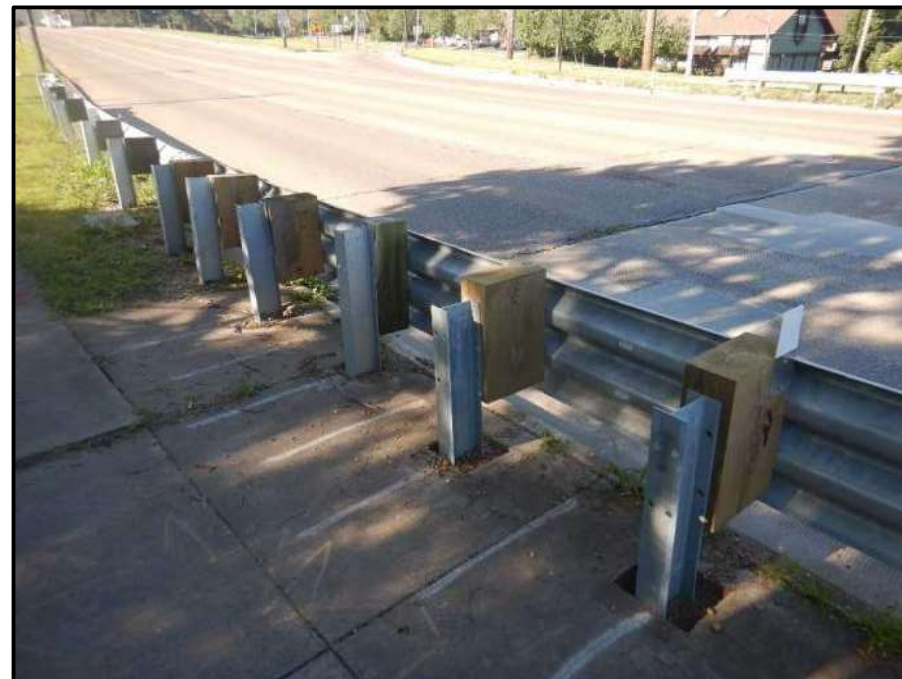
- New W-beam guardrail and steel (previously timber) posts have been installed at both the rear and forward approaches. No significant deficiencies exist in the approach railing **(photos 6 and 7)**.

Photo 6 – Looking southwest at newly installed approach guardrail along east side of the rear approach.

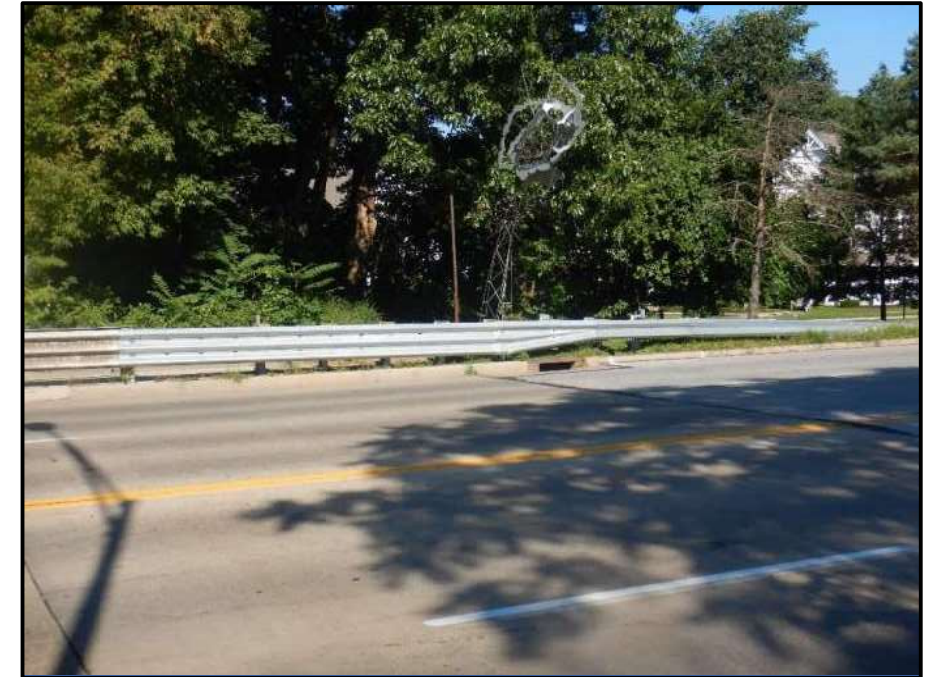
Photo 7 – Looking northwest at newly installed approach guardrail along west side of the forward approach.

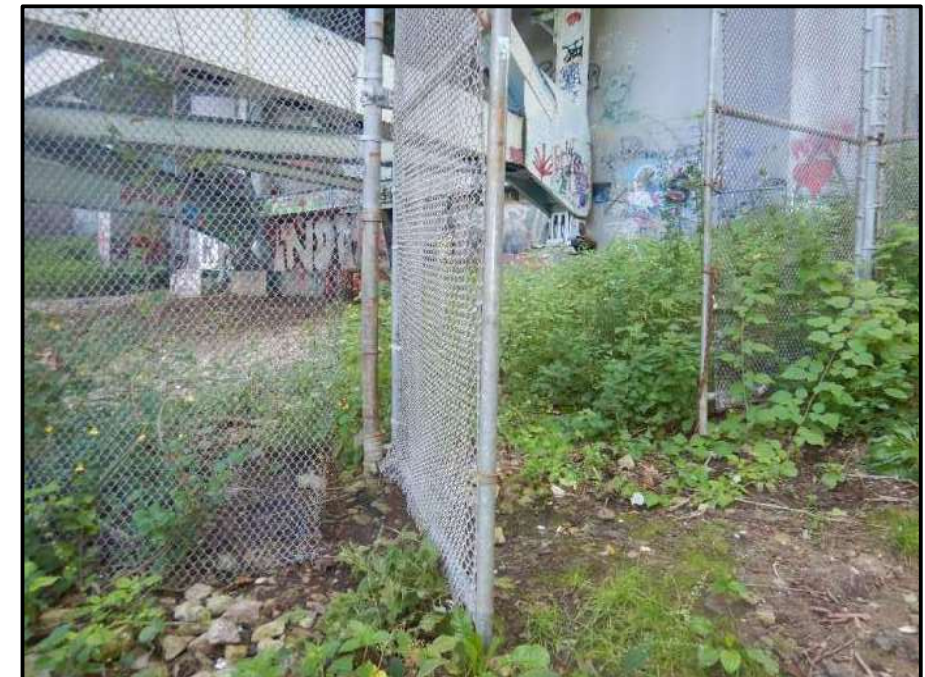
- The security fence is broken or damaged at the following locations: east and west side of the rear abutment **(photos 8 and 9)**; east side of the forward abutment **(photo 10)**, and the south end of pier 2. The damaged fence allows trespassers to access various locations of the bridge including the catwalk using ropes and makeshift ladders to reach the catwalk.

Photo 8 – Looking southeast at the hole in the fence adjacent to the gate, west side of the rear abutment.

- Replace the security fences at both abutments and on the south side of pier 2. **(Page 6)**
- Trim or remove the trees along east side of forward abutment slope. **(Page 6)**
- Replace the east pedestrian fence. **(Page 6)**
- Abrasively clean and spot paint areas of active corrosion and pack rust to steel superstructure members, especially under the joints and at the tie-down anchorages. **(Pages 8 thru 14)**
- Replace the two missing rivets with high strength bolts for the west U21 outboard gusset plate. **(Page 12)**
- Perform UT (Ultrasonic) Testing on the 6 pins at each abutment (12 total) by 2025 to keep testing on a 10 year cycle (last testing was performed in 2015). **(Page 14)**
- Repair and stabilize the embankment near the forward abutment with additional rip rap. **(Page 16)**

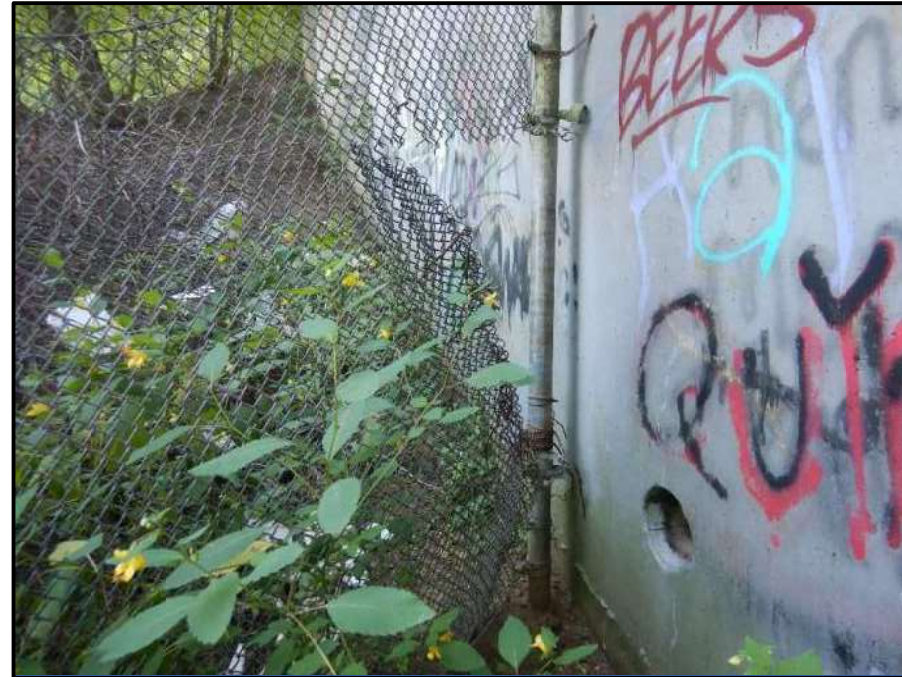
Photo 9 – Looking east at hole in the fence at the east side of the rear abutment.

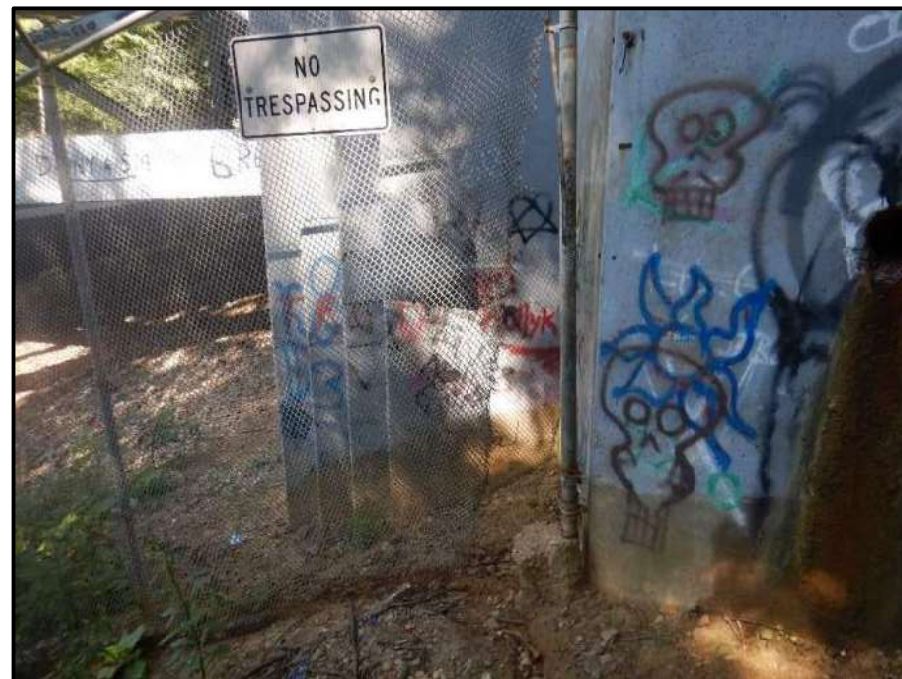
Photo 10 – Looking west at hole in the fence at the west end of the forward abutment.

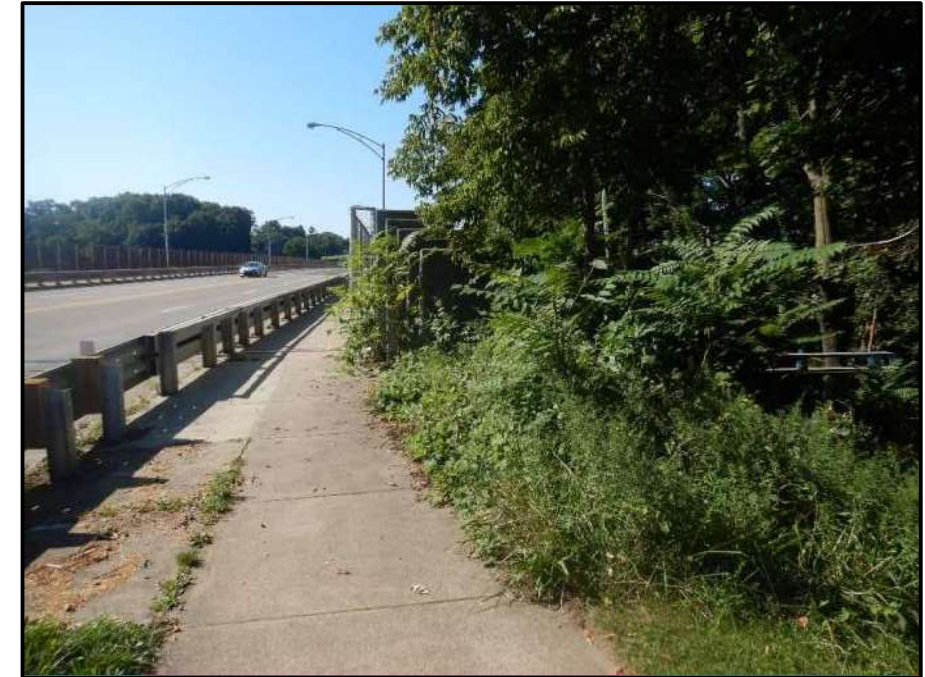
- Overgrown trees and vegetation exist at the northwest corner of the bridge over the forward abutment **(photo 11)**. The vegetation continues to grow and further encroach upon the sidewalk and closer to the roadway every inspection. Additionally, overgrown trees exist along the east side of the forward abutment slope.

Photo 11 – Looking south along the west side of the north end of the bridge. Note: overgrown trees onto sidewalk, no change.

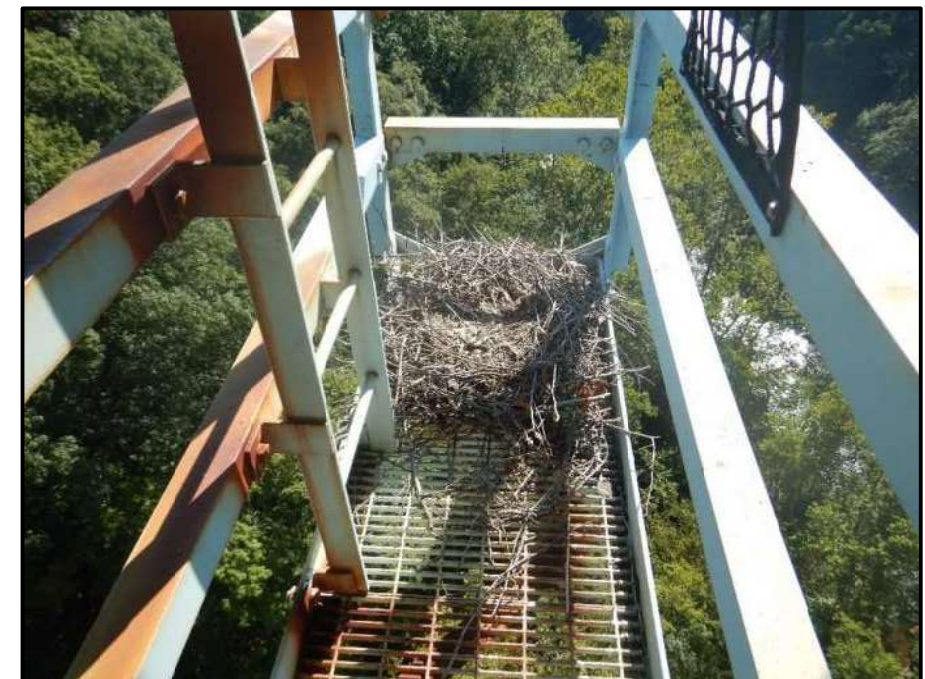
- A bird’s nest exists at the east end of the catwalk at panel point 17 **(photo 12)**. The nest is currently unoccupied and should be removed.

Photo 12 – Looking east at inactive bird's nest at east end of catwalk at panel point 17, span 2.

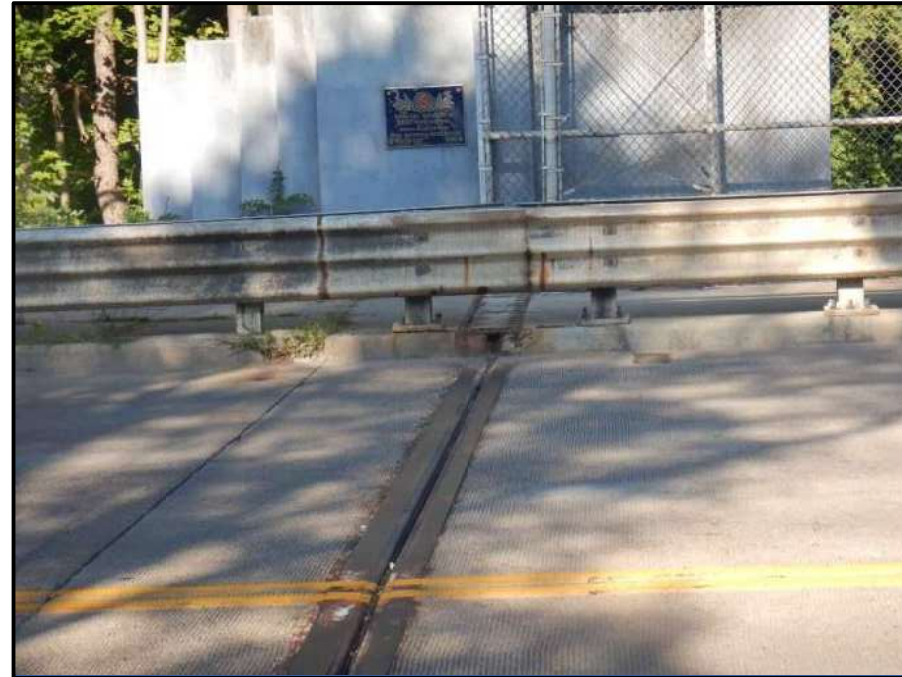
- The concrete curbs in spans 1 and 3 have minor spalls along the curb edges, especially along the expansion joint armor **(photo 13)**. Cracking in the curbs is isolated and is spaced approximately 5 feet apart with the heaviest cracking in span 1 near pier 1. No change from the previous inspection.

Photo 13 – Looking west at west end of rear abutment expansion joint at curb. Note: typical spall in curb at end of joint.

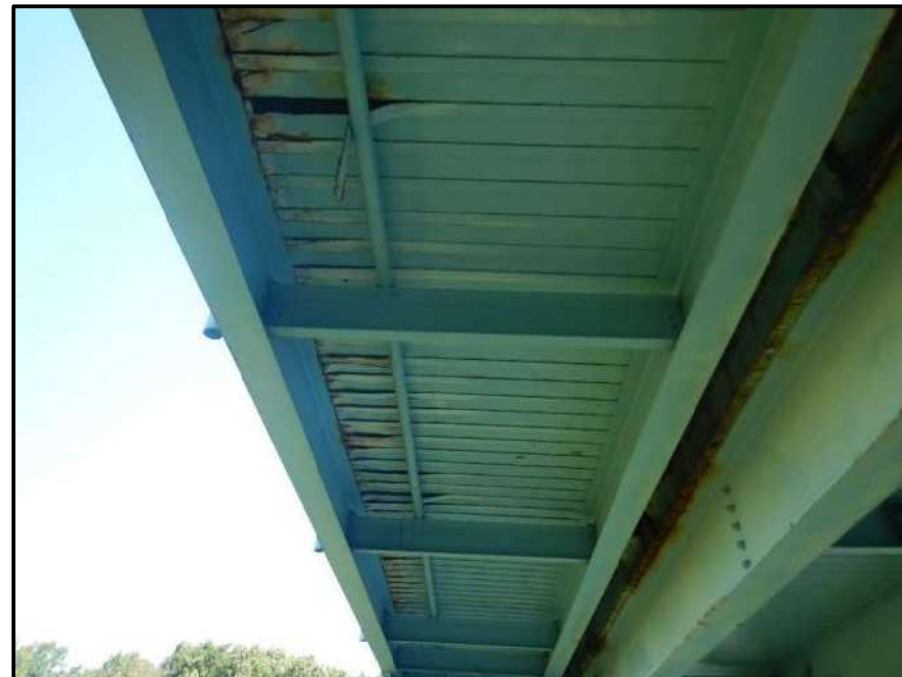
- The longitudinal joint along the curb line in span 2 between the deck and sidewalk leaks and is corroding the grid deck along the joint **(photo 14)**. This problem persists throughout Span 2 along both sidewalk joints. No change from previous inspection.

Photo 14 – Looking north under west sidewalk at steel SIP forms, span 2. Note: heavy corrosion and failing paint throughout.

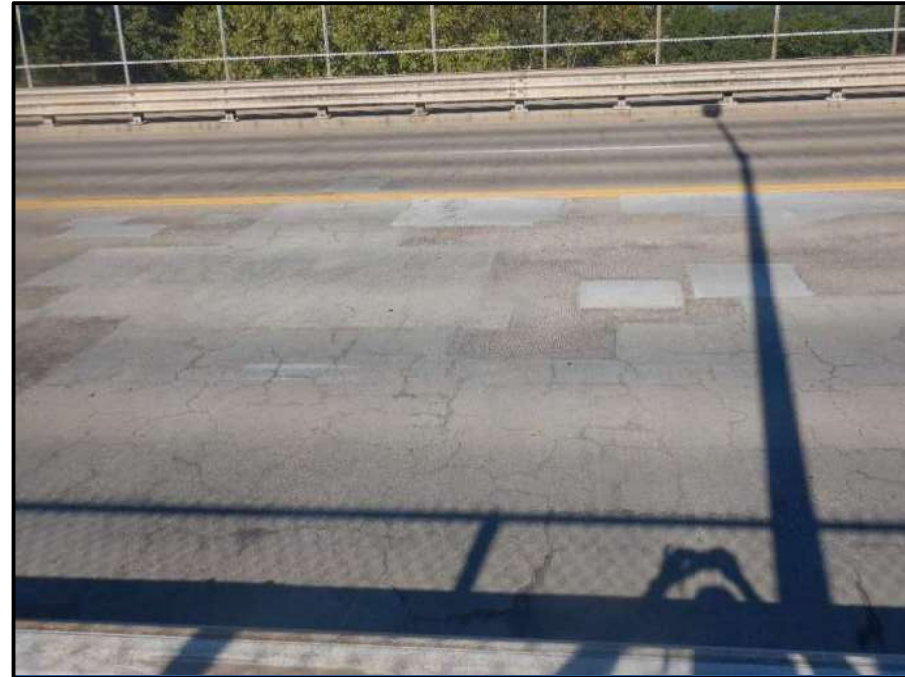
- Approximately 10% of the wearing surface (including patches) in spans 1 and 3 is delaminated. The highest density of delaminations, cracking, and cracked patches exists along the northbound lane of span 1 **(photos 17 and 18)**. Approximately 75% of the 2018 patches are cracked. Isolated locations of shallow spalls typically less than 1 square foot and up to 1 inch deep exist in the northbound lane.

Photo 17 – Looking west at northbound lanes of bridge wearing surface in span 1. Note: cracking in patches throughout.

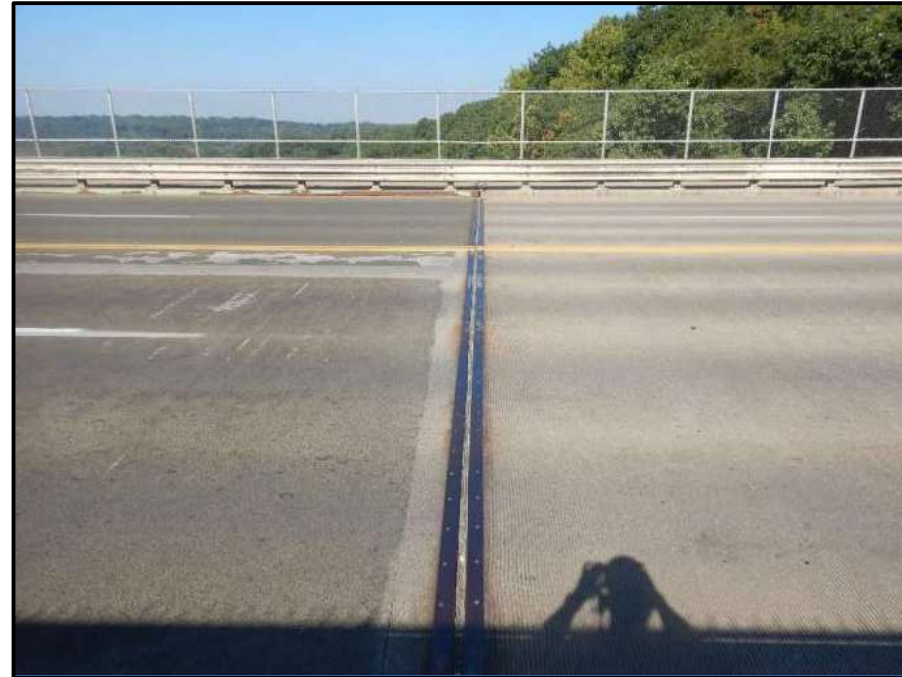
- Minor to moderate debris and standing water was noted on the strip seal joints at the time of inspection (**photo 21**). Prior to 2018, the joints had previous issues with leakage evident by the corrosion and failing paint on the steel superstructure below each joint. The joints were repaired, and neoprene flashing sheets to direct water into the pans were installed under each joint at floorbeams 13 and 17 in 2018 to mitigate past drainage issues (**photo 22**). The sheets exhibit minor areas of misalignment; however, no leakage was noted at the time of the **2023 inspection**. No significant changes from the previous inspection.

Photo 21 – Looking west at pier 2 strip seal joint. Note: minor debris in joint.

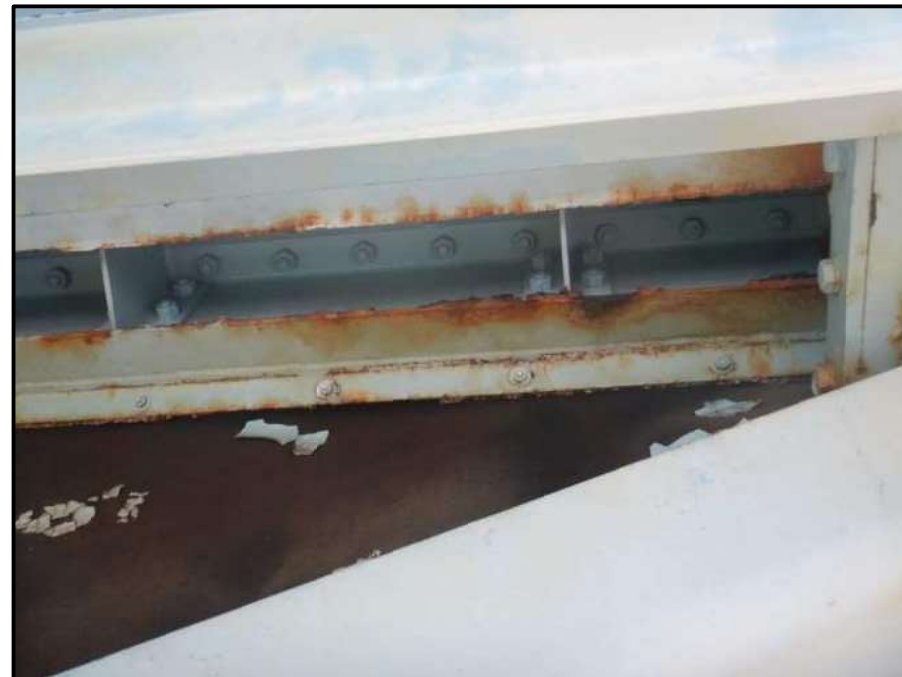
Photo 22 – Looking north at underside of top flange of floorbeam 13 below finger joint. Note: corrosion to floorbeam from previous leakage. Neoprene flashing sheet in place to direct water.

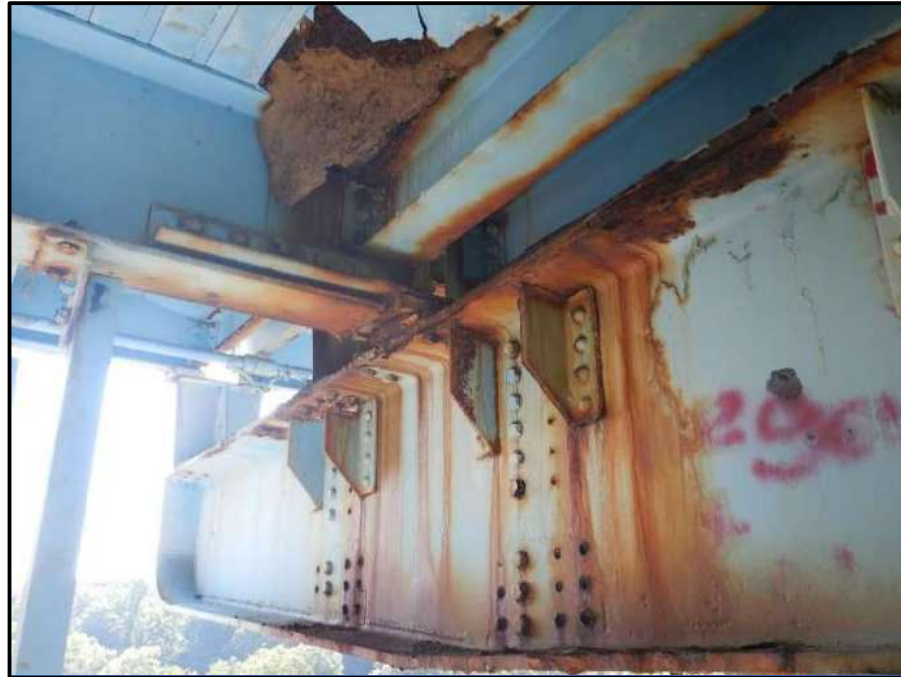
- Isolated areas of peeling paint with exposed primer exist throughout (**photo 24**). No change from previous inspection.
- Up to 1/2-inch-thick pack rust exists between stringer 11 and floorbeam 17 bearing plate (**photo 25**). The exterior stringers under joints exhibit heavier than typical surface corrosion and section loss due to past leakage issues at the joints. The noted issues have existed in the past and have not significantly changed since the joint leakage has been resolved.
- Two loose bolts exist at the south connection angle of stringer 8 to floorbeam 28 connection (**photo 26**). This condition exists at random locations throughout the superstructure for stringer to floorbeam connections. However, no bolts appeared to have loosened further since the 1994 rehabilitation/painting project was performed.

Photo 25 – Looking southeast at stringer 11 connection to north face of floorbeam 17, span 2. Note: heavy corrosion and pack rust under stringer bearing.

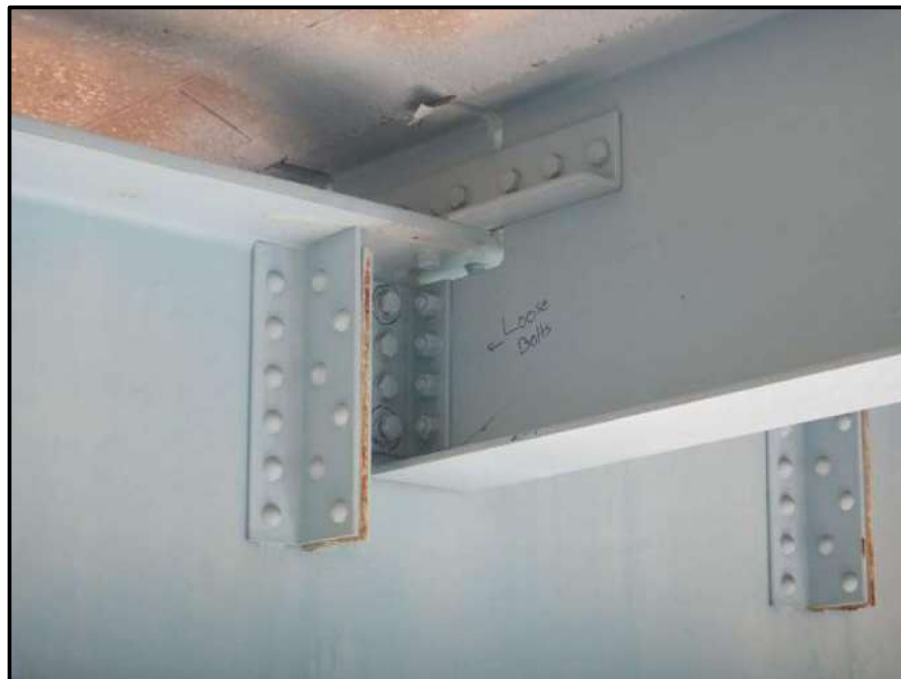
Photo 26 – Looking northeast at stringer 8 connection angle to south face of floorbeam 28, span 3. Note: two loose bolts.

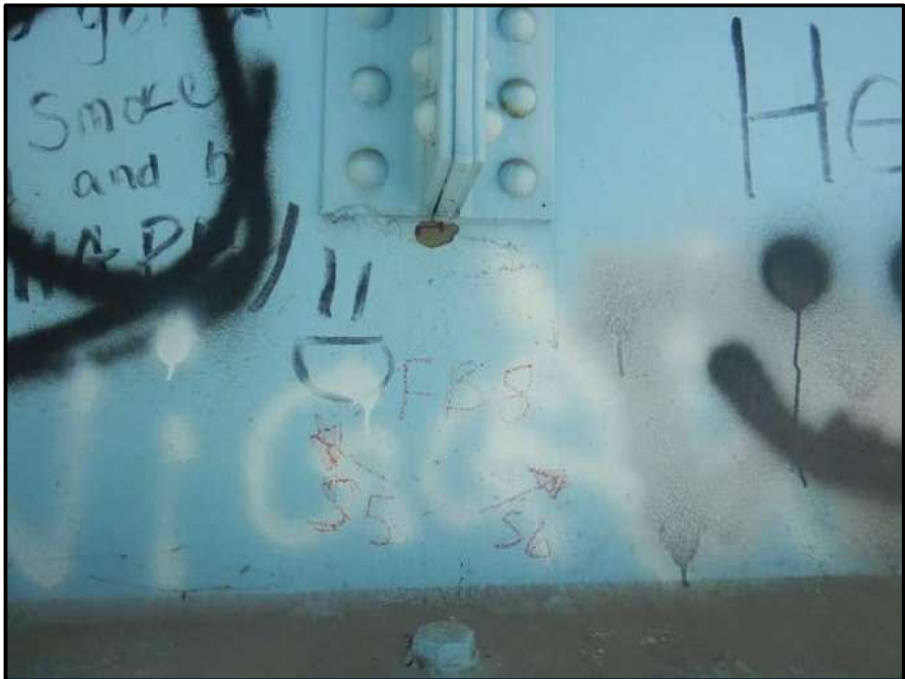
Photo 30 – Looking north at south face of floorbeam 8 under stringer 5, span 2. Note: minor cut in floorbeam web below stiffener. No change.

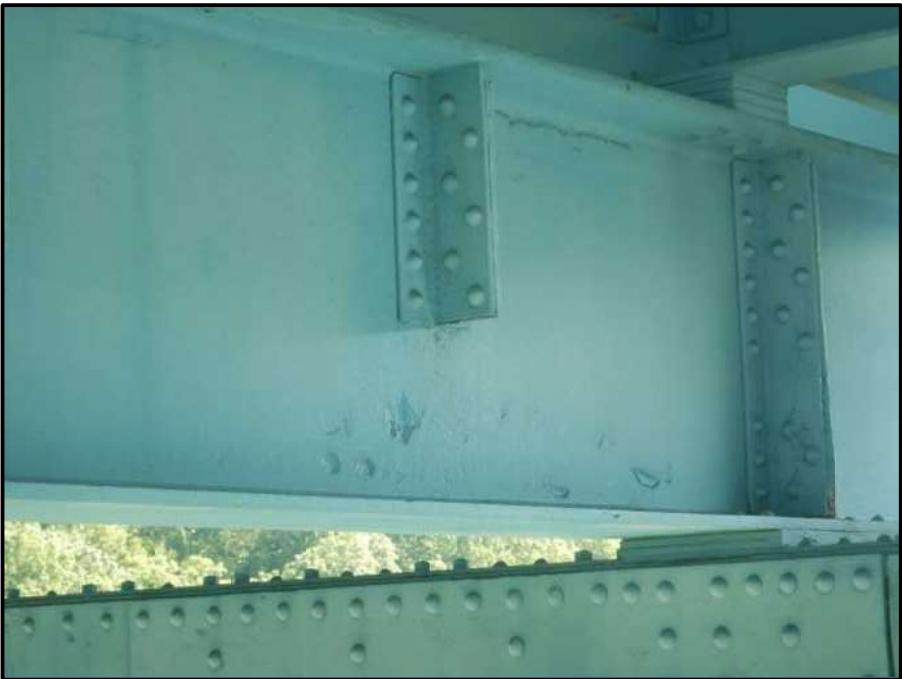
Photo 31 – Looking northeast at south face of floorbeam 14 web under stringers 7 and 8, span 2. Note: multiple gouges in web most likely from construction.

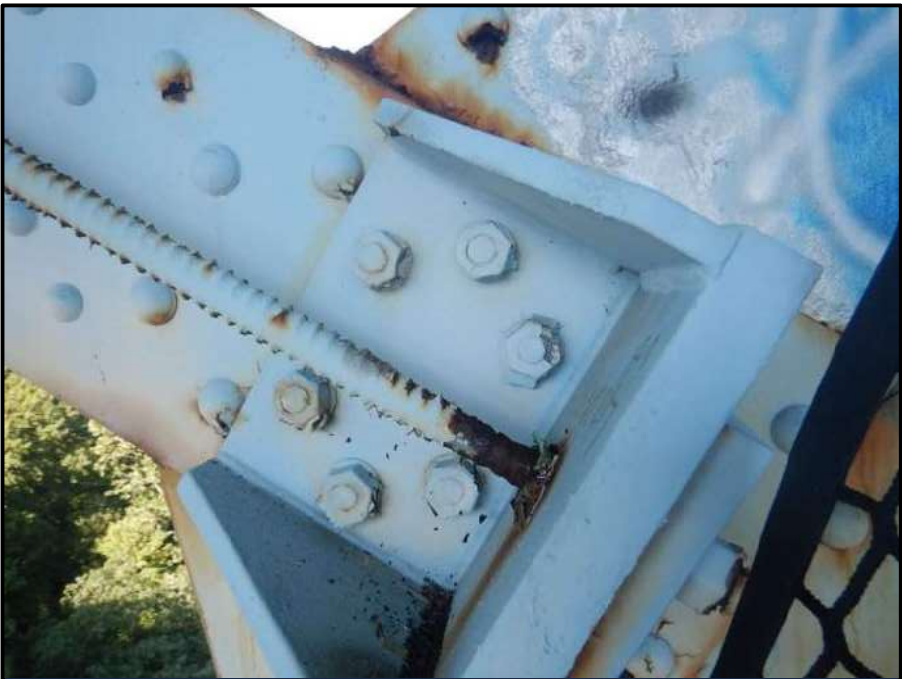
Photo 32 – Looking west at west U12L13 inboard PT rod, span 2. Note: rod exhibits up to 30% section loss, no change.

- Continue to monitor catwalk access for ropes/ladders and for areas of damaged security fencing at each abutment. **(Page 6)**
- Section loss to post-tensioning rods for west U12L13 and U18L17. **(Page 10)**
- Tie-down eyebar anchorages at each abutment for further section loss or distress. **(Page 14)**
- Section loss and corrosion to the pins at panel points 13 and 17. **(Page 14)**
- Abutments and southwest/northeast wingwalls for further rotation and obtain measurements on an annual inspection cycle between the wingwall and backwall joints. **(Pages 15 and 16)**
- Spalling along the expansion joint armor at both abutments. **(Page 16)**

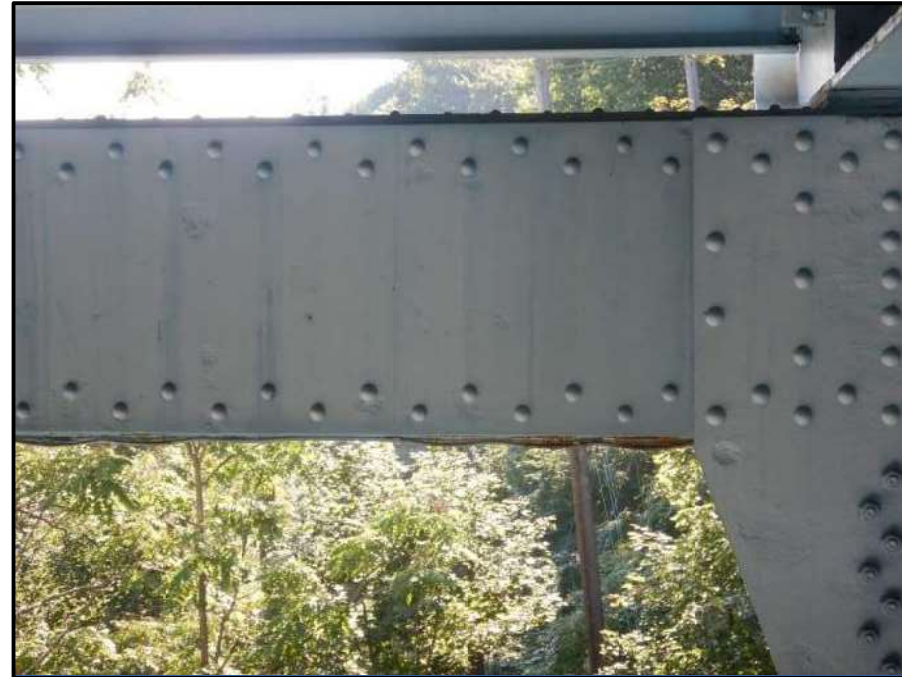
Photo 33 – Looking east at east U3U4 at U3, west face, span 1. Note: typical painted over section loss to web of upper chord. Pack rust up to 1 inch thick between bottom plate and bottom of web.

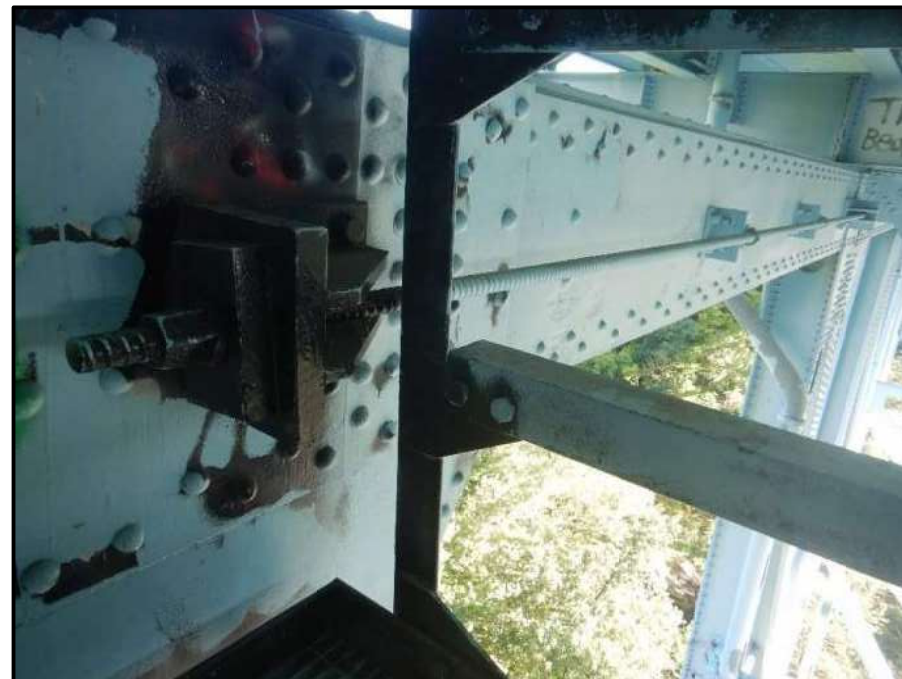
Photo 34 – Looking north along east face of west U7U8 at U7, span 2. Note: typical PT rod repair for upper chord.

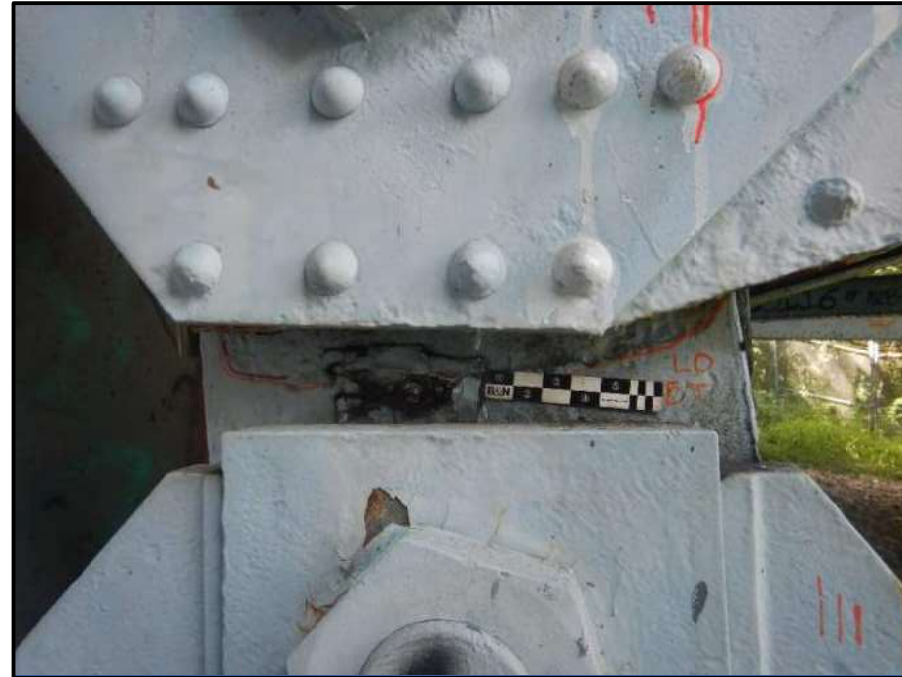
Photo 37 – Looking west at east truss bearing at rear abutment, east face. Note: 3/16-inch deep painted over section loss to exterior of outboard pin plate, no change.

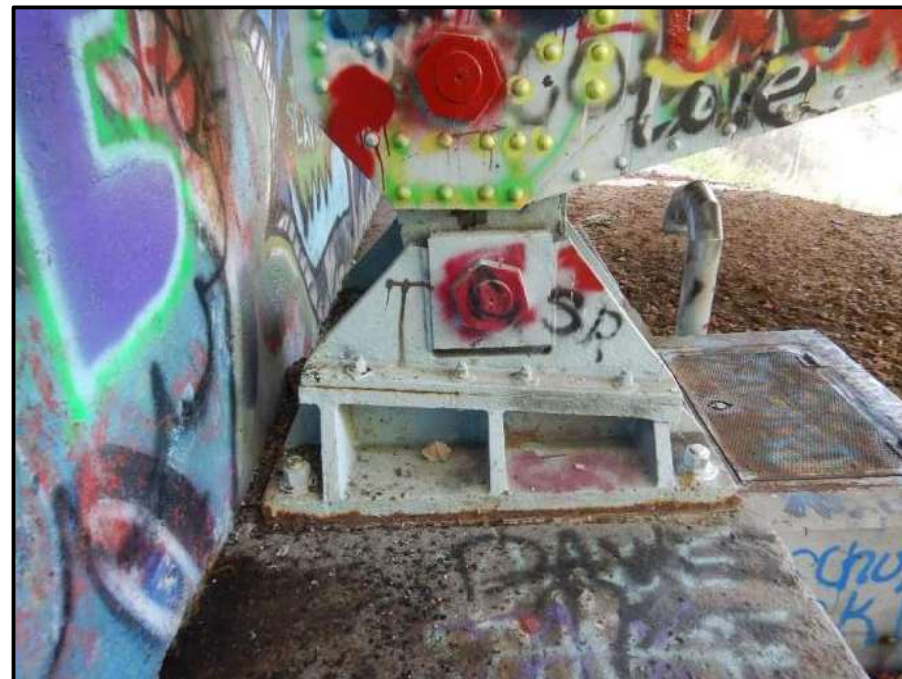
Photo 38 – Looking east at west truss bearing at forward abutment. Note: surface corrosion around edges of masonry plate with 1-inch deep wear into bearing seat.

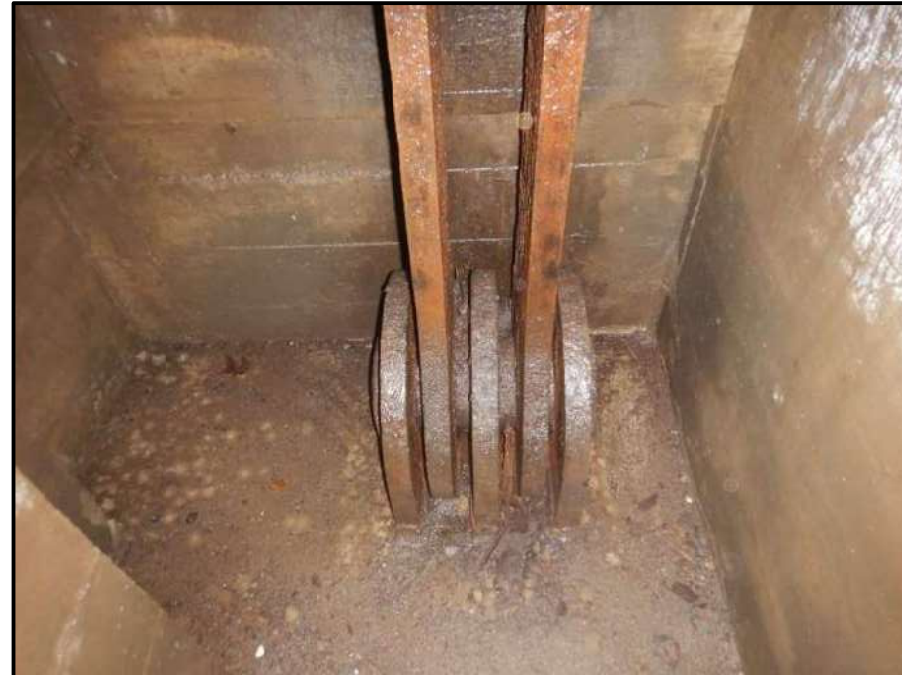
Photo 41 – Looking north at west truss anchor pit for tie down anchorage at forward abutment. Note: moisture inside of pit.

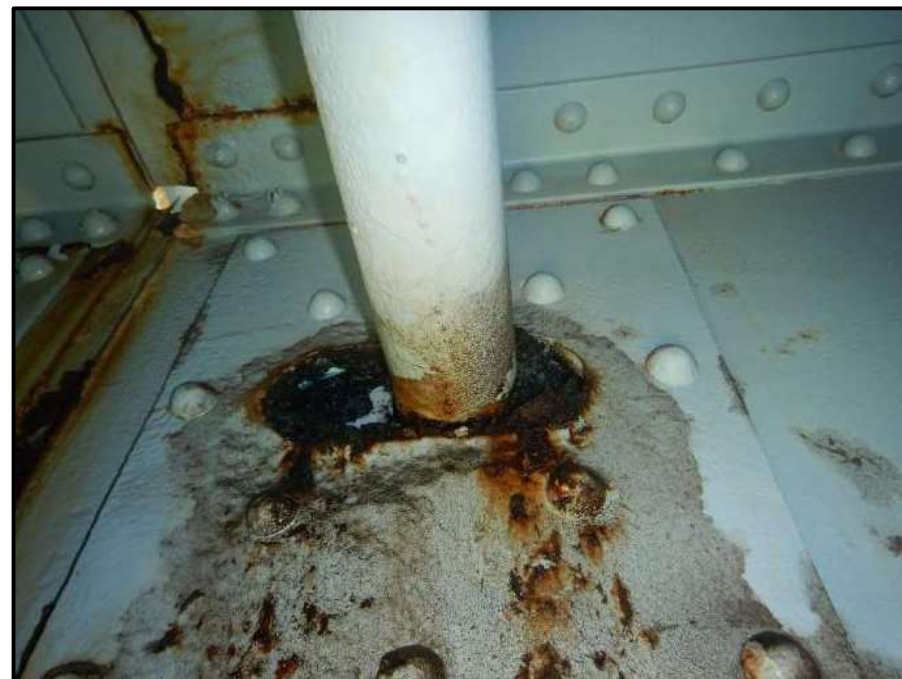
Photo 42 – Looking east at interior of pin at west U13, span 2. Note: painted over section loss and active corrosion in pin plate.

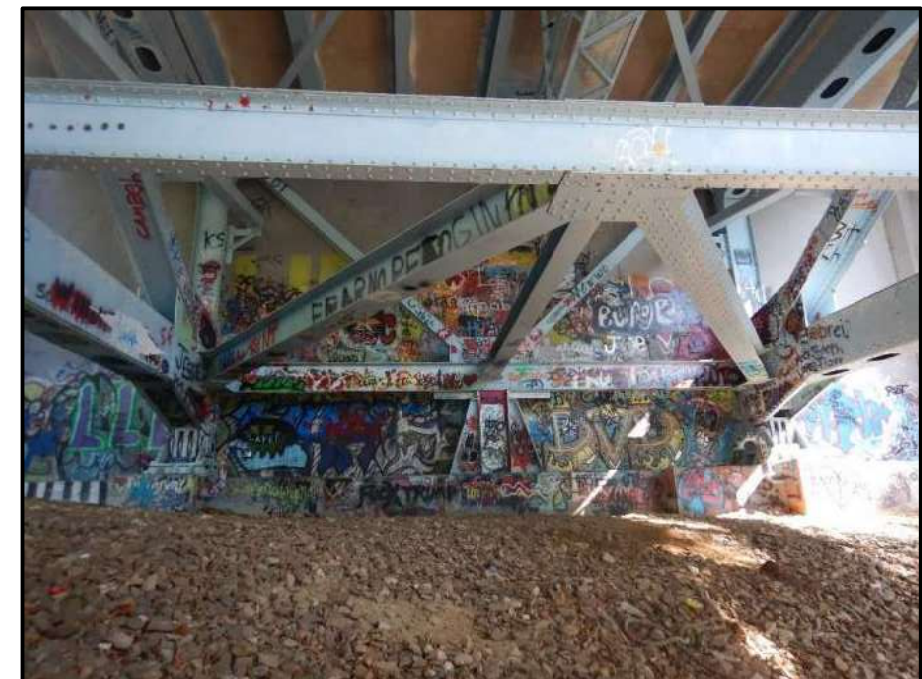
Photo 44 – Looking north at forward abutment, overall. Note: abutment and backwall are covered in graffiti.

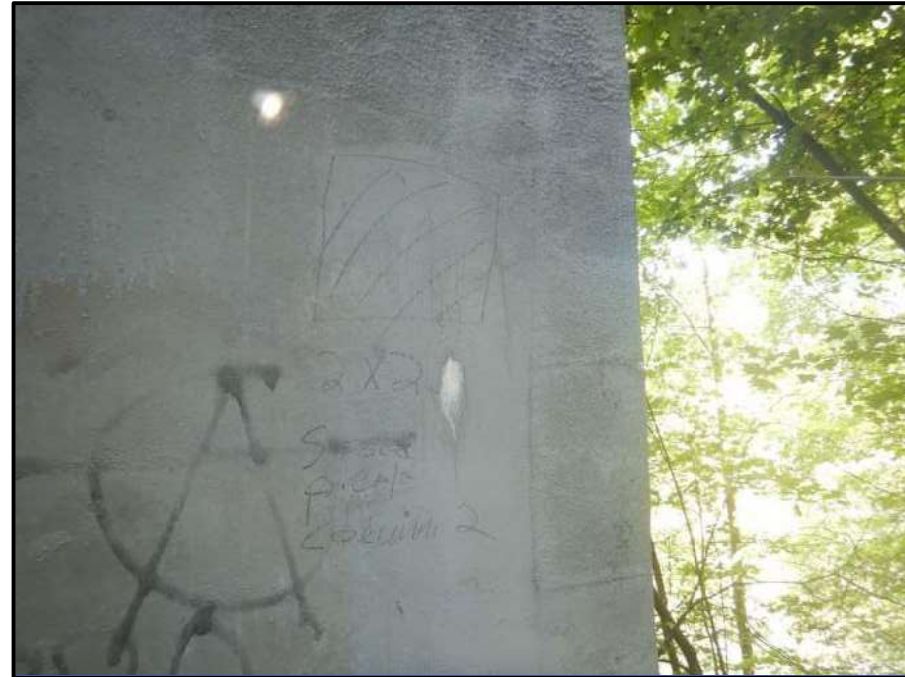
Photo 45 – Looking north at south face of column 2, pier 1 approximately 7 feet above the ground. Note: 2-foot x 2-foot delamination.

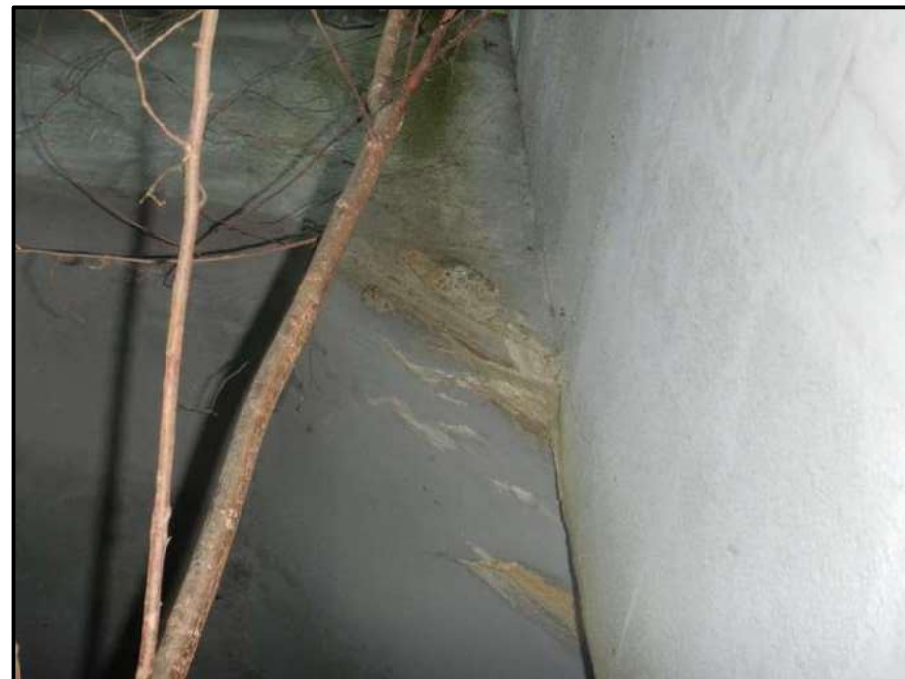
Photo 46 – Looking south at north face of pier 1 cap at column 1. Note: 2-foot long x 1-foot wide x 1-inch deep spall with adjacent efflorescence.

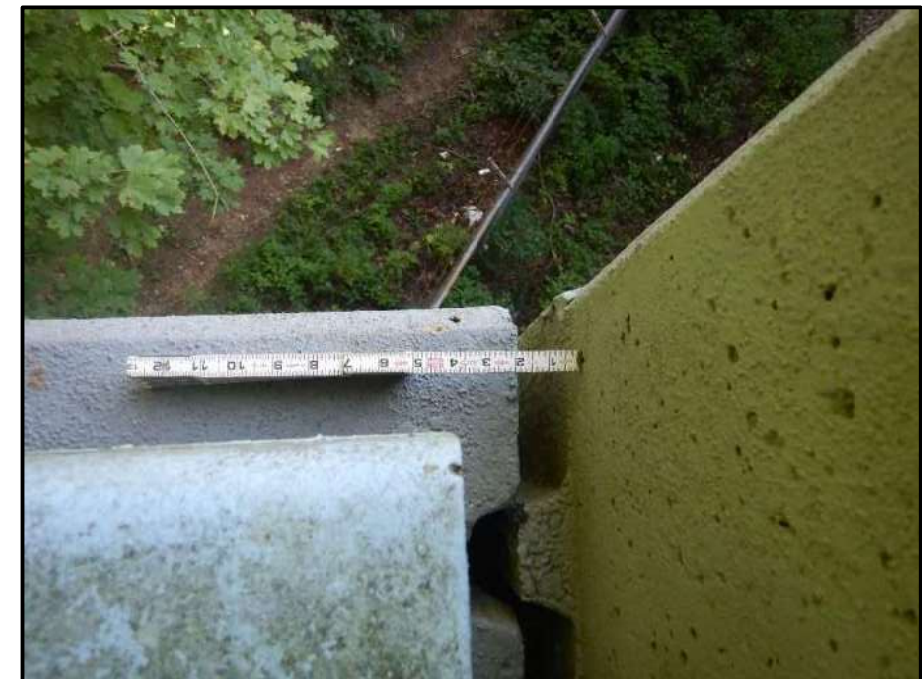
Photo 48 – Looking north at top of southwest wingwall Note: 1 3/4 inches rotation away from abutment.

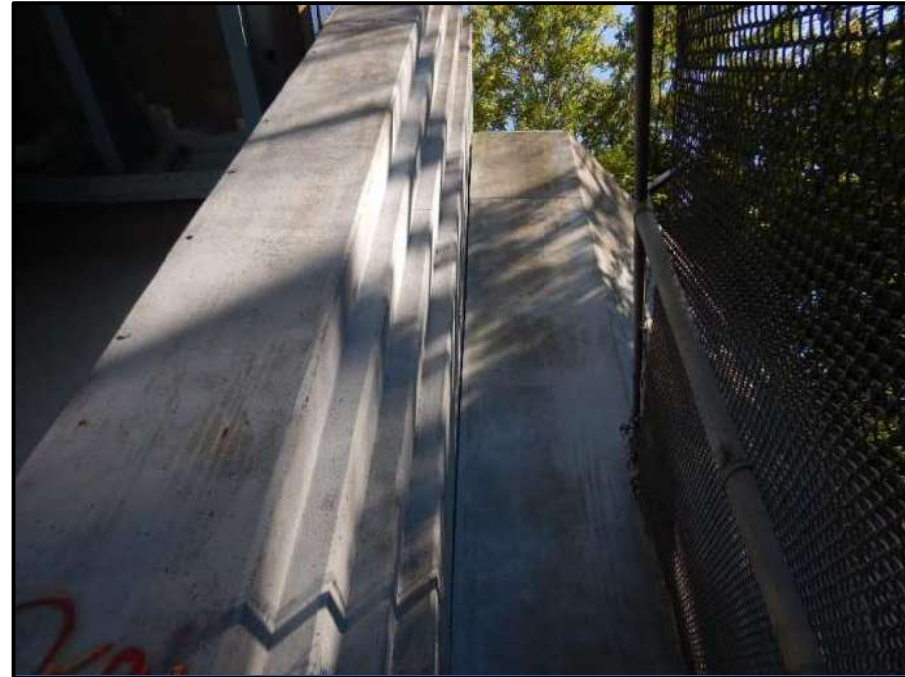
Photo 49 – Looking north at northeast wingwall at forward abutment.
Note: wingwall rotation east away from abutment.

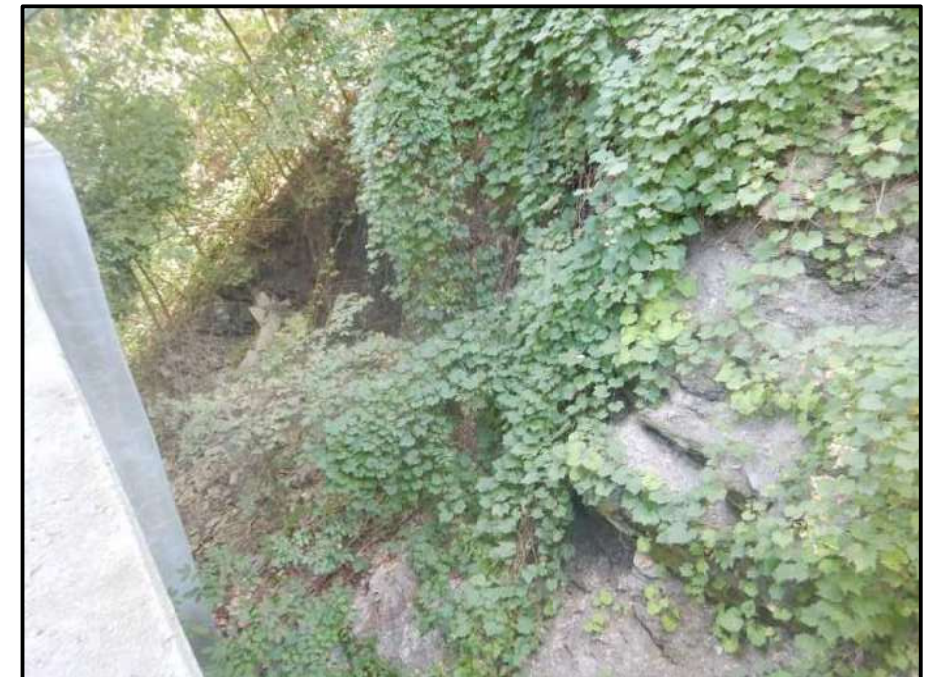
Photo 52 – Looking southeast at southeast embankment near pier 1.
Note: shale banks are steep and eroding.

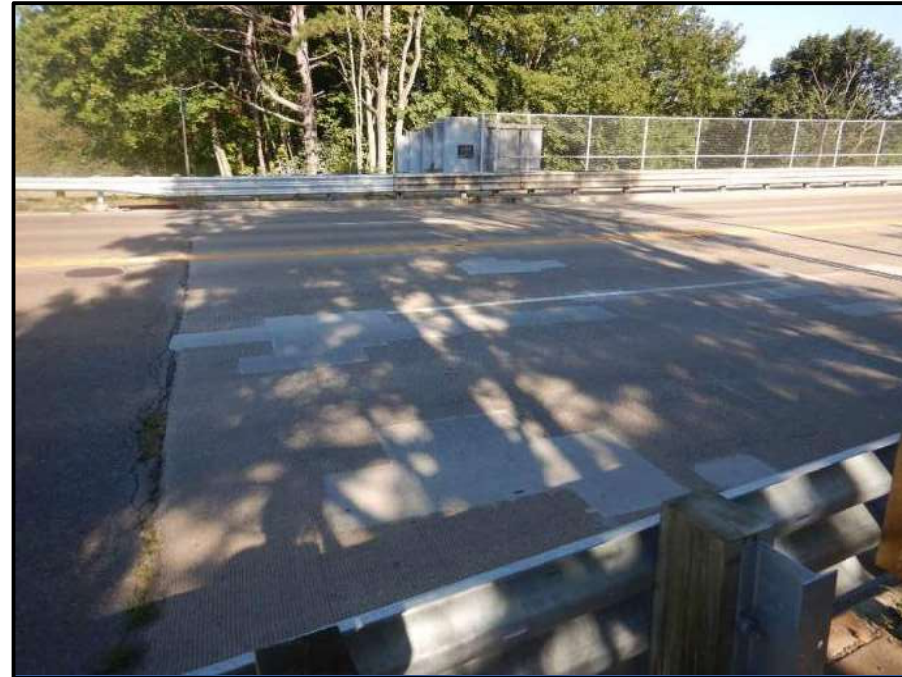
Photo 53 – Looking northwest at rear approach slab. Note: sound patches throughout northbound lanes.
