2023 Routine Bridge Inspection Report

North Main Street High Level Bridge

SUM-M008-00908
SFN: 7730306

October 19, 2023

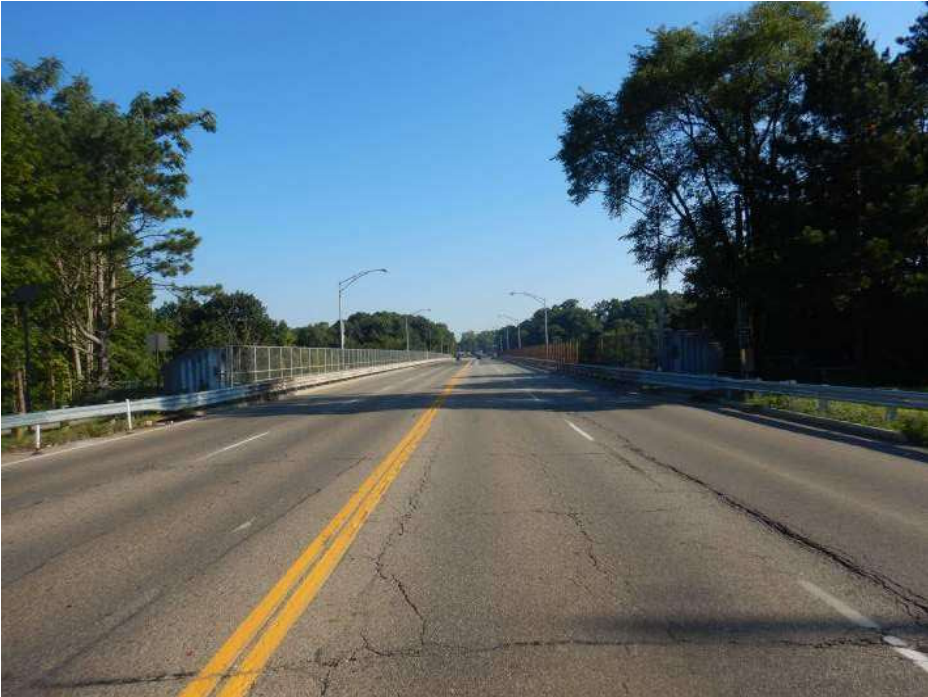
PHOTO 1

End view looking north.

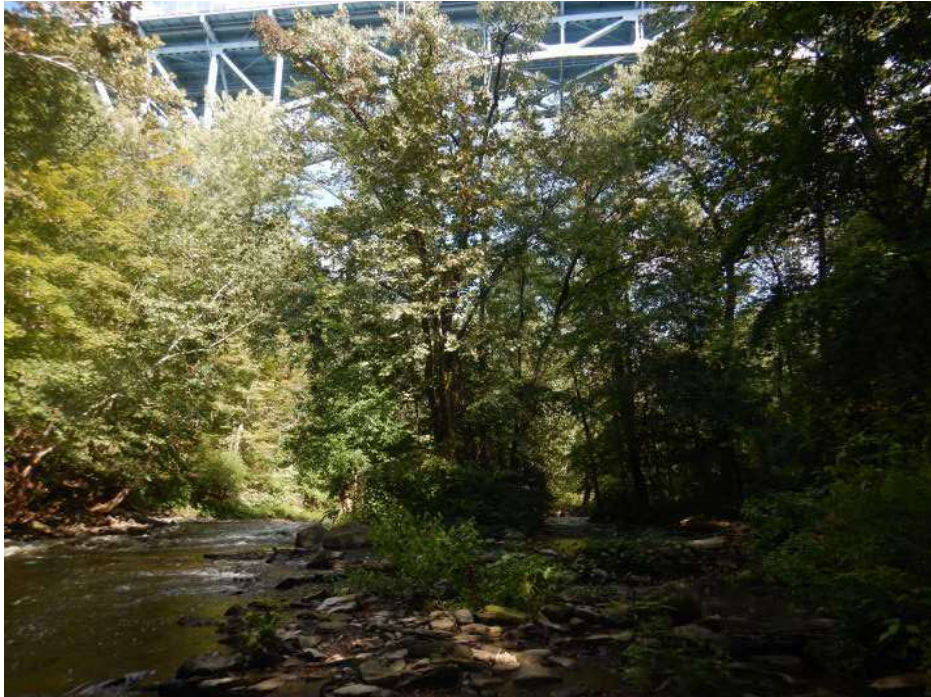
PHOTO 2
Description Upstream channel, looking east.

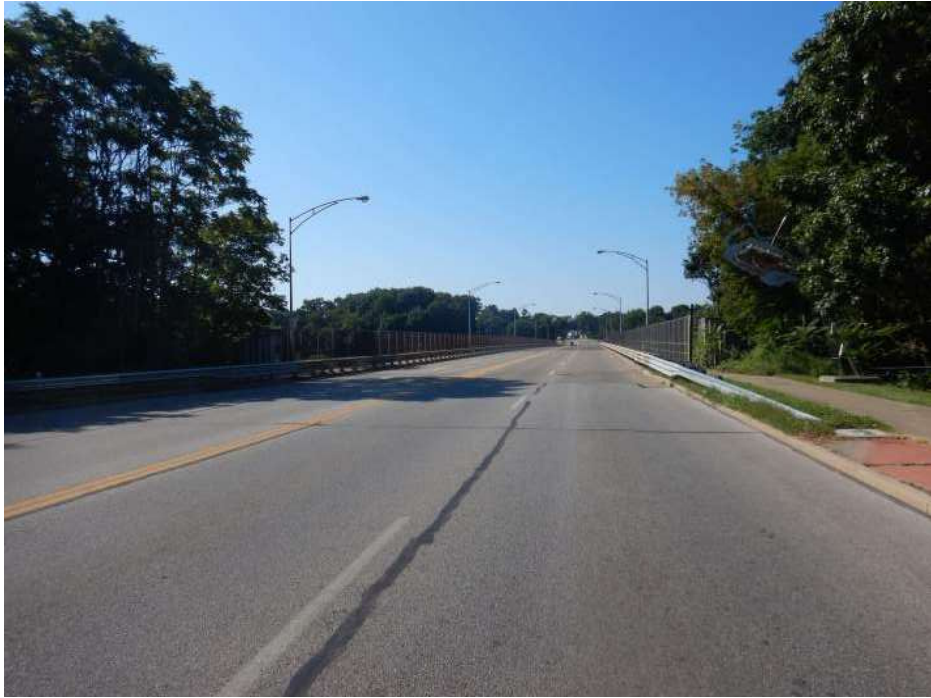
PHOTO 2
Description End view looking south.

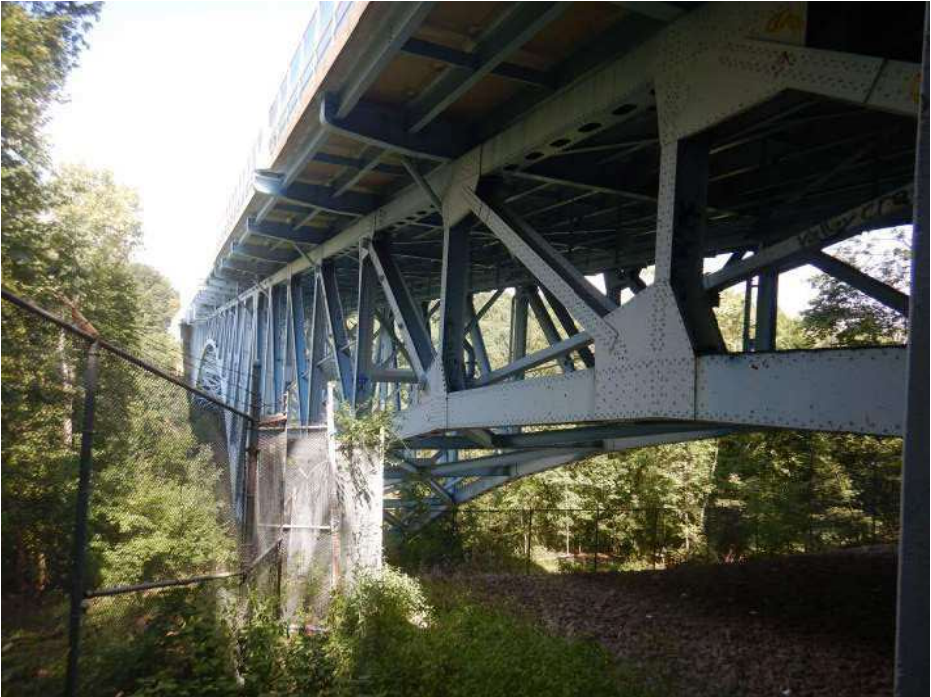
PHOTO 3
Description Elevation of west fascia looking northeast.

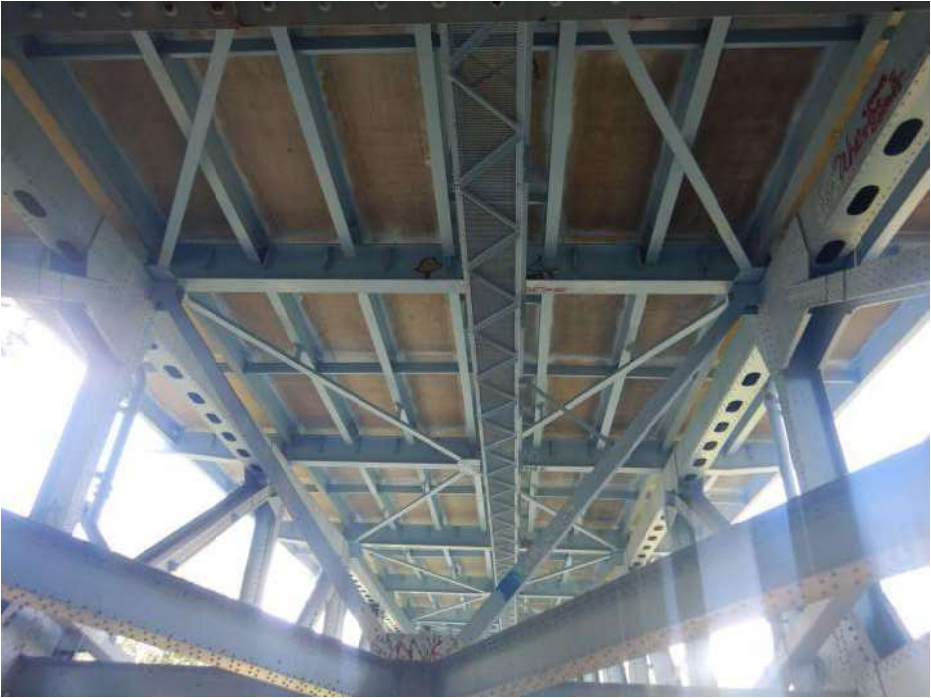
PHOTO 4
Description General underside of Span 1, looking north.

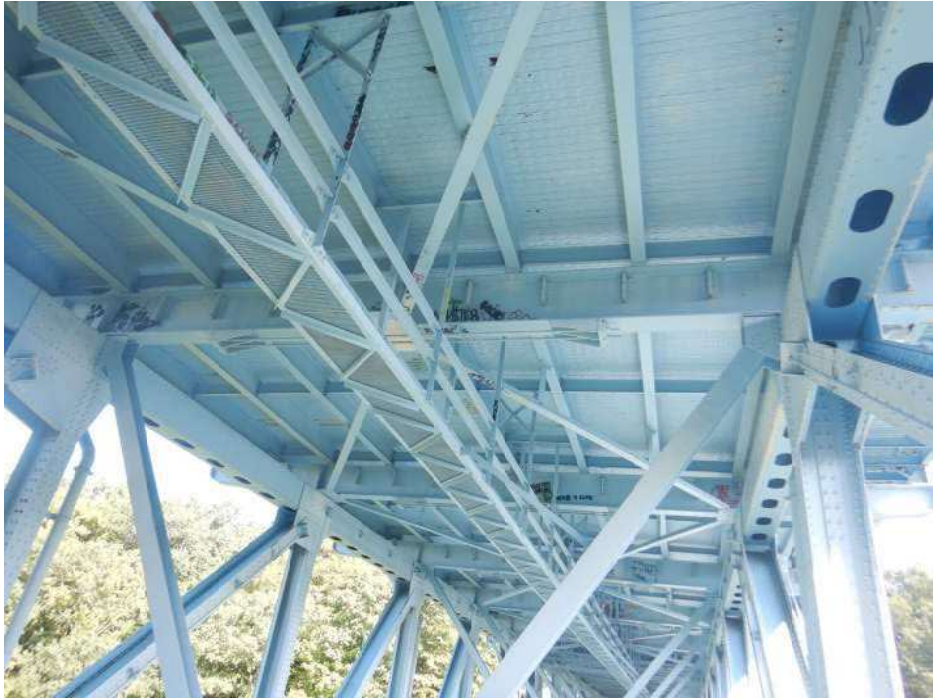
PHOTO 5 Condition
Description General underside of Span 2, looking north.

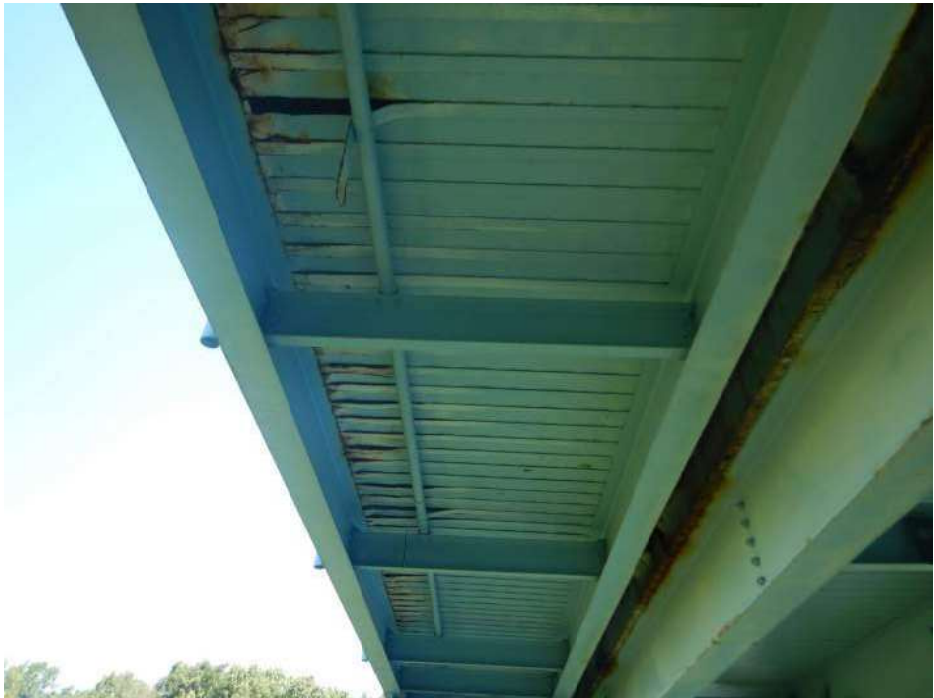
PHOTO 22

Isolated transverse cracks with minor efflorescence in Span 1 deck soffit, looking south.

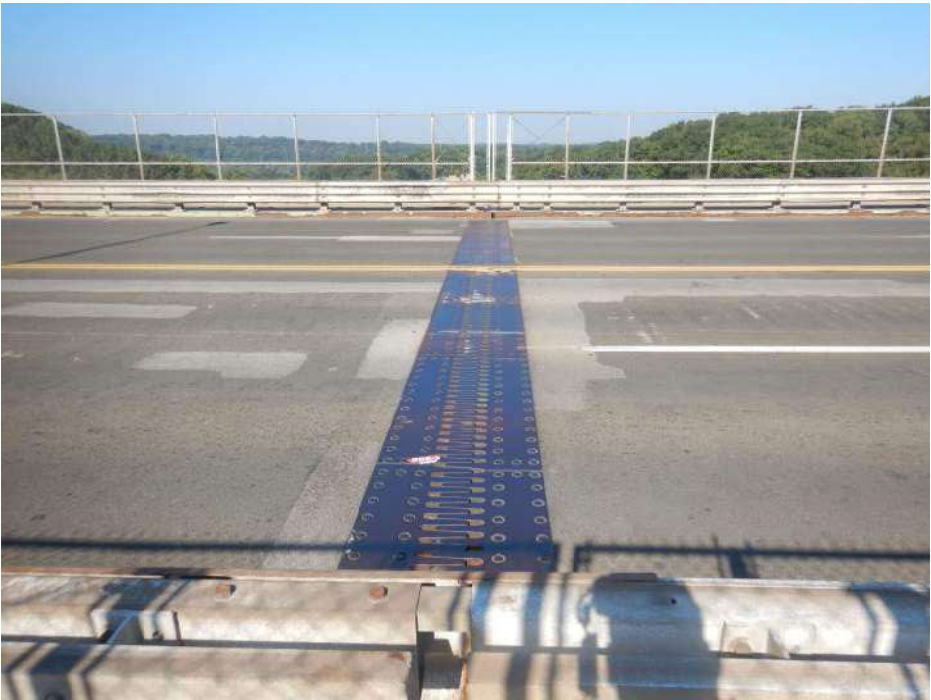
PHOTO 24

Surface corrosion and minor section loss to joint armor from debris, Rear Abutment joint at east end, looking west.

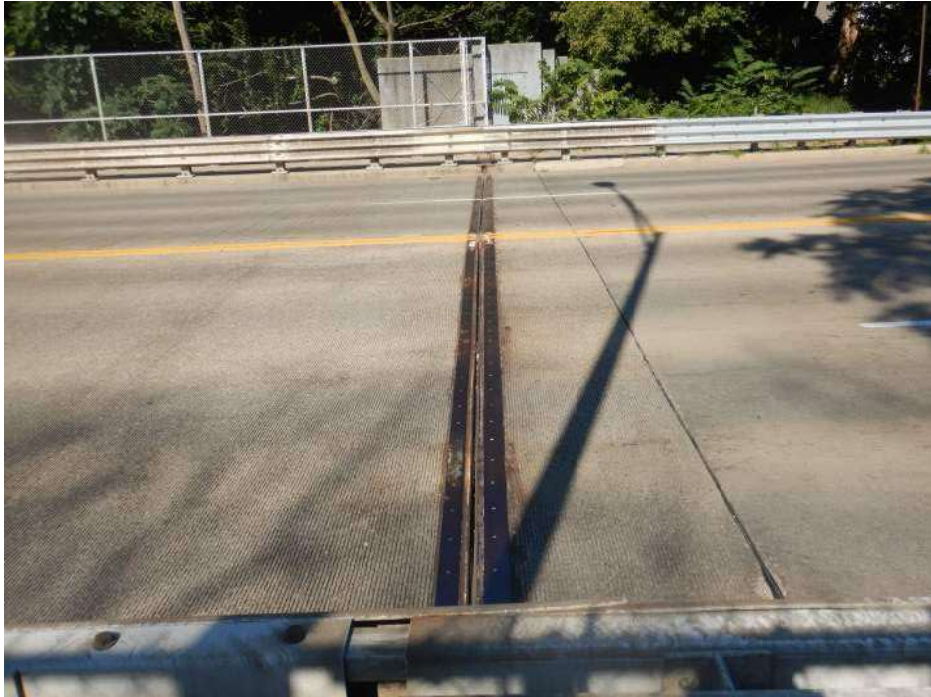
PHOTO 25 Condition
Description Strip seal at Forward Abutment, looking west.

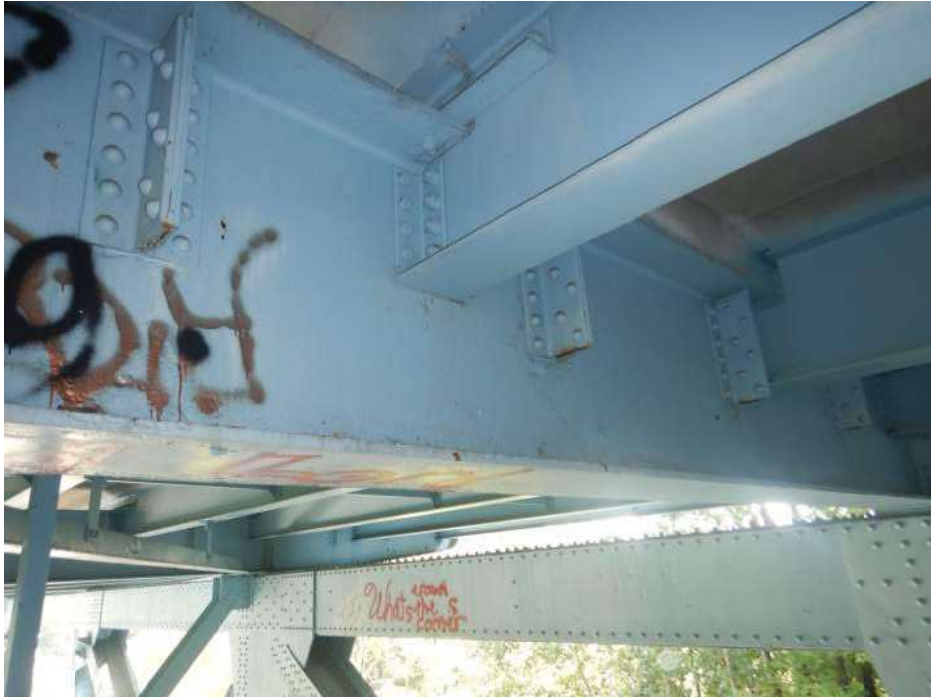
PHOTO 30 Condition
Description Abandoned stringer attachment angles, typical, Floorbeam 1 shown, looking northeast.

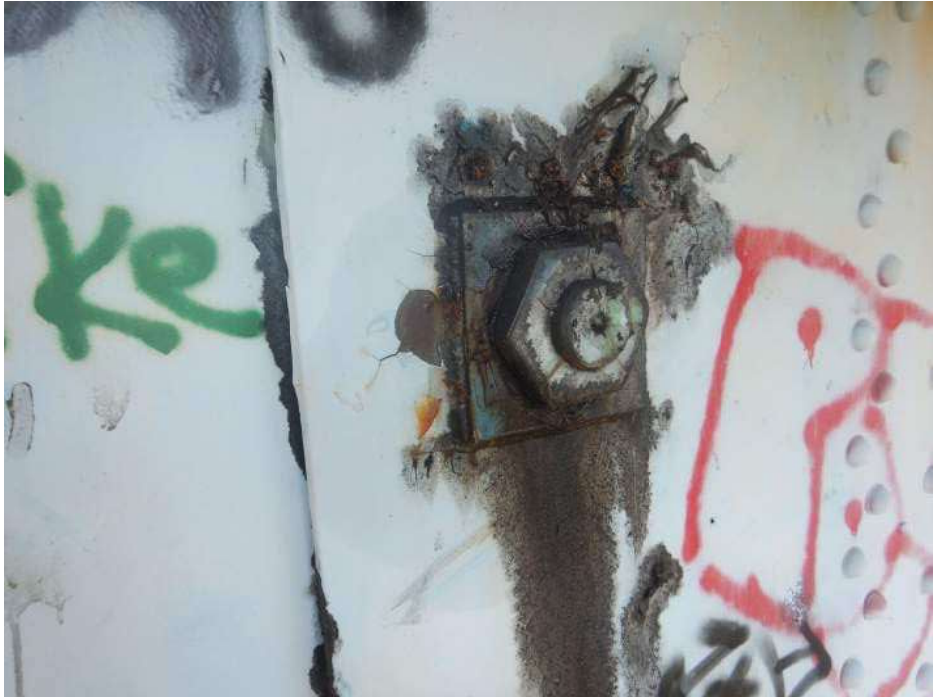
PHOTO 37 Condition

Description Exterior pin and lomas nut connection on OB gusset plate, looking west at East U13. Note: No deficiencies in fillet weld. Pin heavily greased.

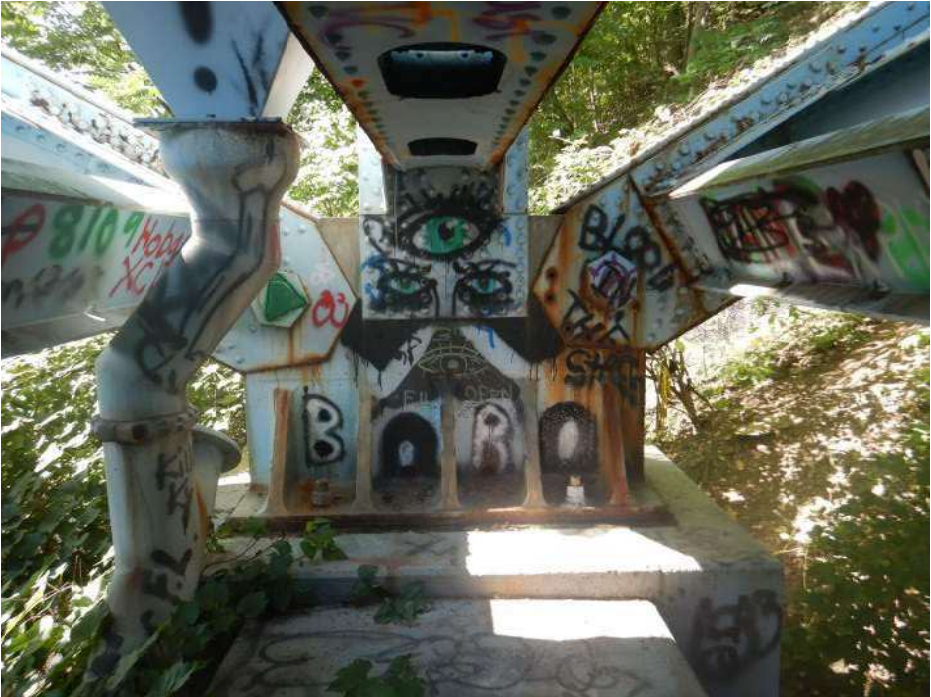
PHOTO 39 Condition

313-Fixed Bearing	3 - Mod.	4	each	0	4	0	0
	The fixed bearings at the piers exhibit active corrosion inside the assembly due to water not being able to fully drain from the assembly.

Description Fixed bearing, typical, looking west at west truss bearing at Pier 2.

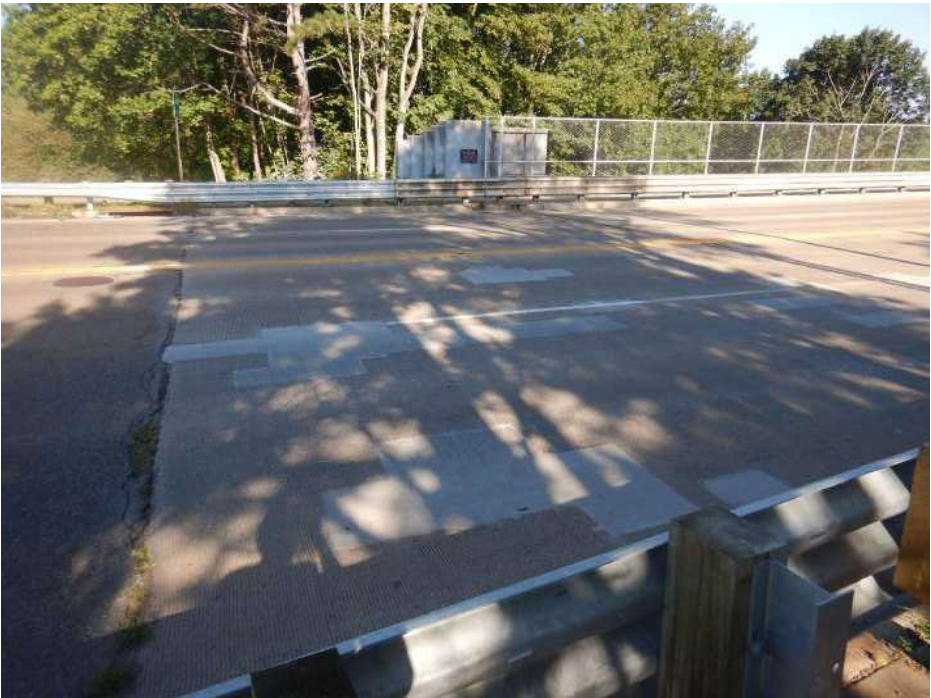
PHOTO 48 Condition
Description Sound patches in NB lanes at Rear Approach, looking northwest.

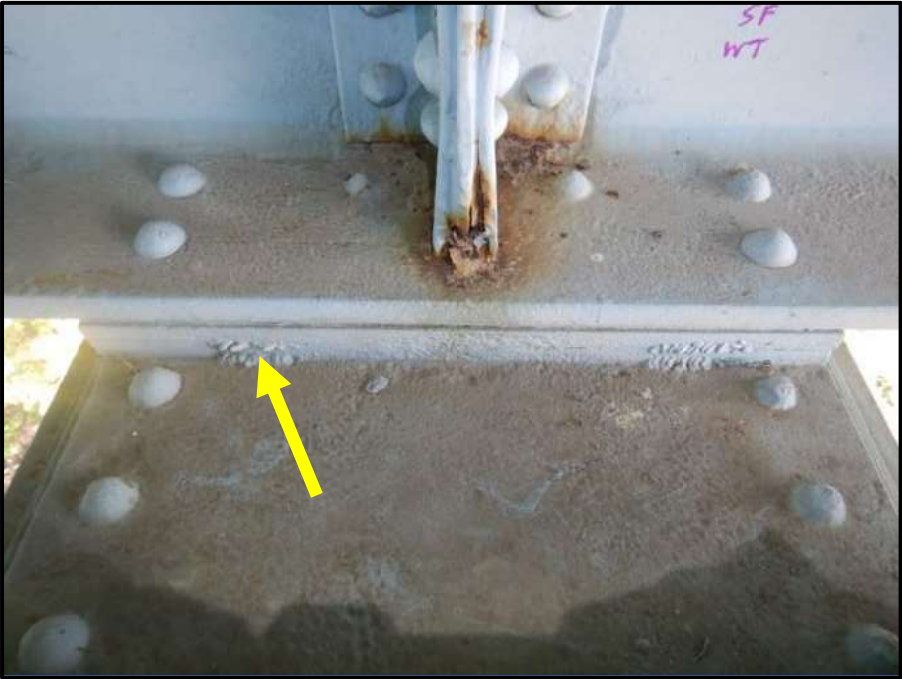
Fatigue Prone Details			
Category	Distribution	Description	Photo
*	Widespread	Tack welds connecting floor beam bearing plate to either top of upper chord or top upper chord splice plate.	Photo 1
E	Isolated	Fillet welds along perimeter of hinge pin plate connected to U13 & U17 gusset plates.	Photo 2

*There is no specific fatigue category for tack welds, however per *section 7.2.1* of *The Manual for Bridge Evaluation, Third Edition*, “Tack welds may be evaluated based upon the requirements of Category C...”.

Photo 1 – Tack welds connecting floorbeam bearing plate to top of upper chord.

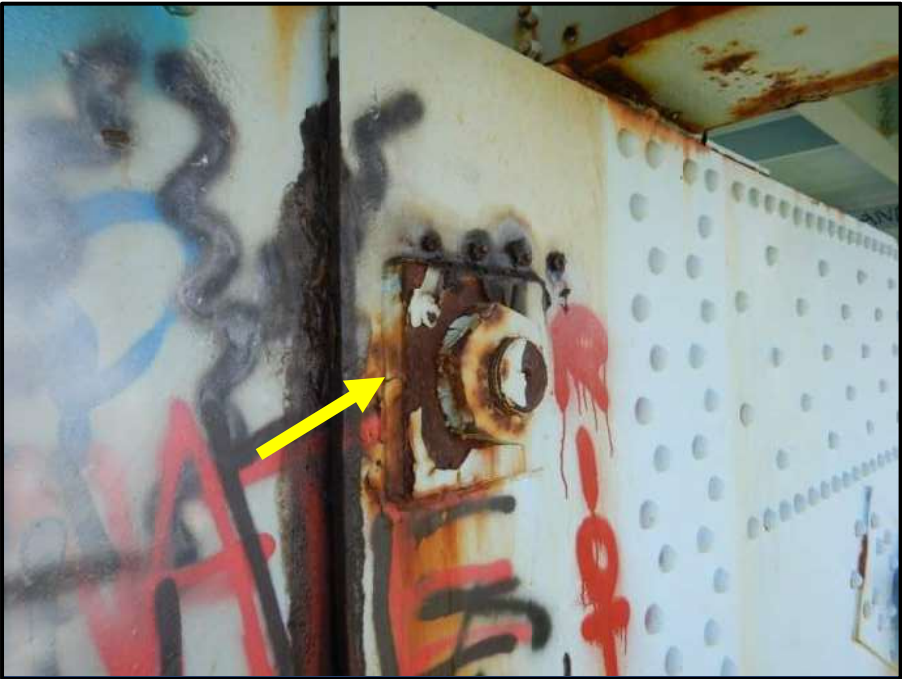
Photo 2 – Fillet welds along perimeter of hinge pin plate connected to U13 & U17 gusset plates.

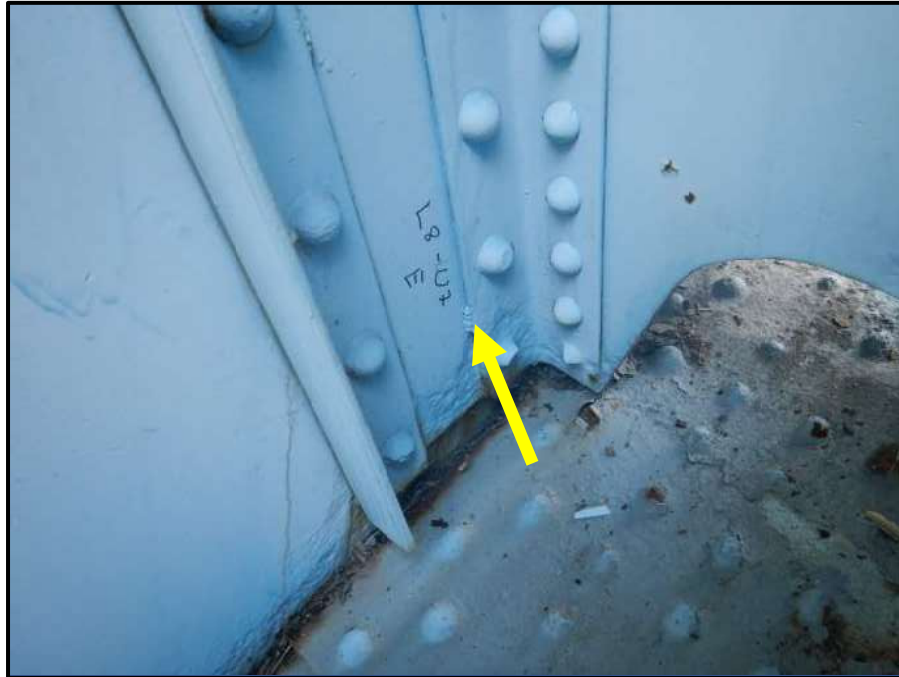
*	Widespread	Tack welds connecting angles to vertical plates on exterior of upper & lower chord box members, near the ends of the member.	Photo 3
*	Widespread	Tack welds between angles and plates at ends of all diagonal members	Photo 4

Photo 3 – Tack welds connecting angles to vertical plates on exterior of upper & lower chord box members, near the ends of the member.

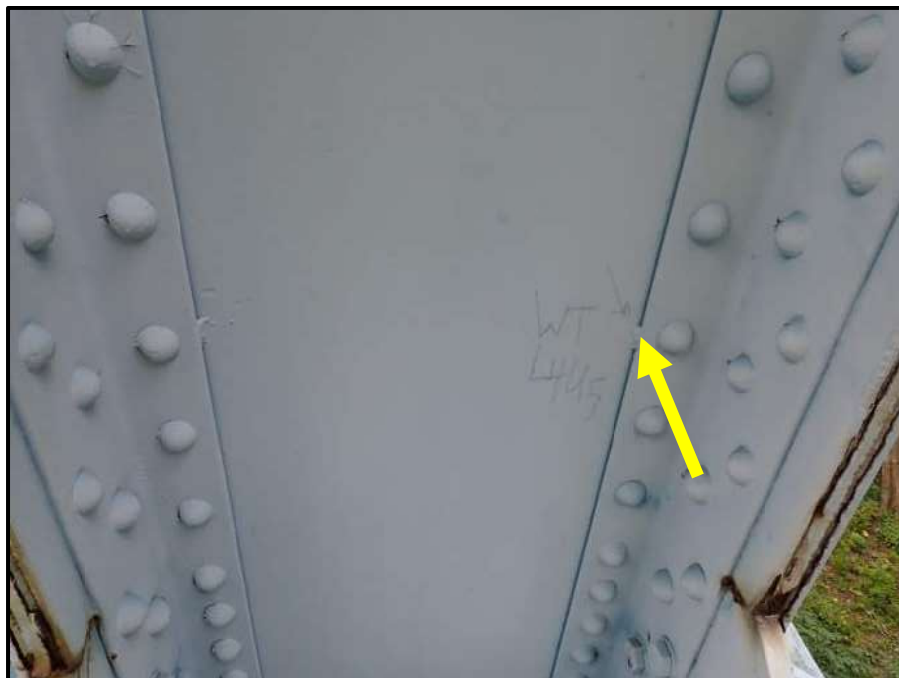
Photo 4 – Tack welds between angles and plates at ends of all diagonal members

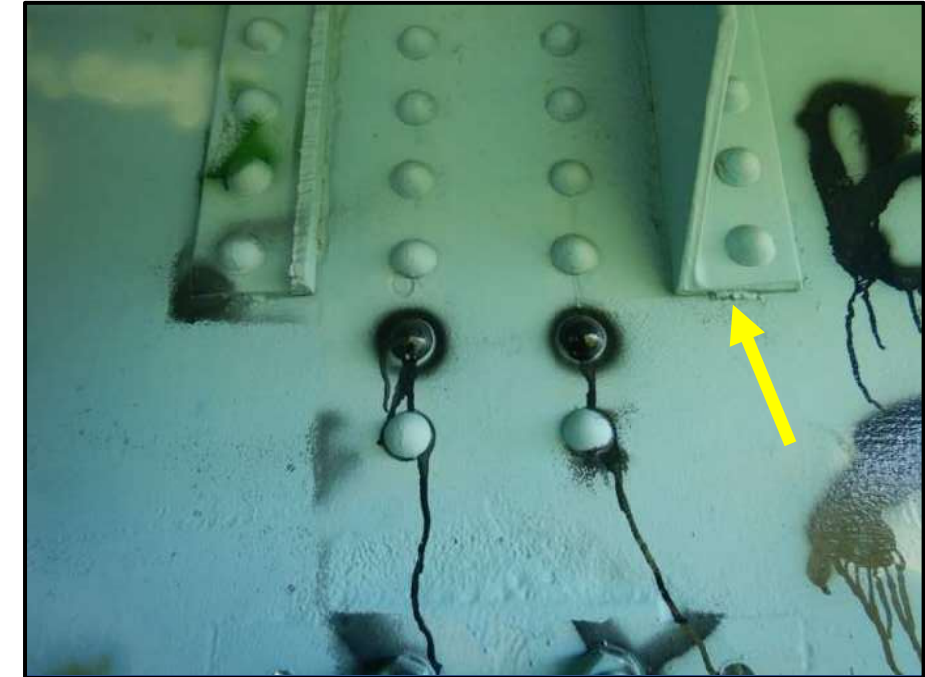
*	Widespread	Tack weld at bottom of old stringer connection angles on floorbeam webs. These welds are fatigue prone in the main bay only. Typically in non-tension zones.	Photo 5
E	Widespread	Fillet weld along bottom flange of floorbeam at lateral bracing center connection plates.	Photo 6

Photo 5 – Tack weld at bottom of old stringer connection angles on floorbeam webs. These welds are fatigue prone in the main bay only. Typically in non-tension zones.

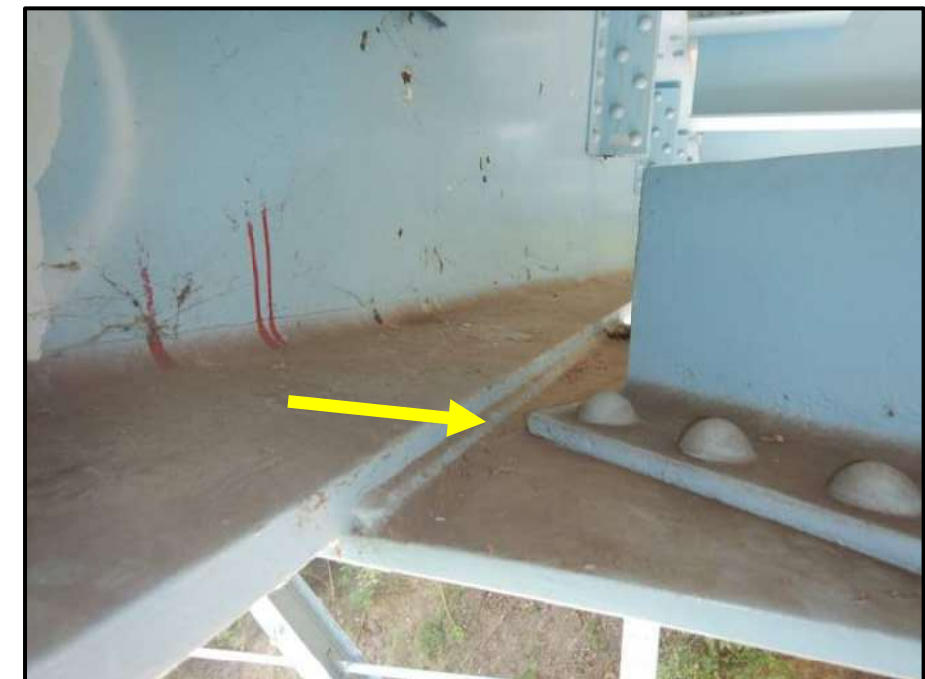
Photo 6 – Fillet weld along bottom flange of floorbeam at lateral bracing center connection plate

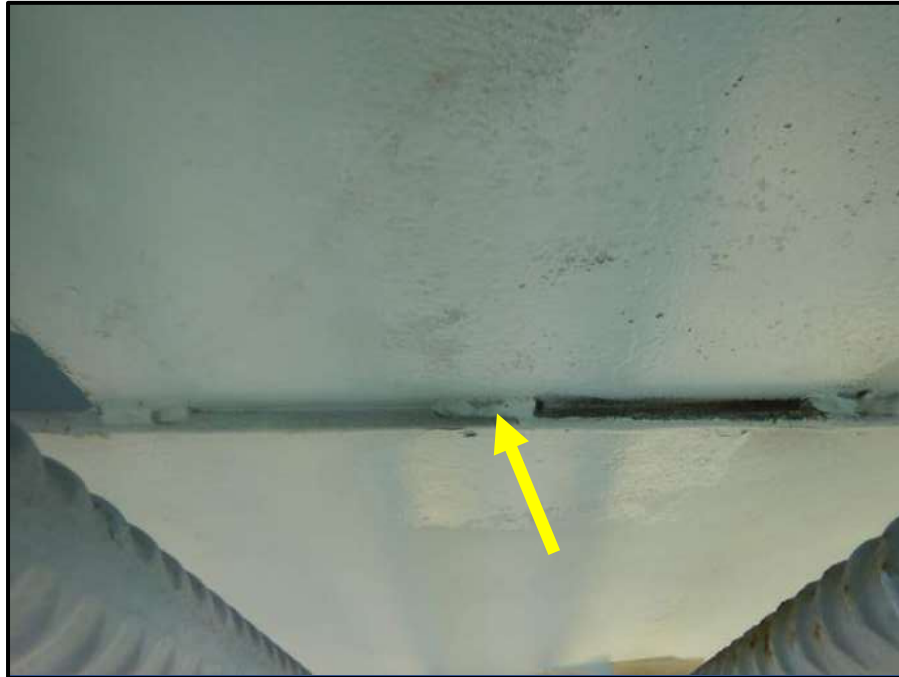
*	Widespread	Tack welds across bottom of bottom flange of floor beam at lateral bracing connection plates.	Photo 7
*	Isolated	Tack welds connecting dwyidag housing to bottom flange of floorbeam 9.	Photo 8
C	Isolated	Close-up of saw cut from 1992 rehabilitation project, floorbeam 19, both faces and south face of floorbeam 20.	Photo 9

Photo 7 – Tack welds across bottom of bottom flange of floorbeam at lateral bracing connection plates.

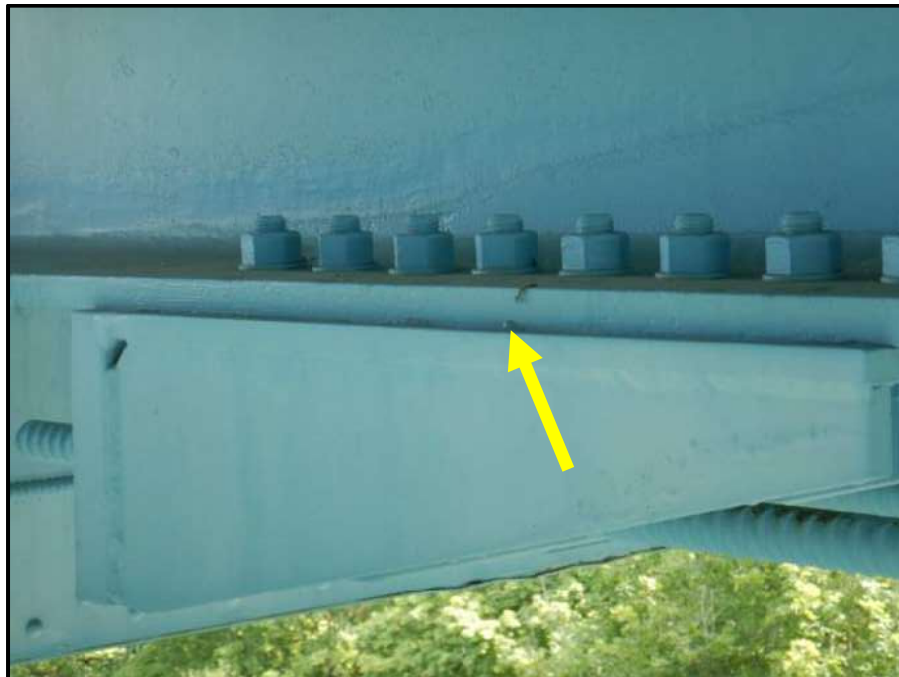
Photo 8 – Tack welds connecting dwyidag housing to bottom flange of floorbeam 9.

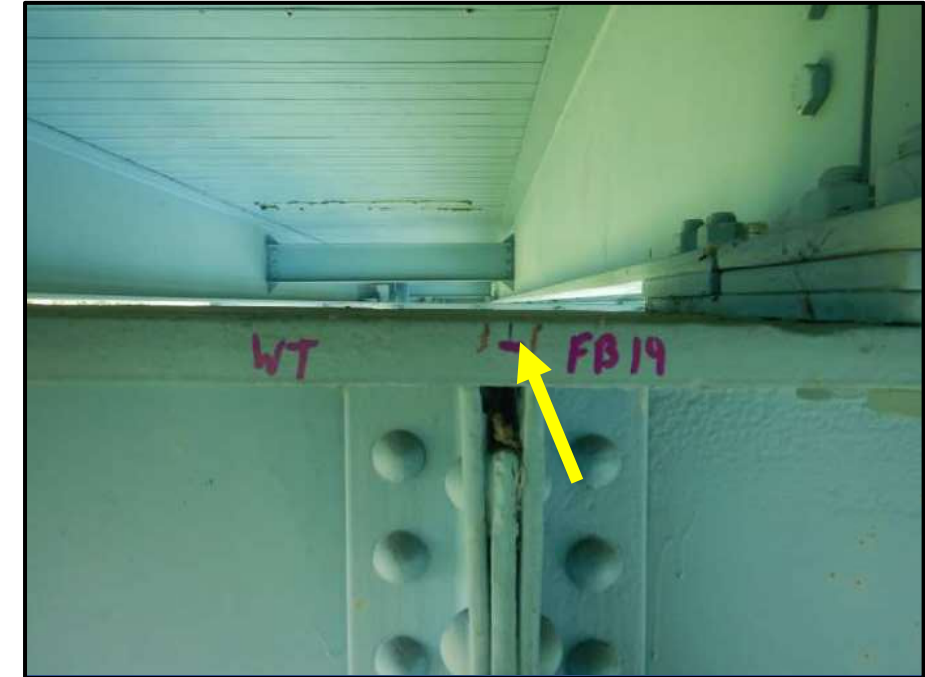
Photo 9 – Close-up of saw cut from 1991 rehabilitation project, south face of floorbeam 19 shown.

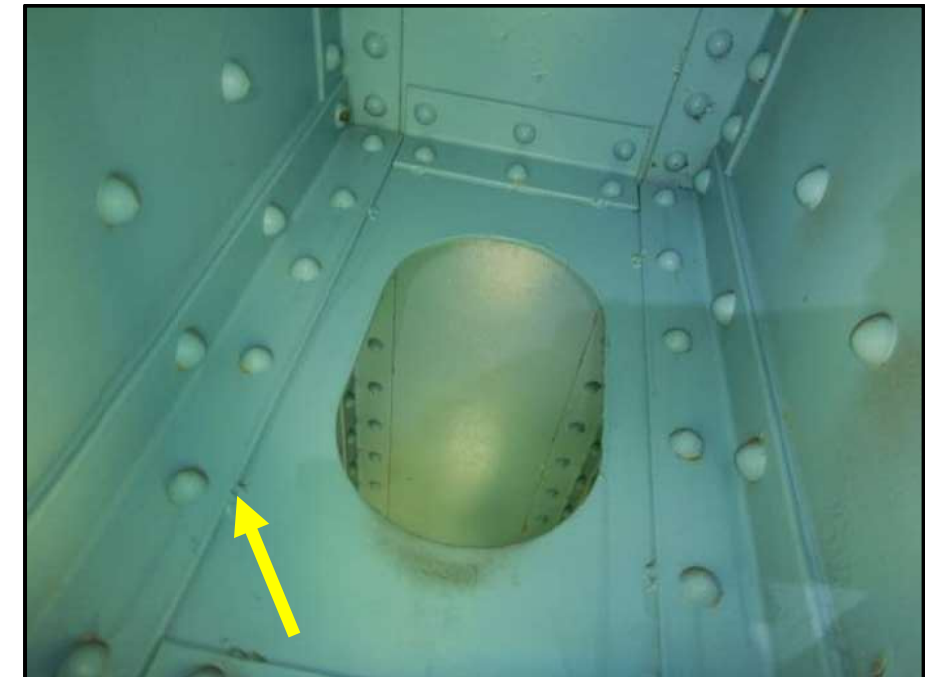
*	Isolated	West L15L16 at L16, angles along web are tack welded to internal diaphragm of lower chord box member.	Photo 10

Photo 10 – West L15L16 at L16, angles along web are tack welded to internal diaphragm of lower chord box member.
