Cuyahoga River Watershed Study

Summit County Surface Water Management District

April 11, 2025

Tetra Tech

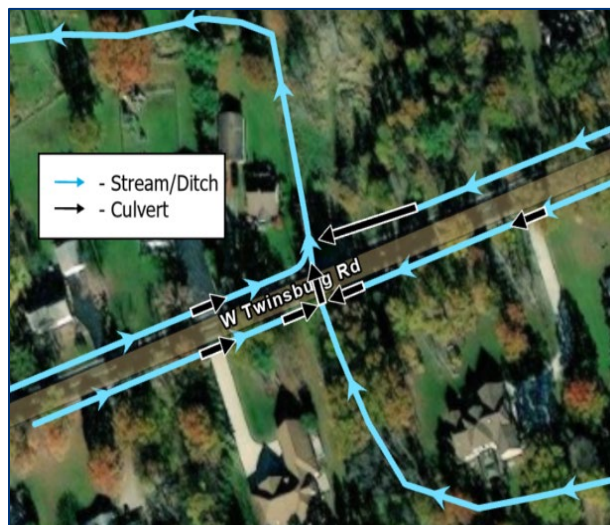
Figure 12. Problem area overview.

As part of the geomorphic assessment, Tetra Tech visited the sites of two service requests along West Twinsburg Road, just west of Olde 8 Road. The service request at 295 West Twinsburg Road is addressed under a baseline recommendation (Section 4.0) and requires no action (Table F- 1). The service request at 148 West Twinsburg Road is addressed under this problem area, and it includes four roadside ditches along West Twinsburg Road that converge at an unnamed stream that flows north and perpendicular to West Twinsburg Road (Figure 12). The county owns the culvert that crosses Twinsburg Road. Residents state the roadway is frequently flooded.

The second component of this problem area involves stabilizing the erosion along the West Twinsburg Road ditches at multiple locations, some of which exhibit lateral erosion into the shoulder of the road and is less than 1-foot from the paved road surface (Figure 14). Moving the ditch away from the roadway to achieve shallower bank slopes and to create a safe distance between the road surface and the ditch may be preferred.

Tetra Tech has provided SCE with a concept plan (Appendix G) and the associated costs of the recommended actions in this problem area as separate supporting documents to this report. Due to the extent and severity of the drainage issue, this problem area may be a good candidate to enact the ditch petition process and/or a larger stream restoration project, at the discretion of SCE.

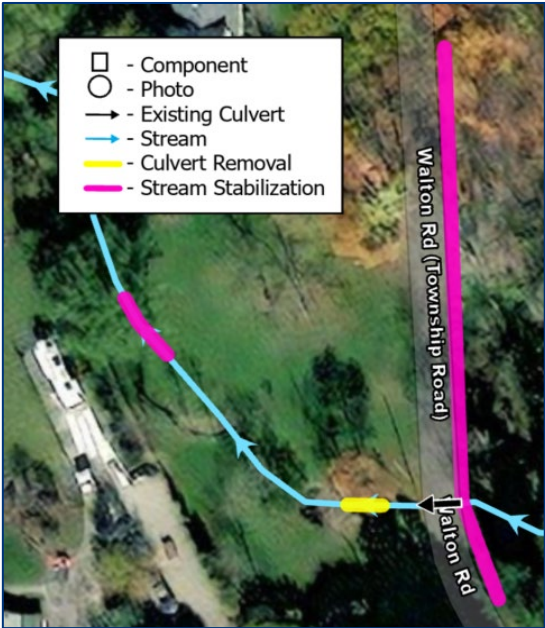
Figure 26. Locations of recommended actions.

This problem area is north of the Valley View Road – Walton Road intersection and is comprised of three components (Figure 26). First, the culvert (corrugated metal pipe; 5-foot diameter) under Walton Road is undersized with scouring at the inlet. Tetra Tech recommends this existing culvert remain in place. If the culvert were upsized, higher flows sent downstream would worsen the existing erosion and the downstream structures would flood more frequently. Rather, it is preferred that this culvert remain in place to attenuate the high flows. Leaving the undersized culvert in place will allow the area upstream of Walton Road to continue to flood and access its natural floodplain north of the existing stream. As such, stabilizing the east road embankment is necessary to prevent future erosion.

A second culvert (corrugated metal pipe; 2-foot diameter) is 20-feet downstream from the first culvert and further constricts flow (Figure 27). This culvert is beneath a small causeway that connects two grass yards. The causeway does not appear to serve any purpose. Tetra Tech recommends this culvert be removed to improve conveyance and restore the natural course of the stream.

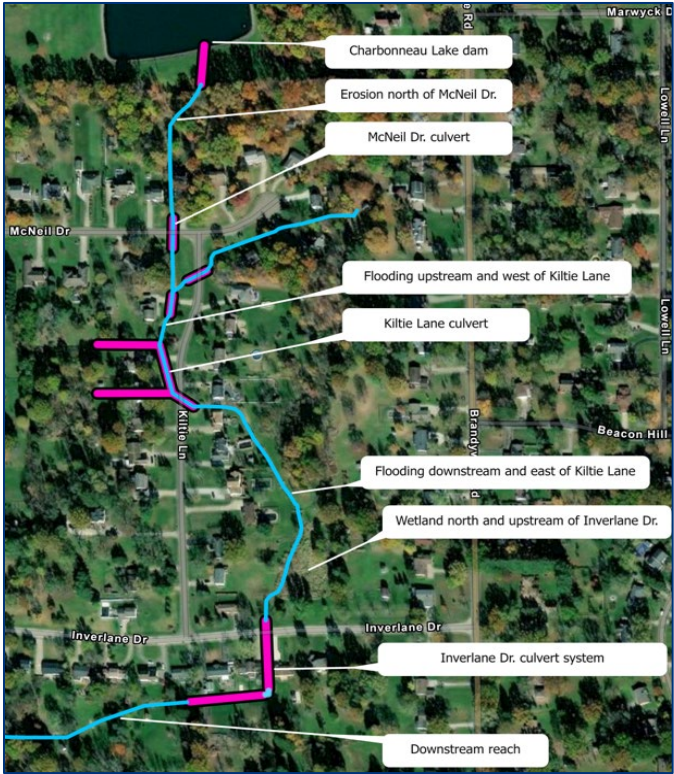
Figure 29. Inverness Highlands problem area overview.

The Inverness Highlands problem area covers a large spatial extent, spans multiple stream reaches and culverts, and addresses both flooding and erosion problems (Figure 29). Portions of this problem area are within the Inverness Highlands Phase V assessed subdivision and a portion of the work may be paid for with assessed subdivision funds. The erosion and drainage issues presented herein are interconnected and require a holistic solution to not disrupt the stream equilibrium and cause issues elsewhere. Due to the complexity of this problem area, Tetra Tech has provided SCE with a separate memorandum for this problem area (Tetra Tech, 2025c) which includes the following: (1) a summary of issues and components in the area, (2) detailed assessment on each issue/component including the HY-8 modeling of the Kiltie Lane culvert, and (3) recommended actions and alternatives. Tetra Tech has also provided SCE with concept plans (Appendix G) and the associated costs for the recommended actions in this problem area as separate supporting documents to this report.

- Stabilize the lateral erosion on the right bank of the reach upstream of McNeil Drive in its current location which may require the purchase of additional easement width.
- Remove the bridges that are obstructing flow in the reach downstream of the Kiltie Lane Culvert and the reach downstream of the Inverlane Drive culvert system.
- Repair the sinkhole above the Inverlane Drive culvert system by re-grading the yard and installing a new catch basin to prevent further washout and possible culvert damage.
- Reduce the 100-year peak flows entering the Kiltie Lane culvert via construction of a detention basin upstream of the Kiltie Lane culvert. The size and location of the detention basin will need to be finalized during the design phase after a topographic survey and more detailed modeling are conducted.

Finally, residents are encouraged to preserve the hydraulic capacity of the unnamed stream by keeping the channel free from obstructions, including yard waste and footbridges.
