Cuyahoga River Watershed Study

Summit County Surface Water Management District

Summit County Engineer

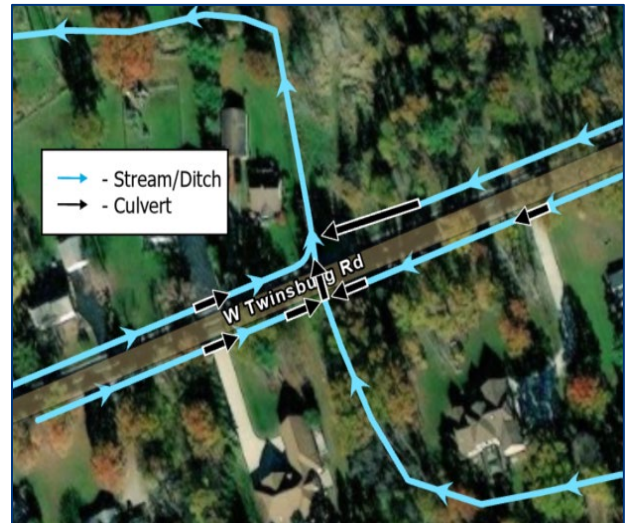
Figure 12. Problem area overview.

As part of the geomorphic assessment, Tetra Tech visited the sites of two service requests along West Twinsburg Road, just west of Olde 8 Road. The service request at 295 West Twinsburg Road is addressed under a baseline recommendation (Section 4.0) and requires no action (Table F- 1). The service request at 148 West Twinsburg Road is addressed under this problem area, and it includes four roadside ditches along West Twinsburg Road that converge at an unnamed stream that flows north and perpendicular to West Twinsburg Road (Figure 12). The county owns the culvert that crosses Twinsburg Road. Residents state the roadway is frequently flooded.

Tetra Tech has provided SCE with a concept plan (Appendix G) and the associated costs of the recommended actions in this problem area as separate supporting documents to this report. Due to the extent and severity of the drainage issue, this problem area may be a good candidate to enact the ditch petition process and/or a larger stream restoration project, at the discretion of SCE.
