Norwood Lake Storm Sewer Outlet Improvements

Cherry Lane and Beechwood Drive
Northfield Center Township, Summit County

DRAINAGE MEMO

Palmer Engineering Company
3745 Medina Rd, Suite A
Medina, OH 44256

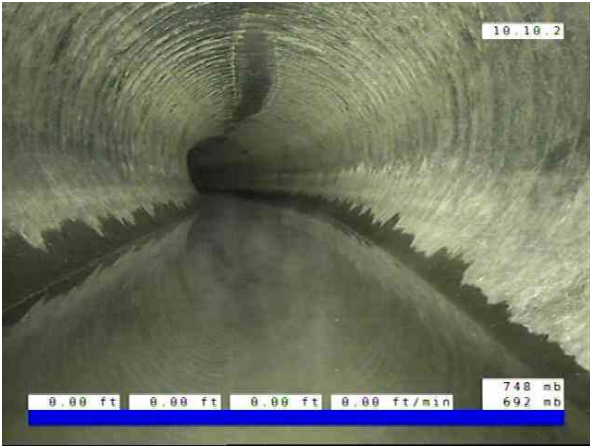
Inlet03-Inlet
04_98847996-b37f-4dea-af19-56fe634cb99e_20251010_0822
15_261.jpg, 00:00:00, 0.00ft
Catch Basin / Inlet 04

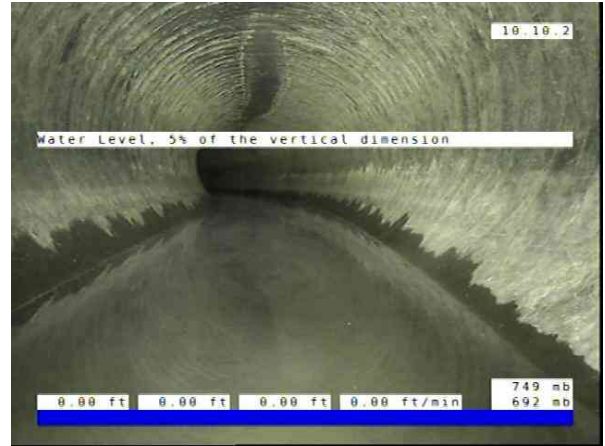
Inlet03-Inlet
04_14fd7f9a-5e35-4ba4-ade9-3bfd7f86d69_20251010_08222
3_298.jpg, 00:00:02, 0.00ft
Water Level, 5% of the vertical dimension

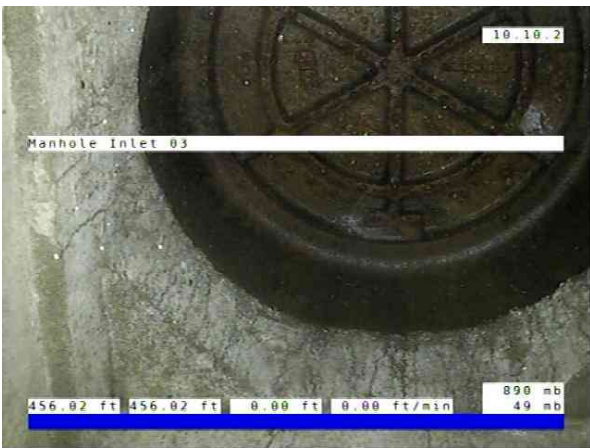
Inlet03-Inlet
04_d446c0f7-ca37-43ab-8d3c-f7ff7cd21453_20251010_08505
9_820.jpg, 00:21:13, 456.02ft
Manhole / Inlet 03

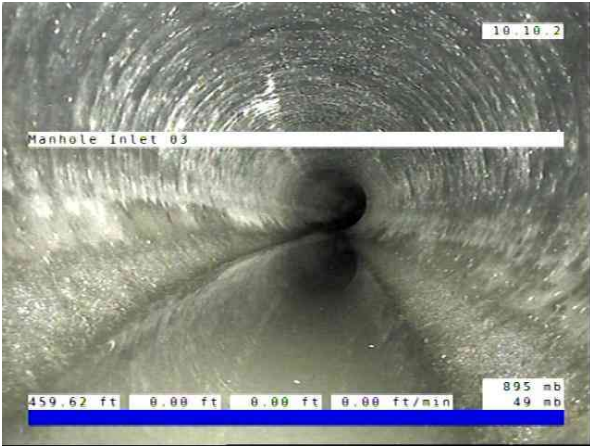
Inlet02-Inlet
03_bf241c86-e28c-4c86-b9c5-b242dc8ddb64_20251010_085
213_290.jpg, 00:00:00, 0.00ft
Manhole / Inlet 03

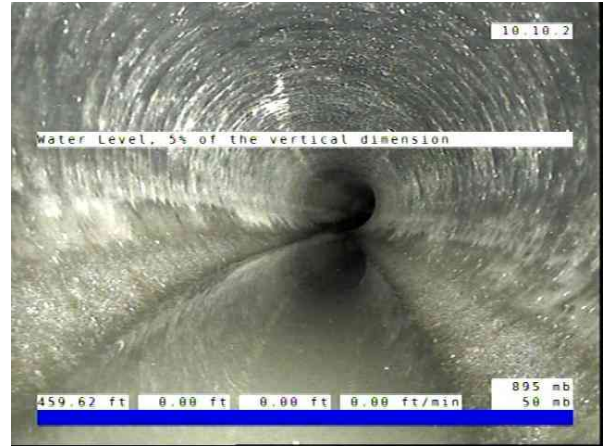
Inlet02-Inlet
03_6cd41142-0efb-4015-8b6c-2e067fc3128f_20251010_0852
19_792.jpg, 00:00:03, 0.00ft
Water Level, 5% of the vertical dimension

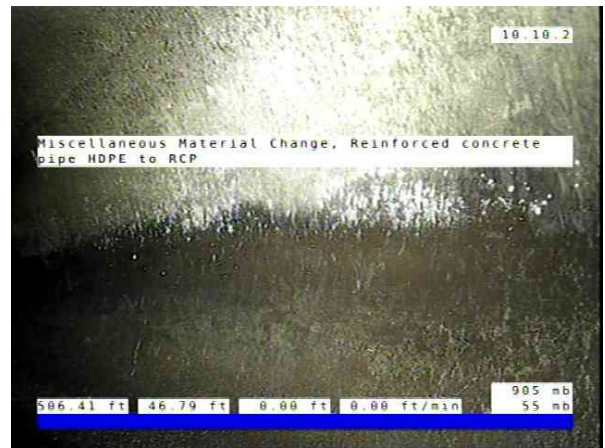
Inlet02-Inlet
03_3e24ec0e-4f99-405f-947d-06956c2e0b8c_20251010_0855
51_095.jpg, 00:03:08, 46.79ft
Miscellaneous Material Change, Reinforced concrete pipe /
HDPE to RCP

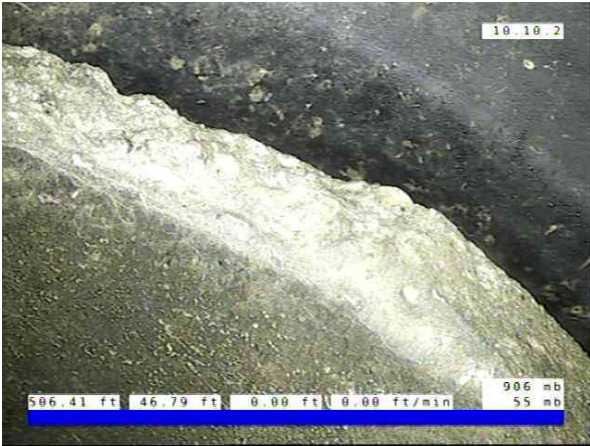
Inlet02-Inlet
03_27a9f95b-5a43-46f0-9739-0911ed2e6077_20251010_085
624_226.jpg, 00:03:11, 46.79ft
Miscellaneous Shape or Size Change / 18" to 15"

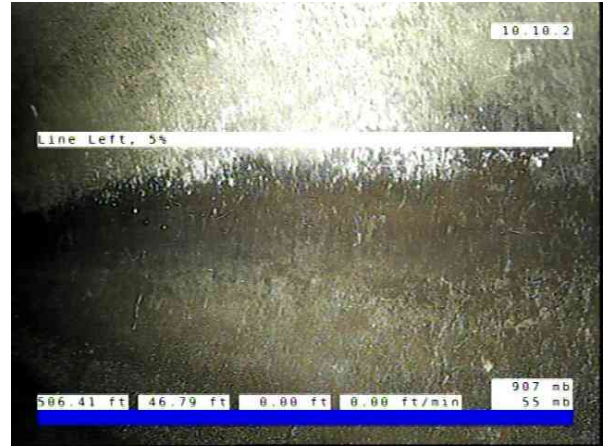
Inlet02-Inlet
03_790d8dd9-b9b3-4802-9c19-c5307b0a59d7_20251010_085
636_937.jpg, 00:03:25, 46.79ft
Line Left, 5%

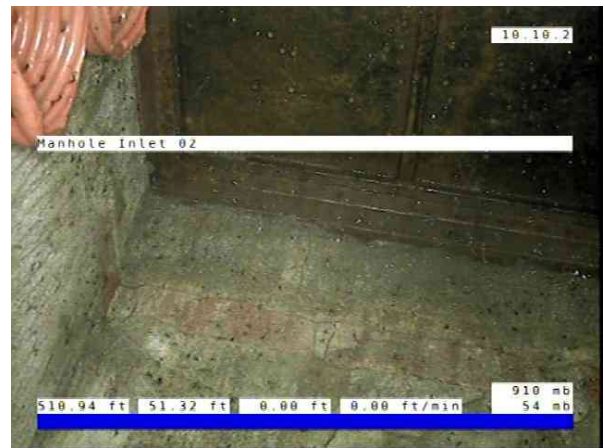
Inlet02-Inlet
03_aa85427d-9380-416e-bf6a-99993cae7bd0_20251010_085
809_833.jpg, 00:04:43, 51.32ft
Manhole / Inlet 02

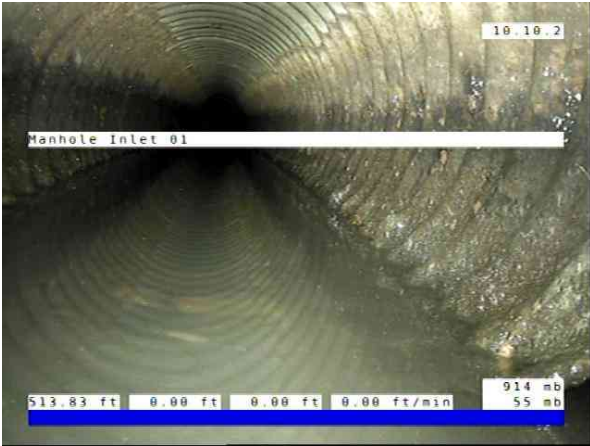
Inlet01-Inlet
02_0e558b1c-3f89-4ecb-bb9c-3f87b4d61fc1_20251010_0859
38_169.jpg, 00:00:00, 0.00ft
Manhole / Inlet 01

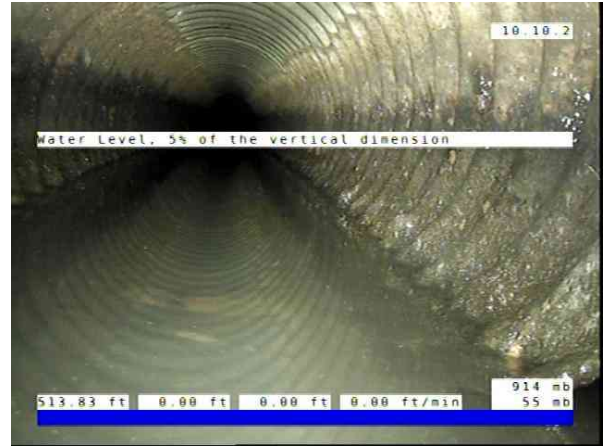
Inlet01-Inlet
02_4f6d9d40-66b9-43d4-a48d-bce40afa5314_20251010_0859
43_388.jpg, 00:00:03, 0.00ft
Water Level, 5% of the vertical dimension

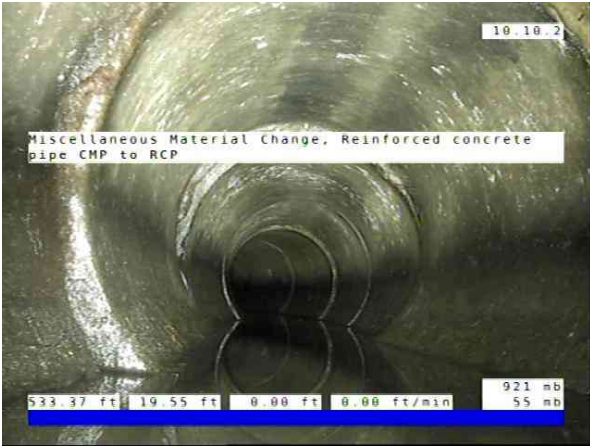
Inlet01-Inlet
02_5e12a33c-8def-4af7-947d-3fb8f3a82718_20251010_0902
51_999.jpg, 00:02:14, 19.55ft
Miscellaneous Material Change, Reinforced concrete pipe /
CMP to RCP

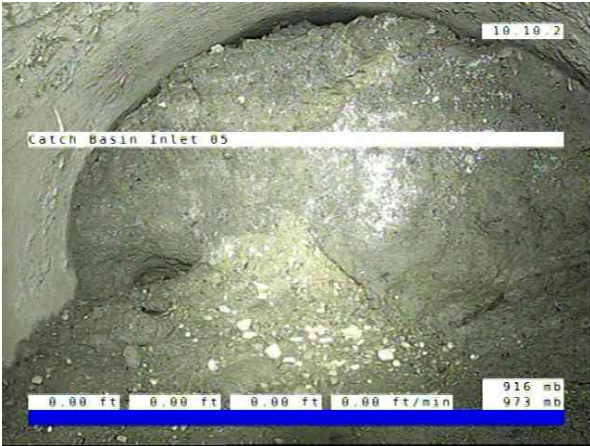
Inlet04-Inlet
05_770bcdde-84b8-4ac9-98a4-e624e9c8505c_20251010_100
716_451.jpg, 00:00:00, 0.00ft
Catch Basin / Inlet 05

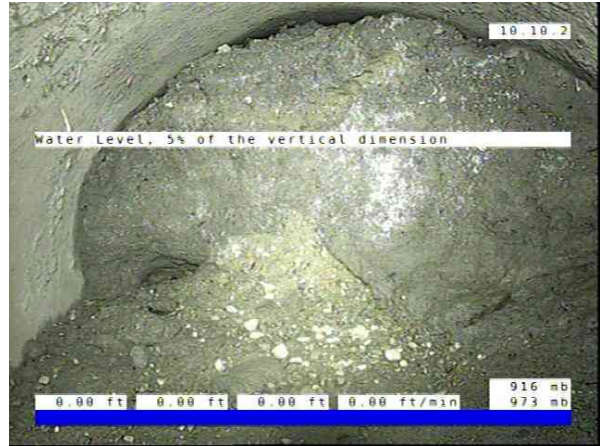
Inlet04-Inlet
05_0b6b54d4-1ae0-4886-a919-0bd9db447a9c_20251010_100
721_453.jpg, 00:00:03, 0.00ft
Water Level, 5% of the vertical dimension
